FgArea: [' 1']  
NJ15 L1  
2026-01-27 (Day 113)

Trend plot for LIA1\_1

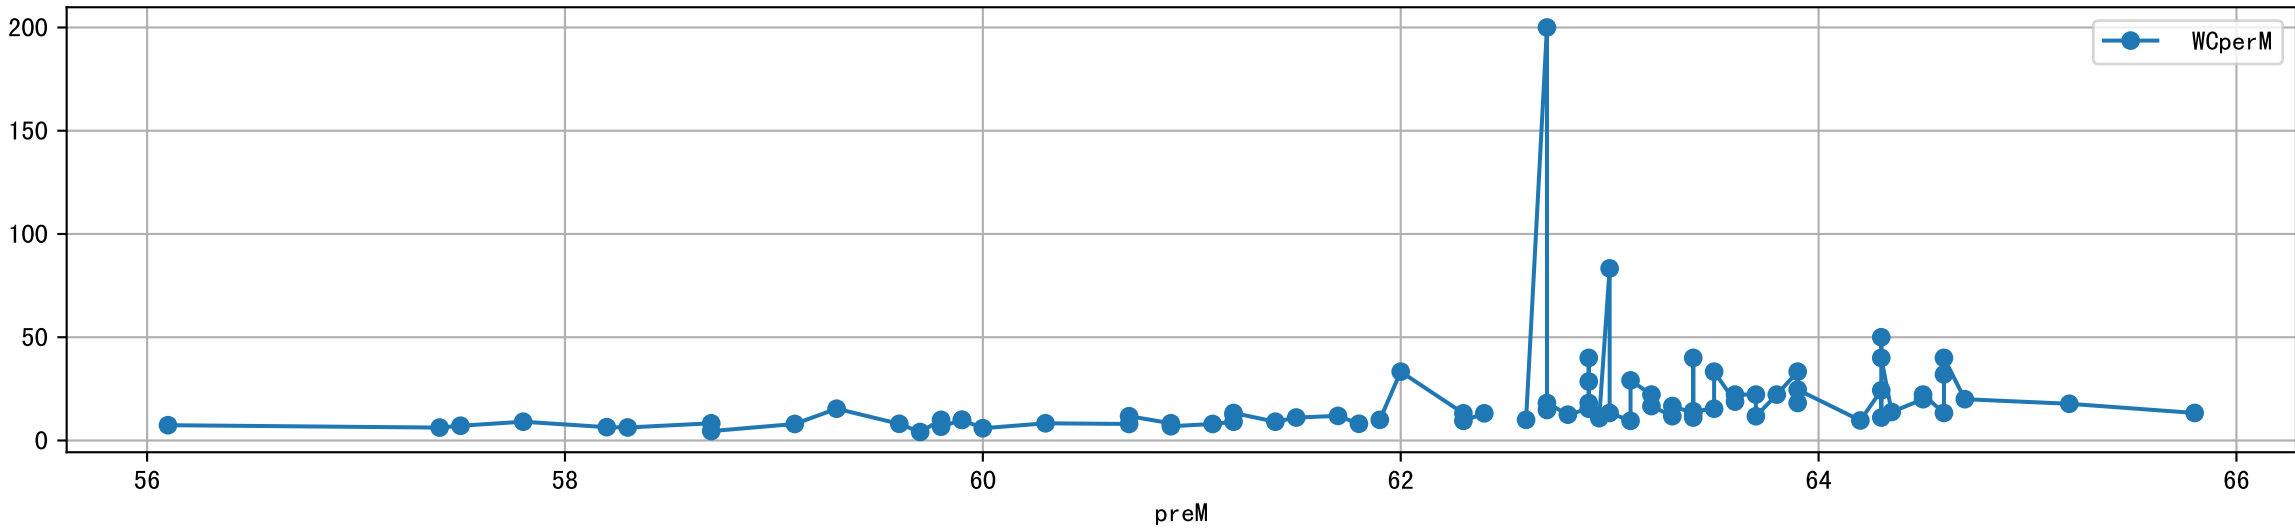
Plot preM vs WCperM

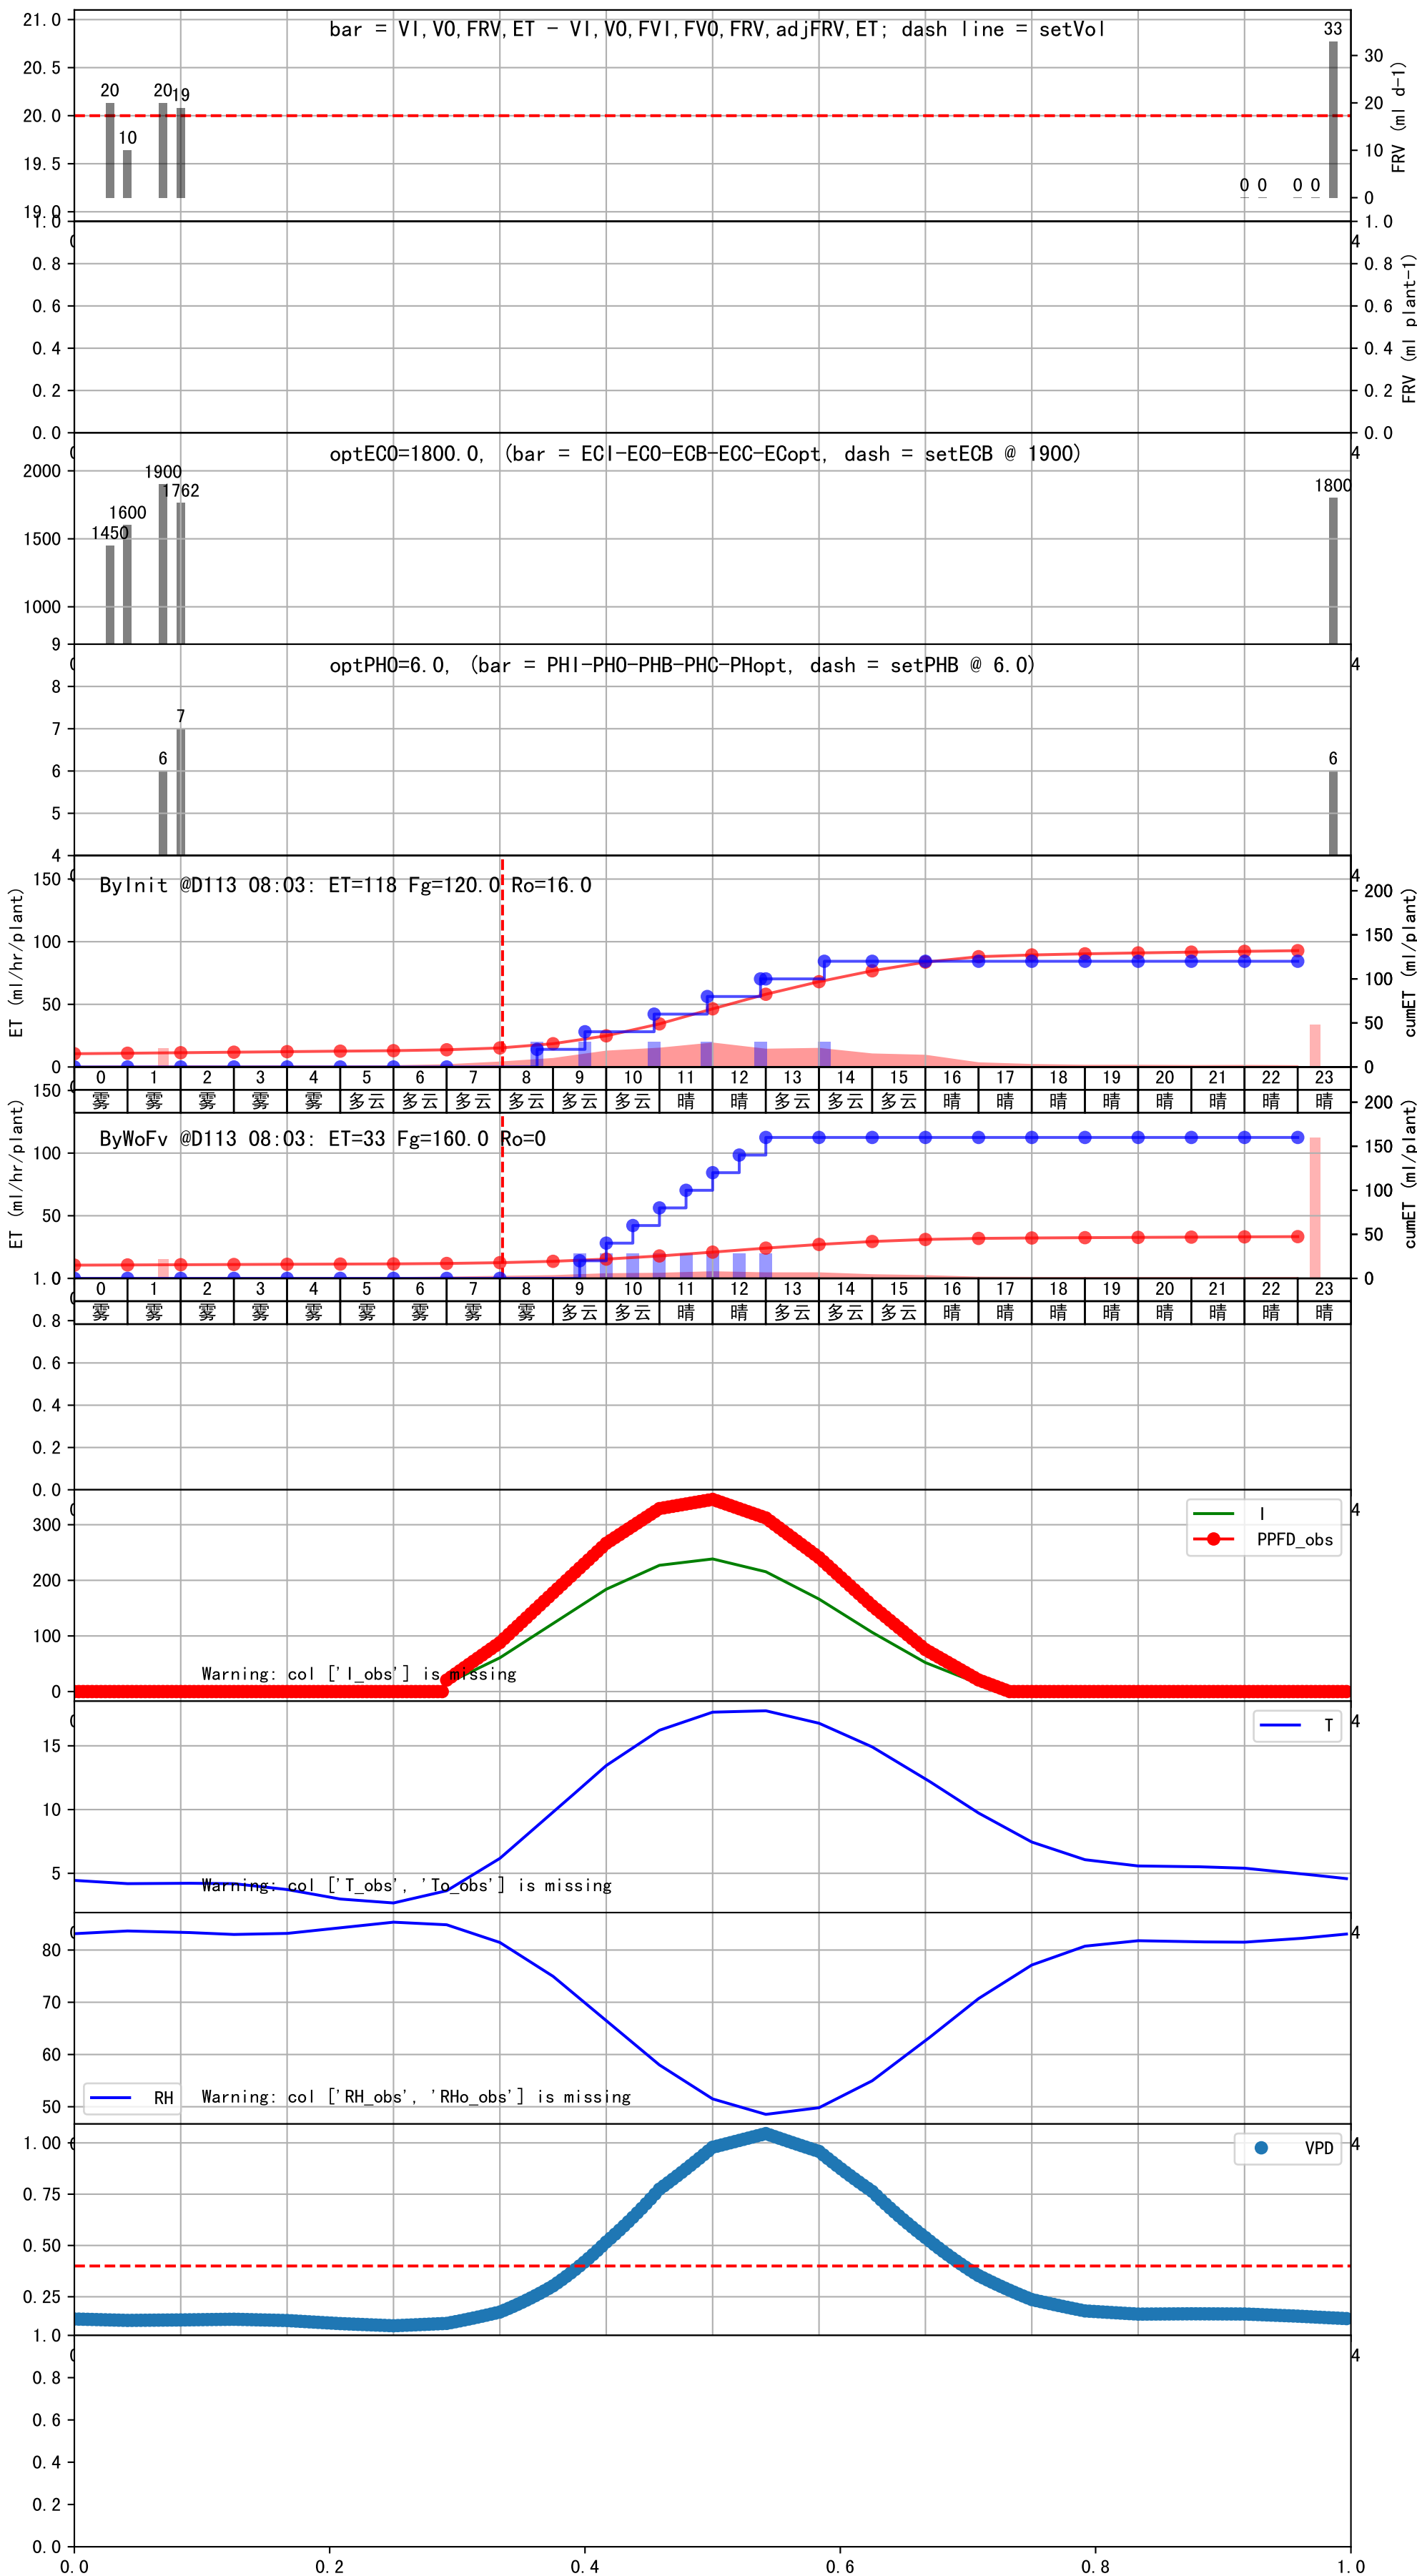
L1A1

时间	灌溉时长(秒)	灌溉量(毫升/株)	灌溉总量(方/次)	天气	注释
10:35	32	20.0	0.081	阴	假设@10:35 自动 (未用传感器)
总计	32.0 (1次)	20.0			建议进液EC: 1900, PH: 6.0

上次灌溉流速比过去5天平均大 (0.61 vs 0.55), 可能管道压力异常或有管道漏水  
上次灌溉时长未按模型建议 (32 vs 36.0)  
默认实际灌溉18.0 ml.

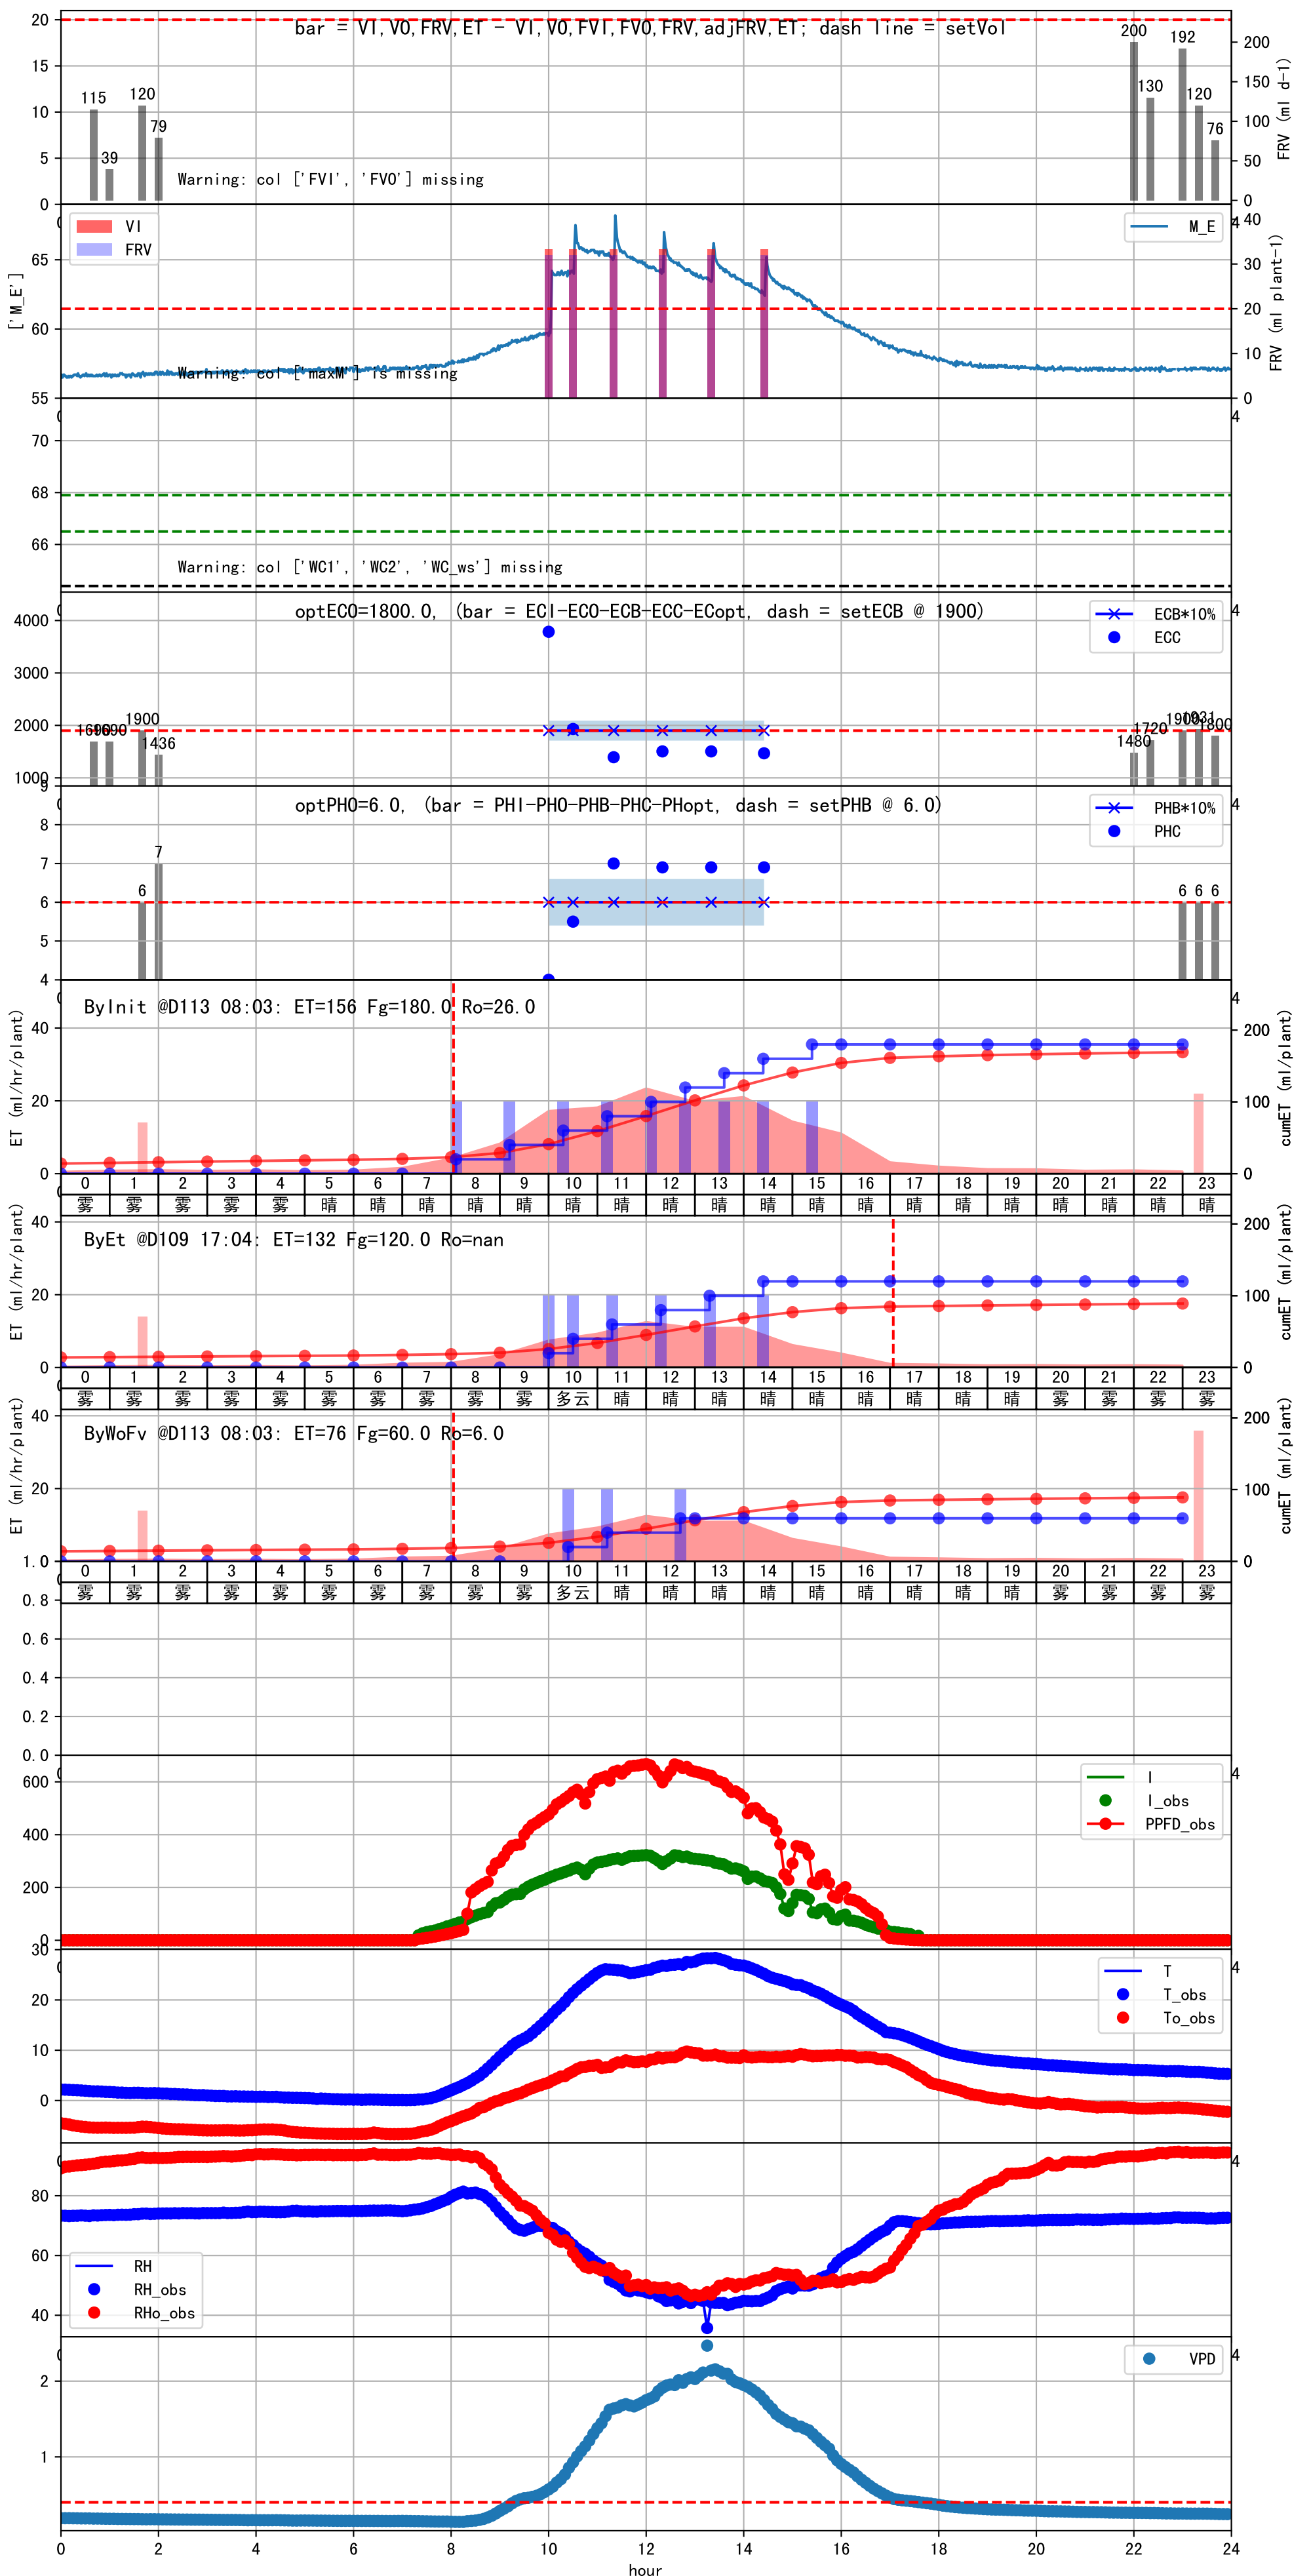
时间	灌溉时长(秒)	灌溉量(毫升/株)	灌溉总量(方/次)	天气	注释
10:25	36	20.0	0.081	多云	假设@10:25 自动 (未用传感器)
11:10	36	20.0	0.081	晴	假设@11:10 自动 (未用传感器)
12:40	36	20.0	0.081	晴	假设@12:40 自动 (未用传感器)
总计	108.0 (3次)	60.0			建议进液EC: 1900, PH: 6.0

上次灌溉流速比过去5天平均大 (0.89 vs 0.55), 可能管道压力异常或有管道漏水  
 施肥机灌溉量与预期值不符 (32.0 : 20.0), 可能水表需要校准  
 默认实际灌溉20.0 ml.
