FgArea: [' C4']
NJ15 L1
2026-02-28 (Day 145)

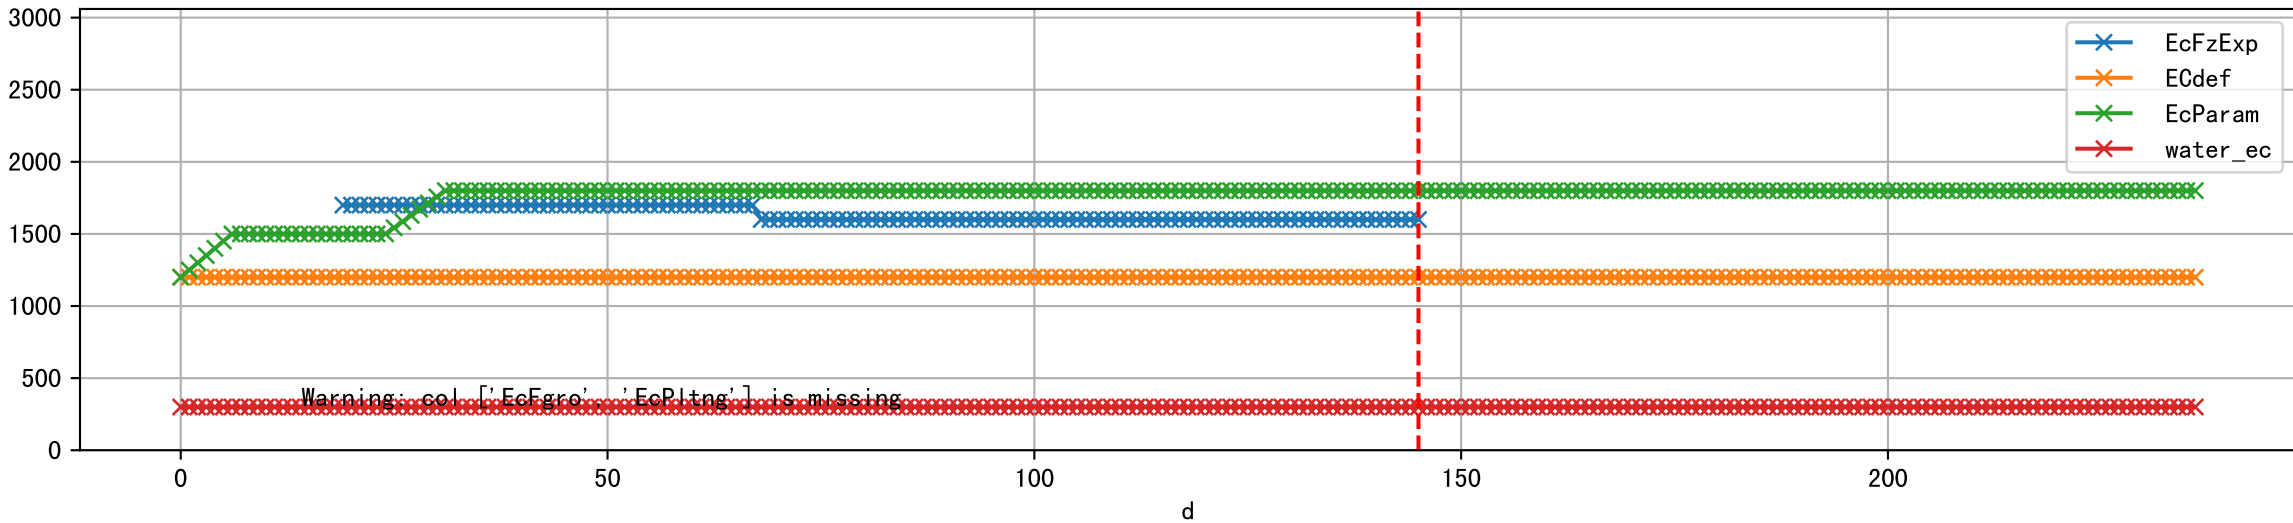
Plot [['EcFgro', 'EcFzExp', 'EcPltng', 'ECdef', 'EcParam', 'water_ec']]

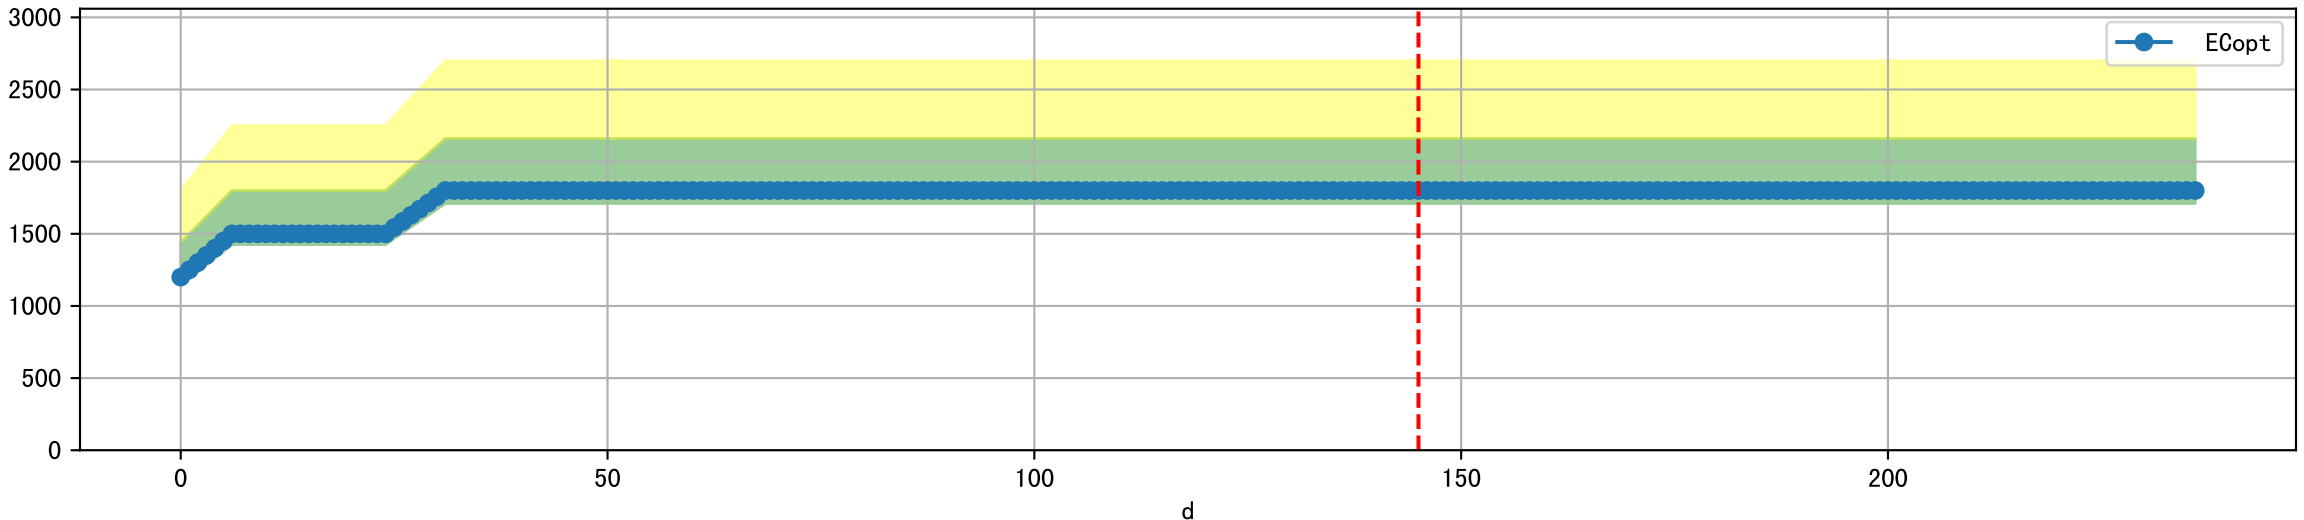
Plot [' ECopt ']

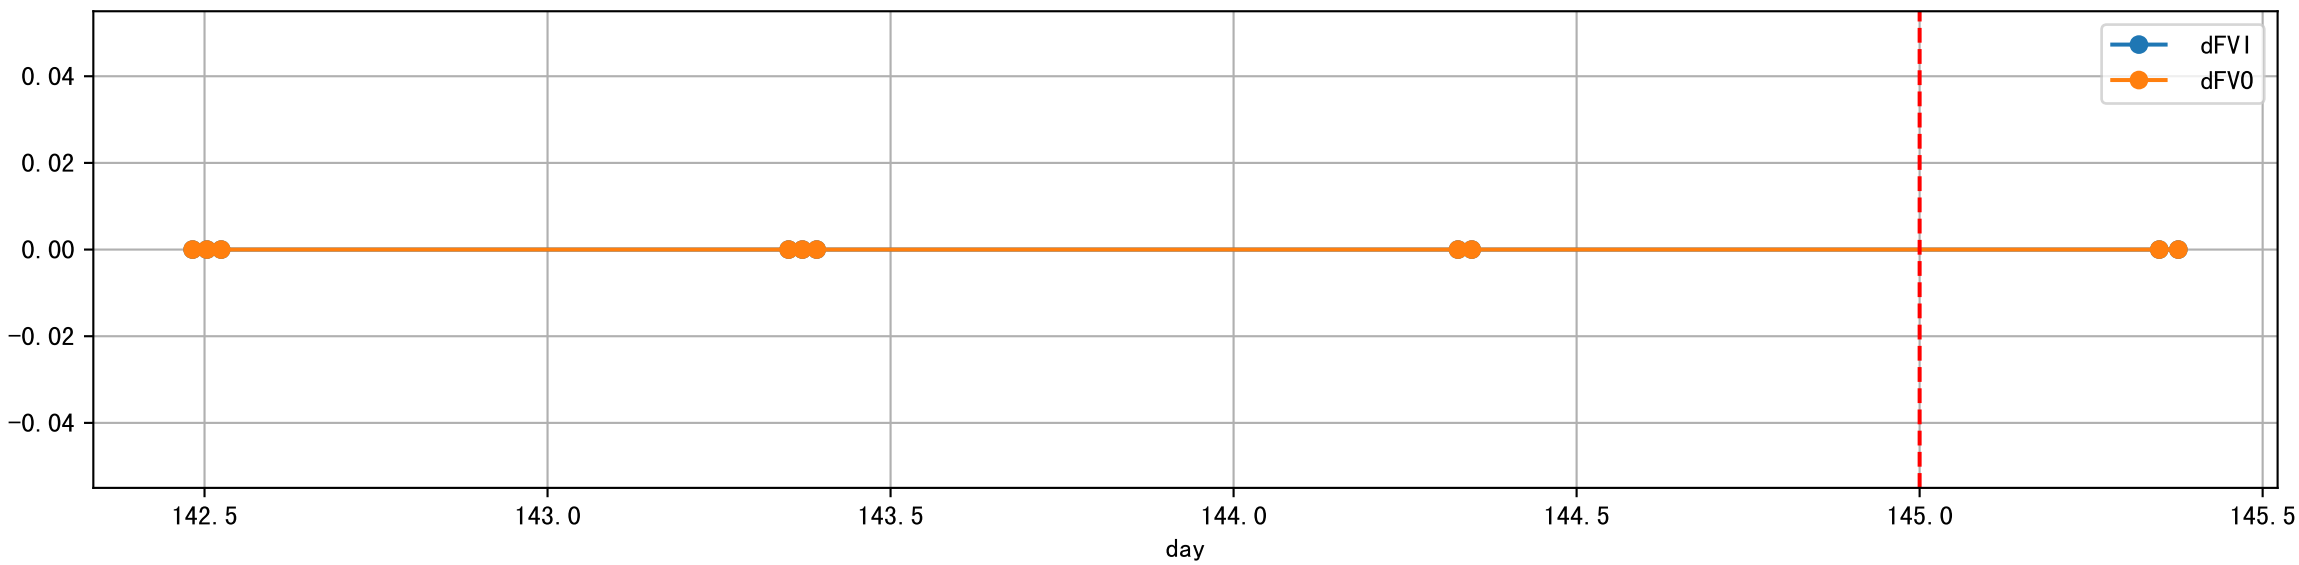
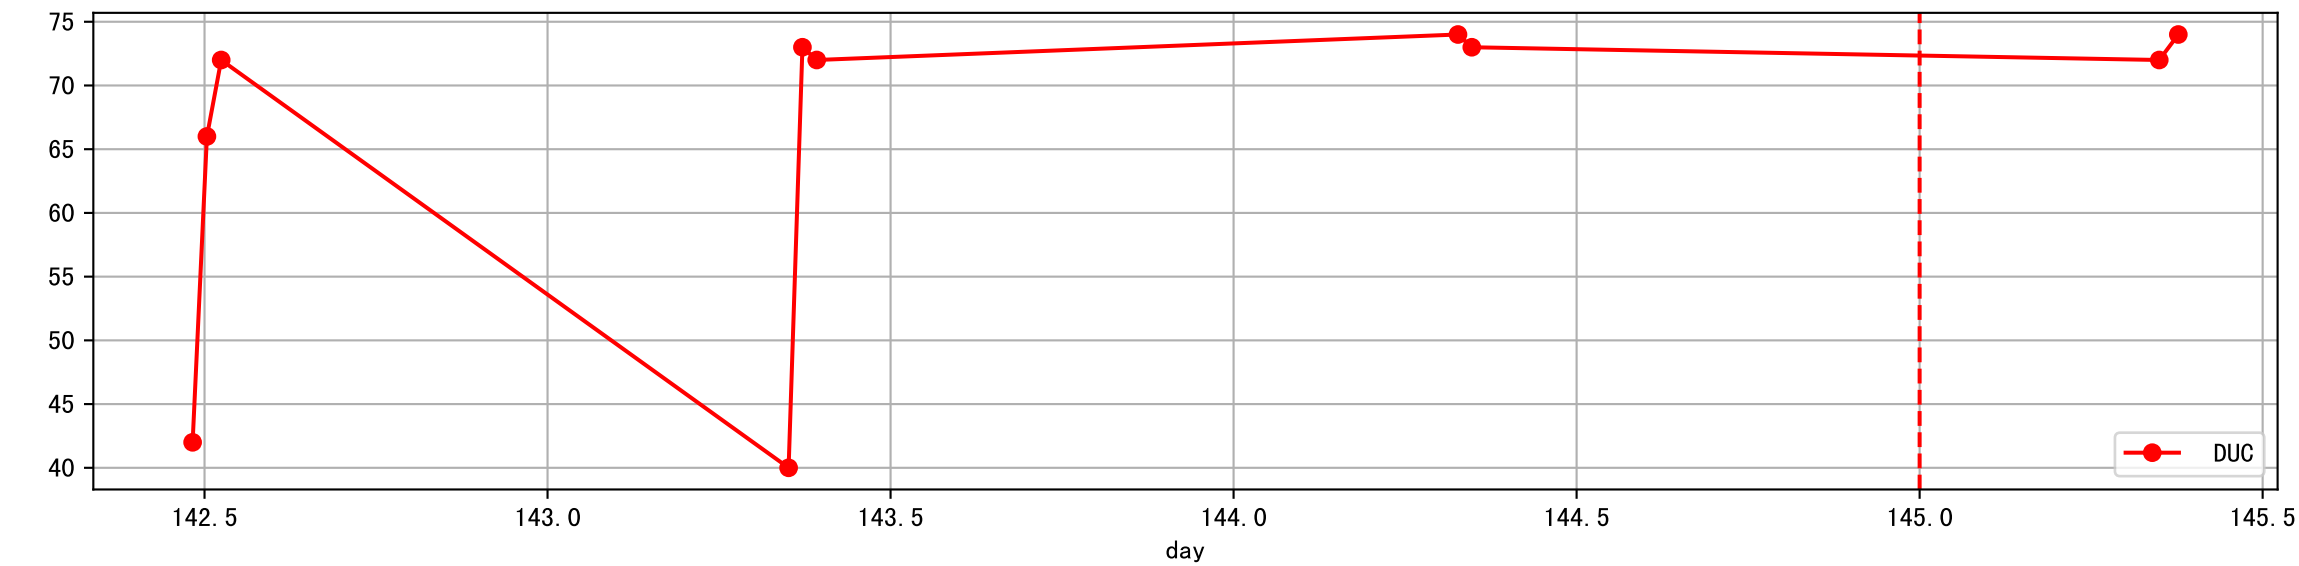
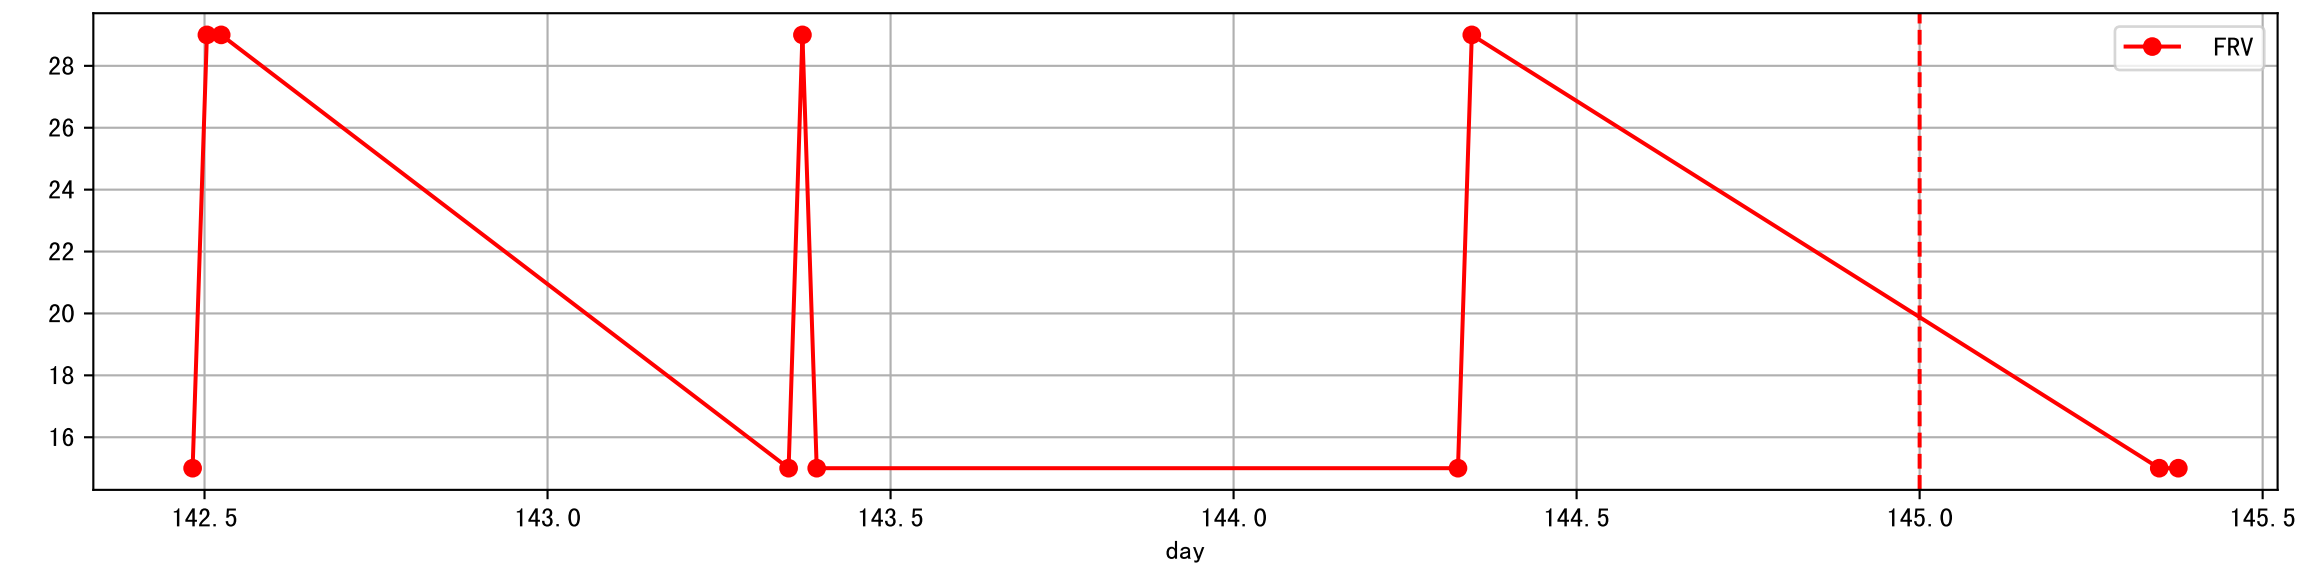
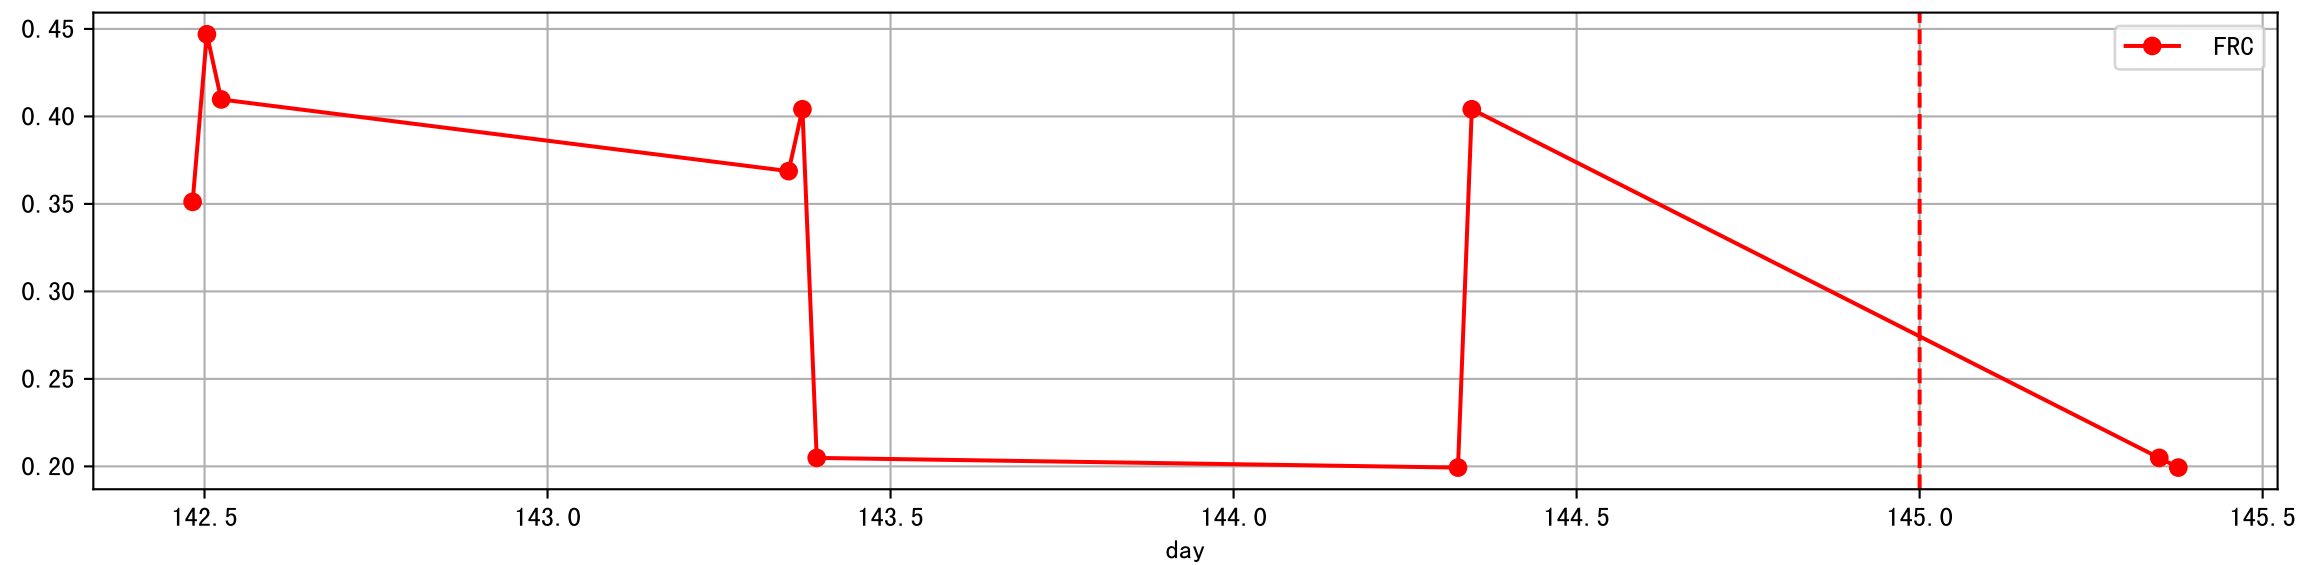
Plot Sensor and FgRec Data

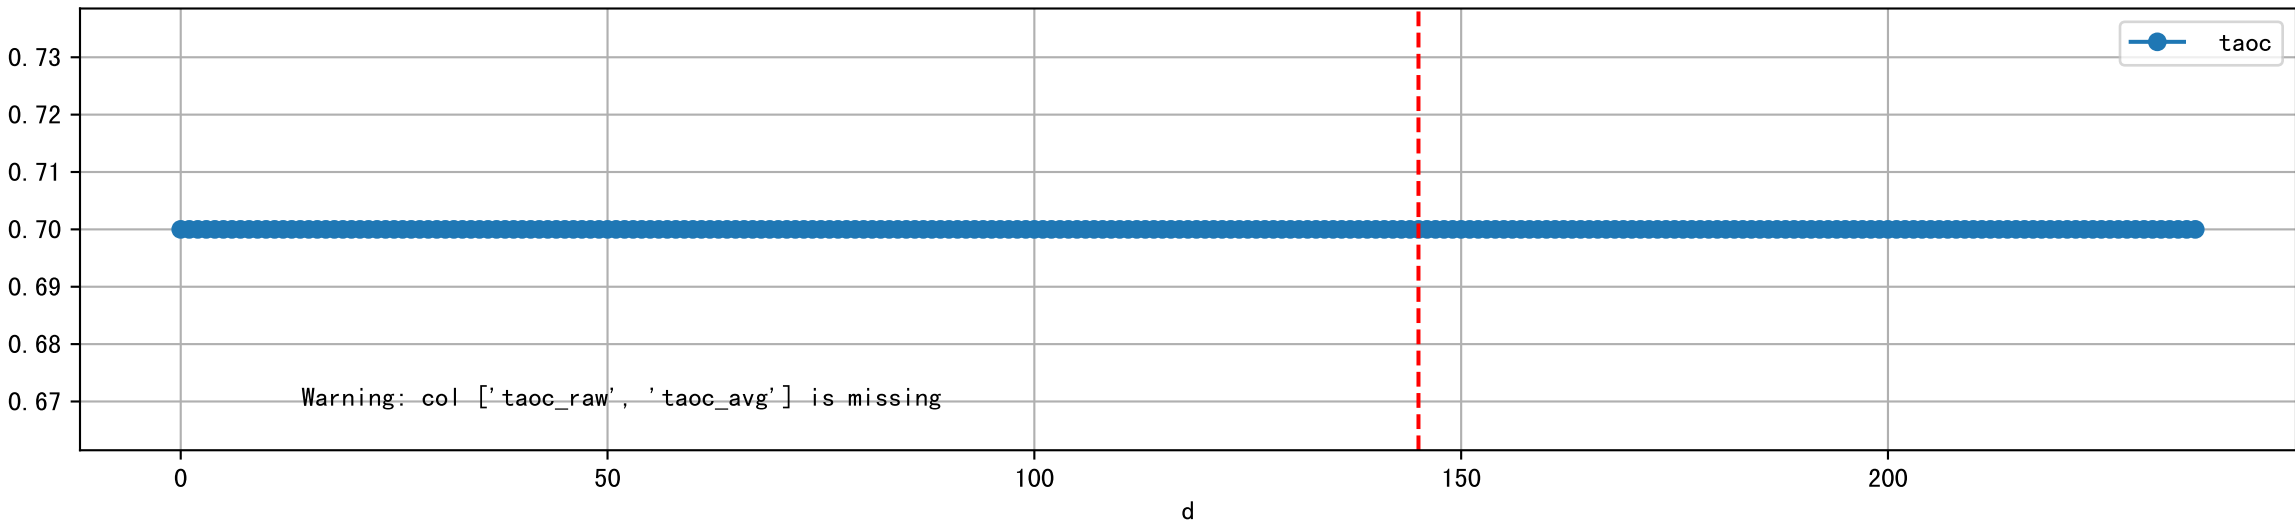
Plot [['taoc', 'taoc_raw:ro', 'taoc_avg:r-']]

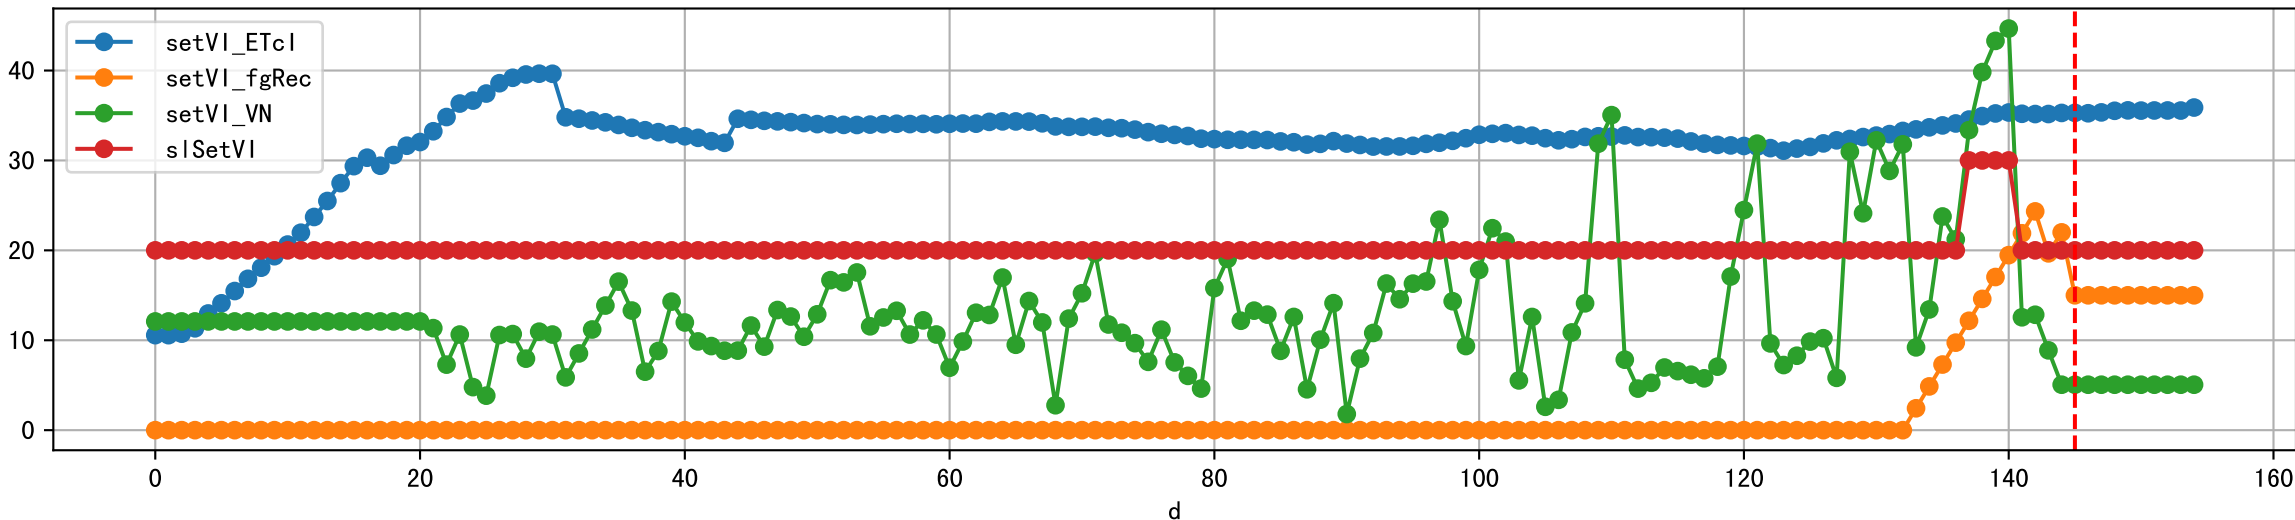
Plot [['setVI_ETcI', 'setVI_fgRec', 'setVI_VN', 'sISetVI']]

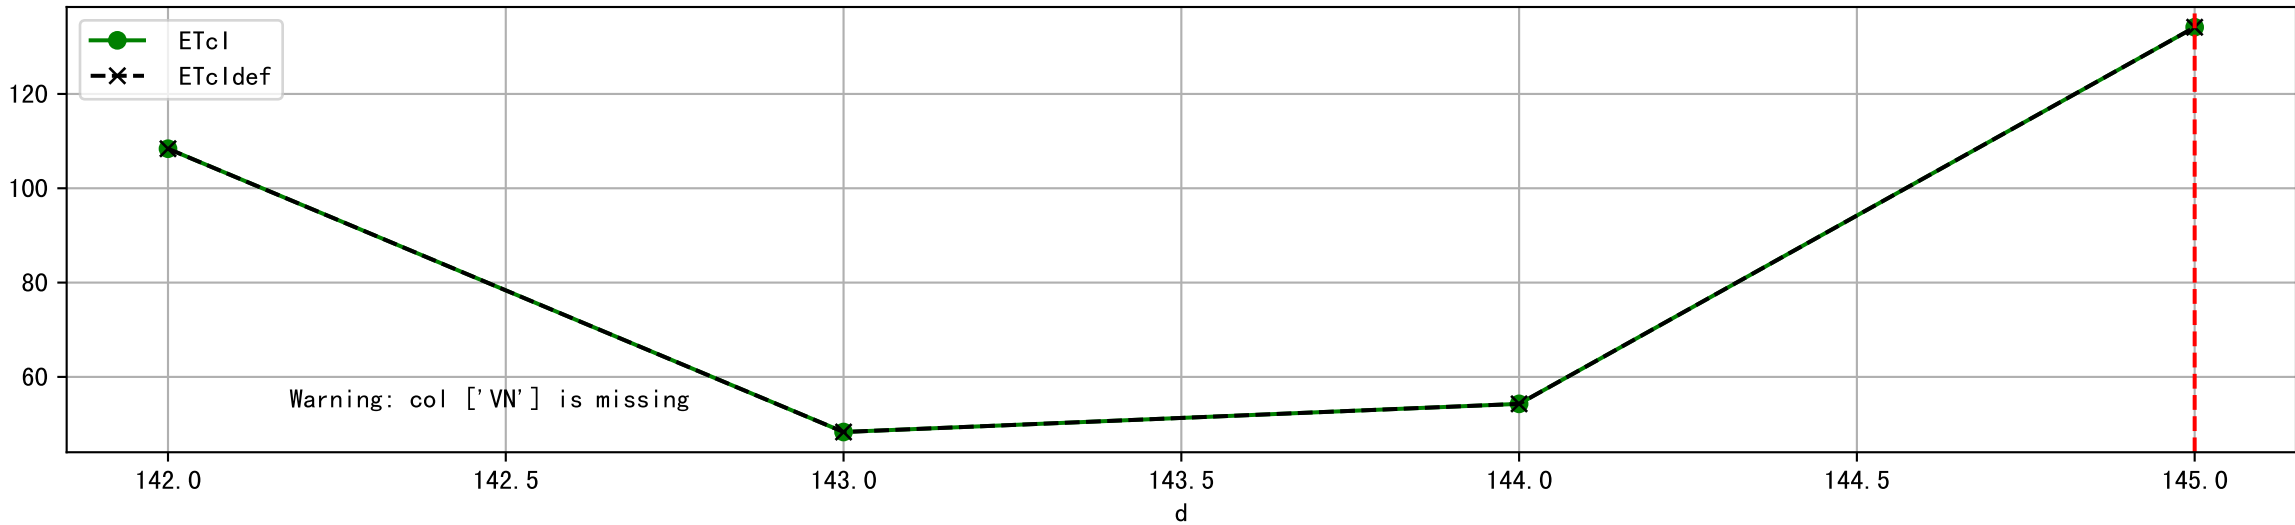
Plot ET/VN

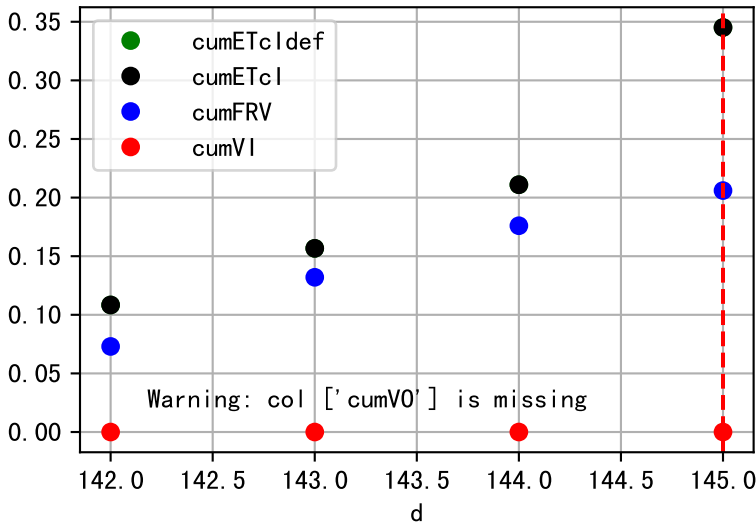
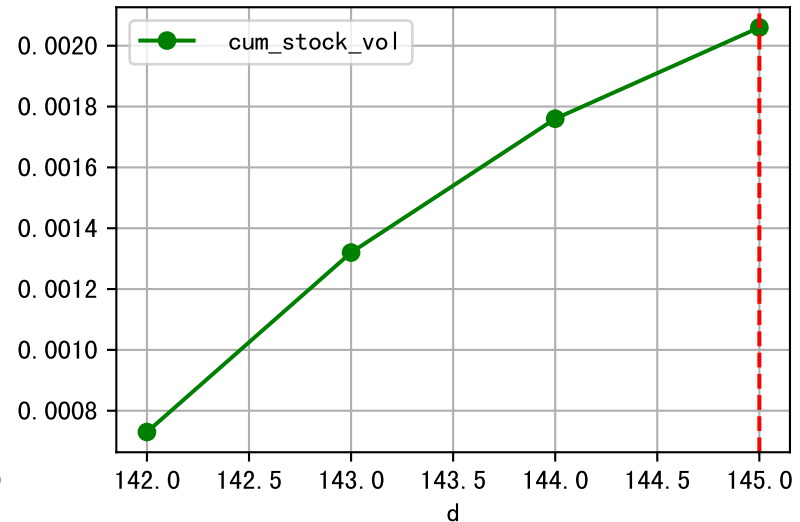
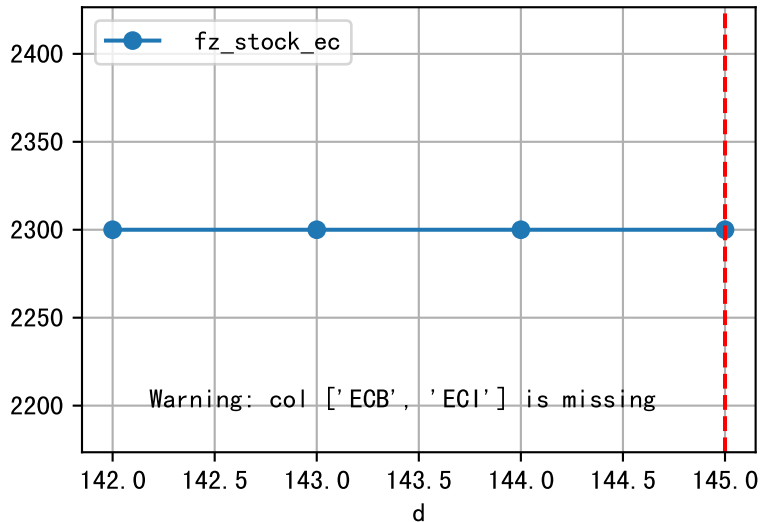
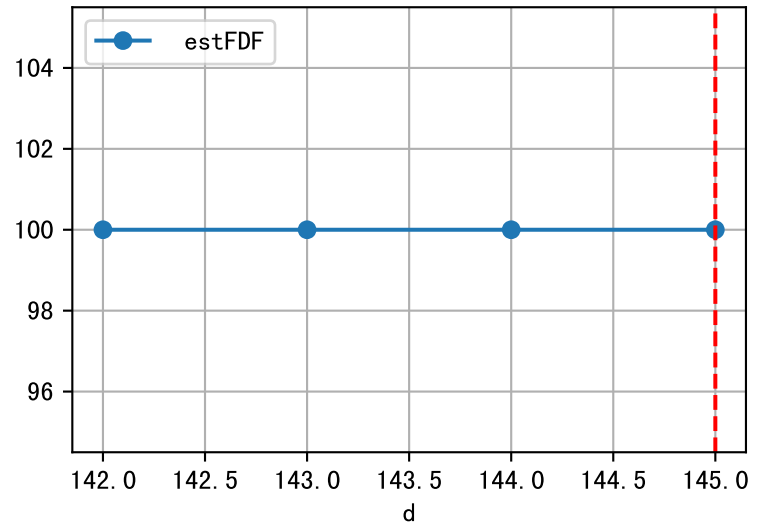
Plot Fv and fertilizer usage

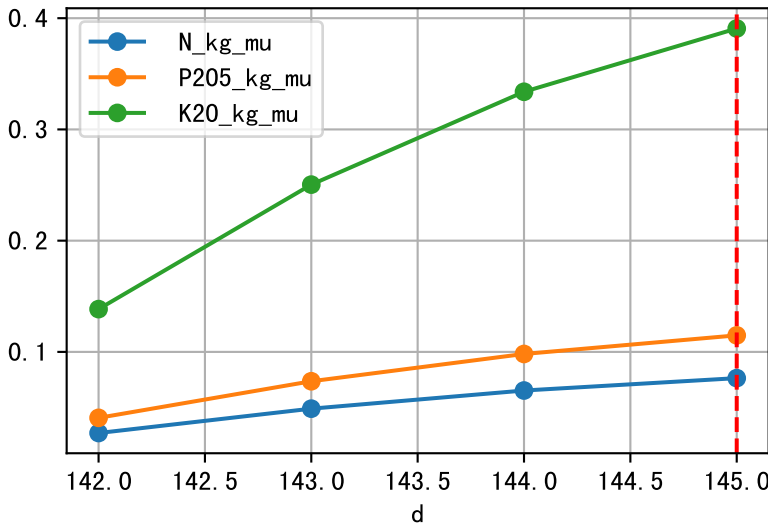
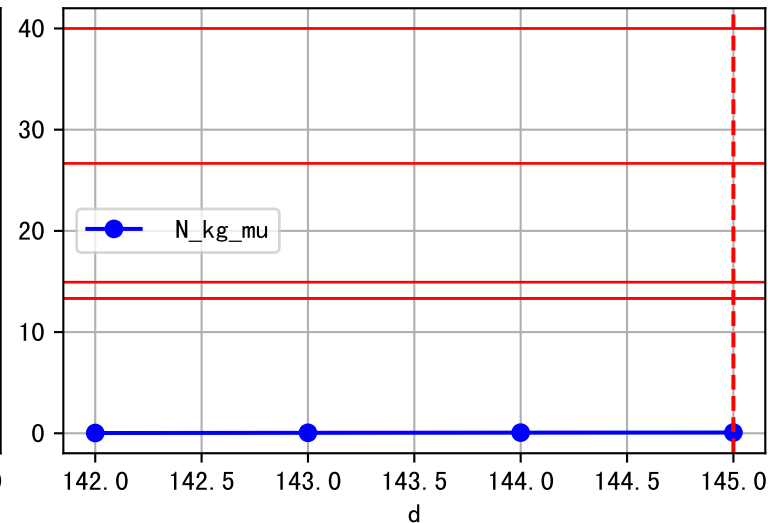
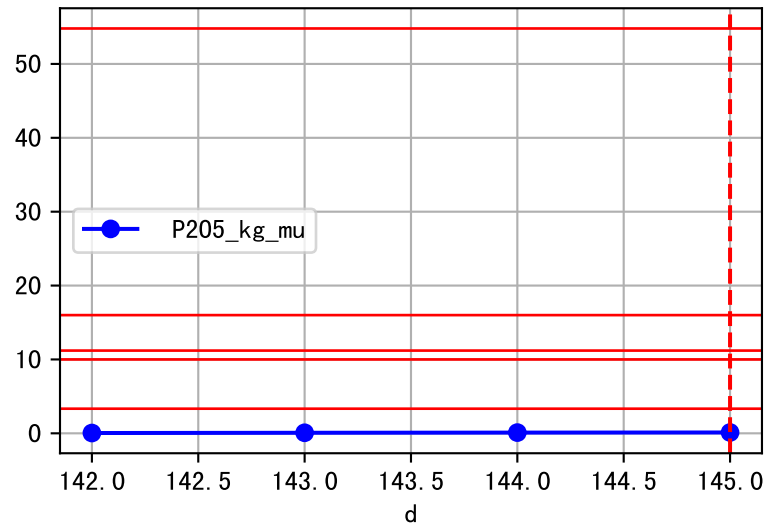
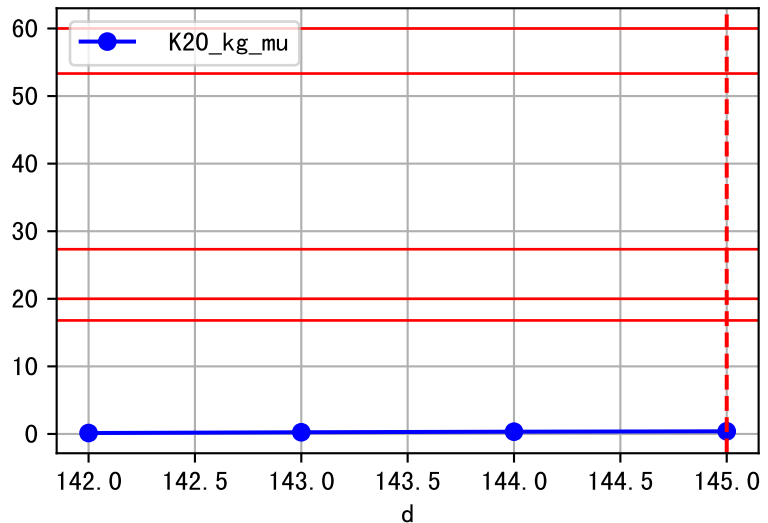
Fertilizer Range Source: kerleyL, kerleyH, UnivFL, TNAI, Haifa

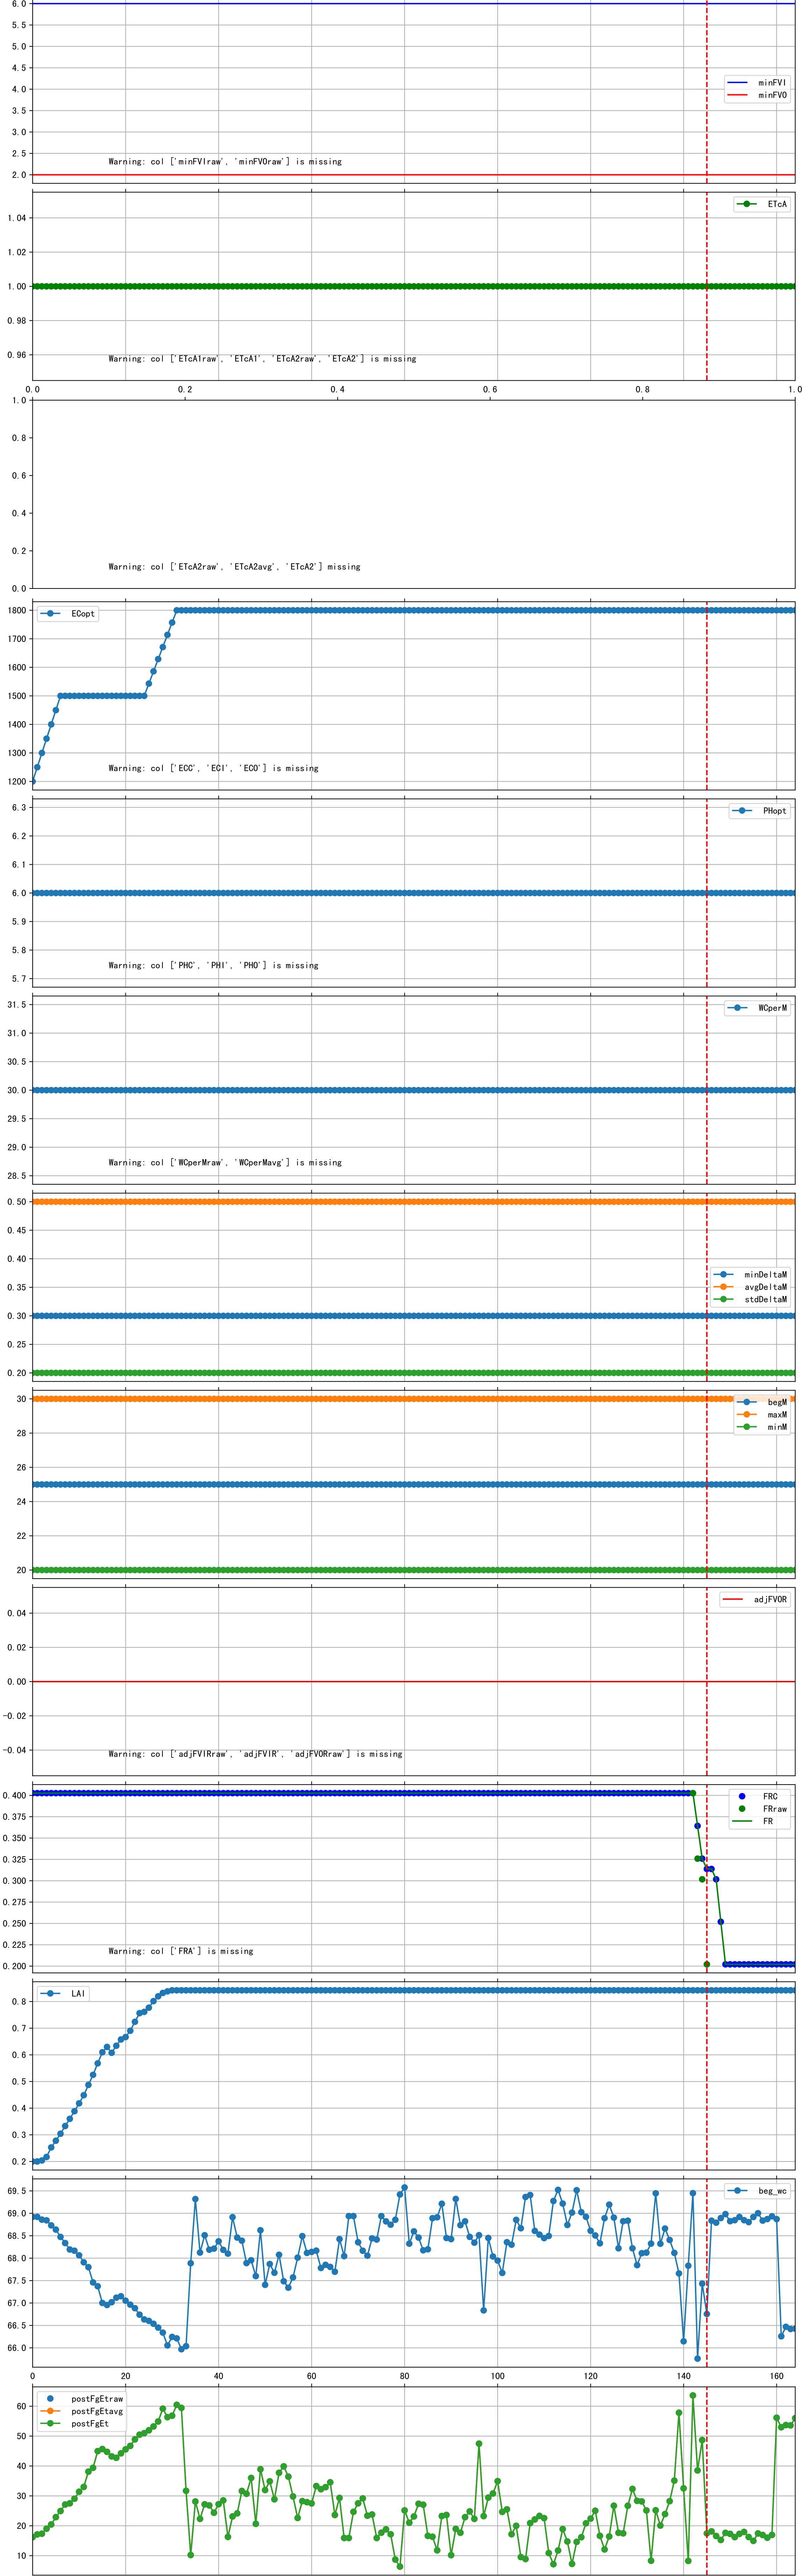
Trend plot for L1AC4_C4

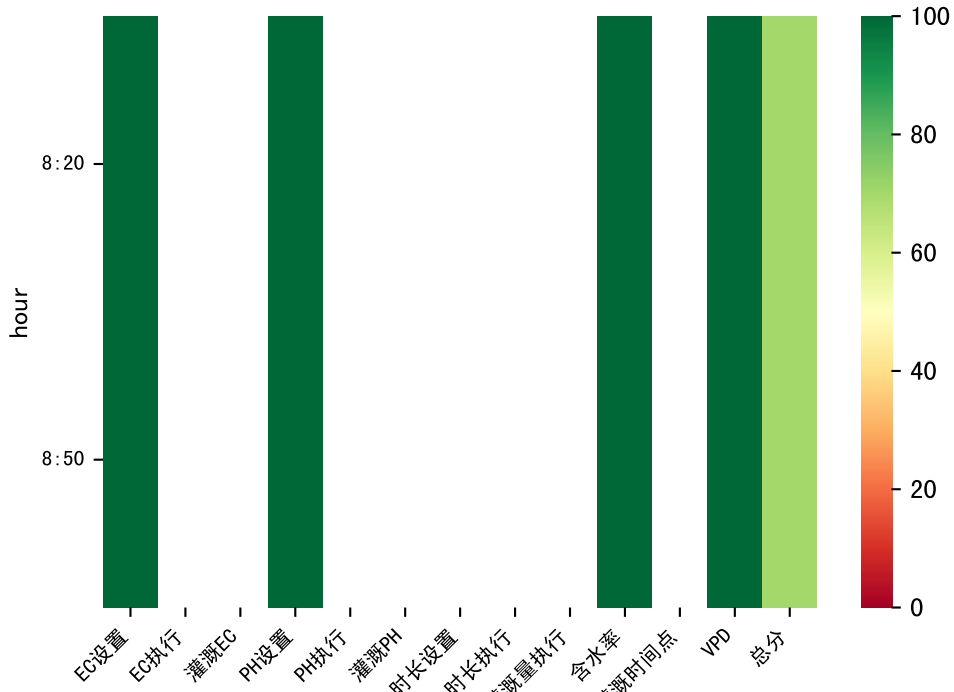
A阀开关时间(秒)	B阀开关时间(秒)
关' : 13, ' 占空比' : 50}, {' 开' : 35, ' 关' : 43, ' 占空比' : 50}]	[{' 开' : 16, ' 关' : 24, ' 占空比' : 50}, {' 开' : 46,
关' : 13, ' 占空比' : 50}, {' 开' : 35, ' 关' : 43, ' 占空比' : 50}]	[{' 开' : 16, ' 关' : 24, ' 占空比' : 50}, {' 开' : 46,

上次灌溉流速比过去5天平均小 (0.2 vs 0.59), 可能管道压力异常或有管道堵塞
 施肥机灌溉量与预期值不符 (15.0 : 37.0), 可能水表需要校准
 默认实际灌溉37.0 ml.
 上次灌溉施肥机流速0.19931435860639402与平均值0.59偏差较大, 请检查。

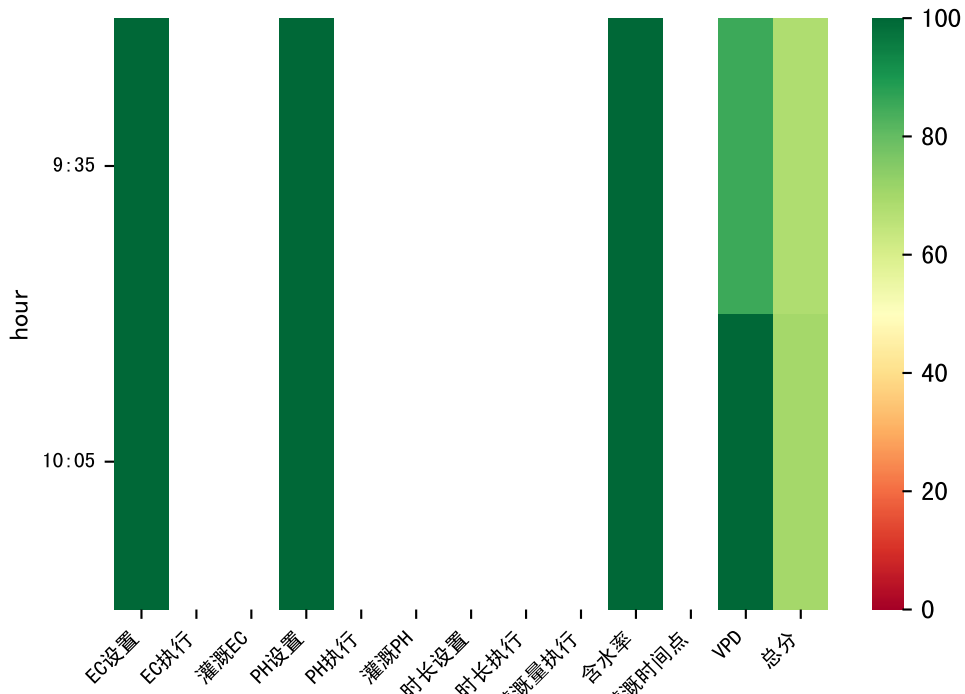
A 阀开关时间 (秒)	B 阀开关时间 (秒)
关' : 13, ' 占空比' : 50}, {' 开' : 35, ' 关' : 43, ' 占空比' : 50}]	[{' 开' : 16, ' 关' : 24, ' 占空比' : 50}, {' 开' : 46,
关' : 13, ' 占空比' : 50}, {' 开' : 35, ' 关' : 43, ' 占空比' : 50}]	[{' 开' : 16, ' 关' : 24, ' 占空比' : 50}, {' 开' : 46,

上次灌溉流速比过去5天平均小 (0.4 vs 0.59), 可能管道压力异常或有管道堵塞
 施肥机灌溉量与预期值不符 (29.0 : 36.0), 可能水表需要校准
 默认实际灌溉36.0 ml.

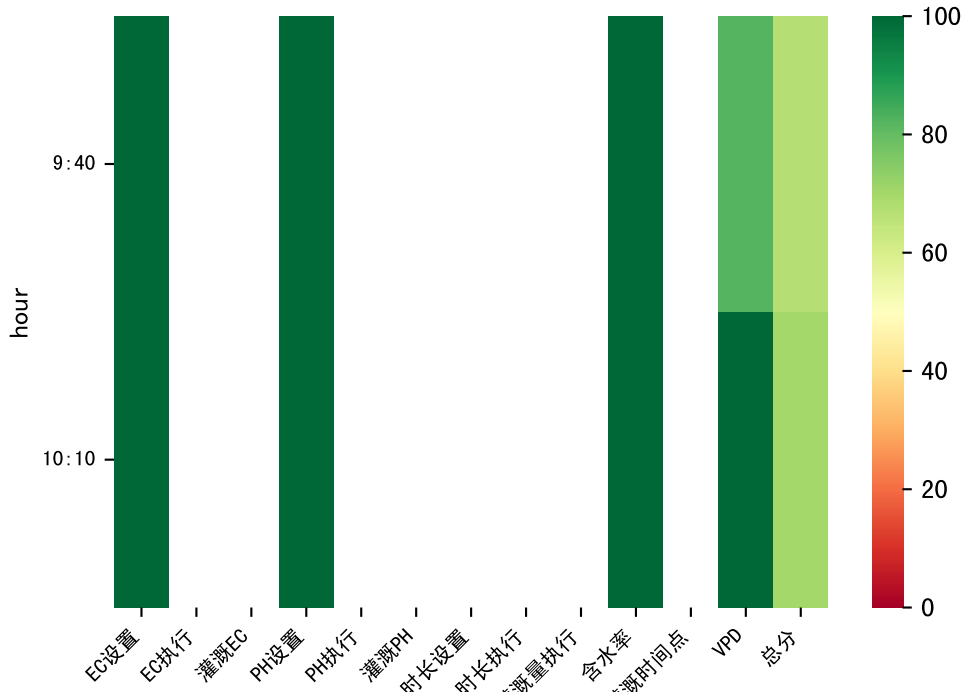
A阀开关时间(秒)	B阀开关时间(秒)
关' : 13, ' 占空比' : 50}, {' 开' : 35, ' 关' : 43, ' 占空比' : 50}]	[{' 开' : 16, ' 关' : 24, ' 占空比' : 50}, {' 开' : 46,
关' : 13, ' 占空比' : 50}, {' 开' : 35, ' 关' : 43, ' 占空比' : 50}]	[{' 开' : 16, ' 关' : 24, ' 占空比' : 50}, {' 开' : 46,

上次灌溉流速比过去5天平均小 (0.2 vs 0.6), 可能管道压力异常或有管道堵塞
 施肥机灌溉量与预期值不符 (15.0 : 36.0), 可能水表需要校准
 默认实际灌溉36.0 ml.
 上次灌溉施肥机流速0.20485086856768273与平均值0.6偏差较大, 请检查。

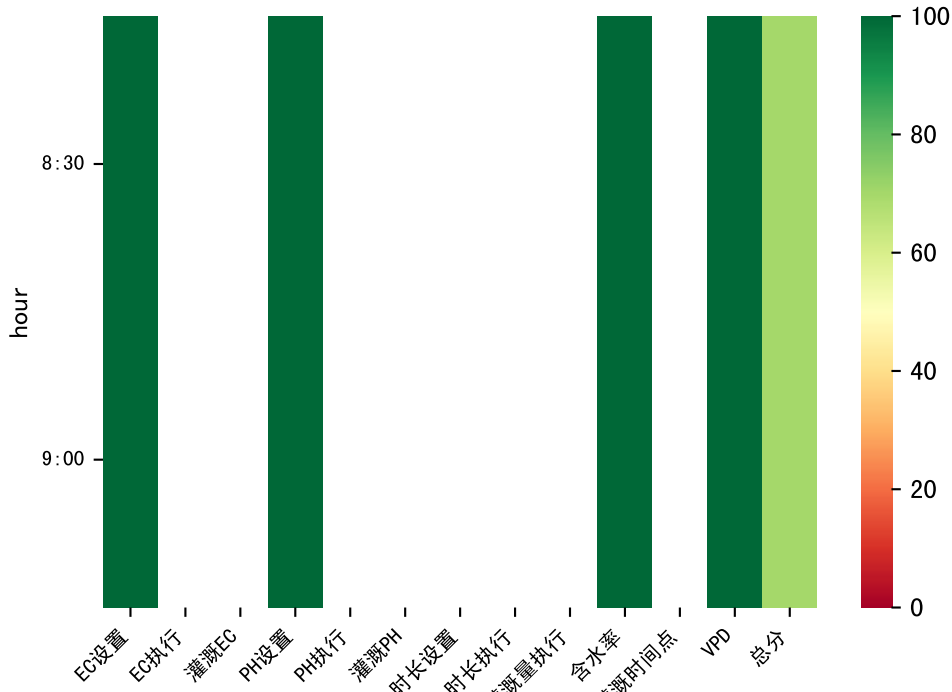
A 阀开关时间 (秒)	B 阀开关时间 (秒)
关' : 13, ' 占空比' : 50}, {' 开' : 35, ' 关' : 43, ' 占空比' : 50}]	[{' 开' : 16, ' 关' : 24, ' 占空比' : 50}, {' 开' : 46,
关' : 13, ' 占空比' : 50}, {' 开' : 35, ' 关' : 43, ' 占空比' : 50}]	[{' 开' : 16, ' 关' : 24, ' 占空比' : 50}, {' 开' : 46,

上次灌溉流速比过去5天平均小 (0.41 vs 0.61), 可能管道压力异常或有管道堵塞
 施肥机灌溉量与预期值不符 (29.0 : 36.0), 可能水表需要校准
 默认实际灌溉36.0 ml.

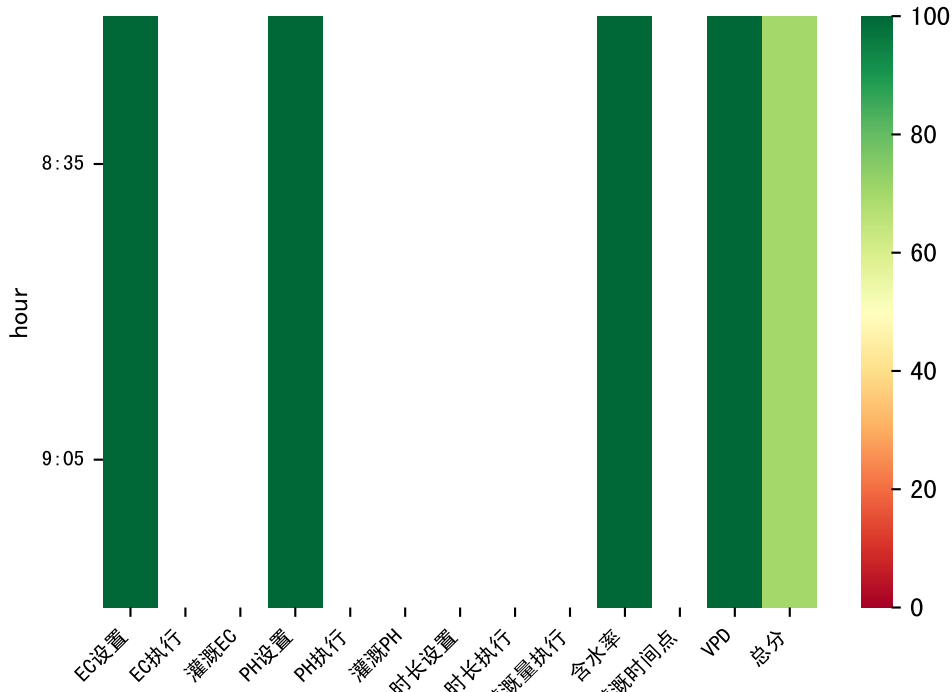
A阀开关时间(秒)	B阀开关时间(秒)
关' : 13, ' 占空比' : 50}, {' 开' : 35, ' 关' : 43, ' 占空比' : 50}]	[{' 开' : 16, ' 关' : 24, ' 占空比' : 50}, {' 开' : 46,
关' : 13, ' 占空比' : 50}, {' 开' : 35, ' 关' : 43, ' 占空比' : 50}]	[{' 开' : 16, ' 关' : 24, ' 占空比' : 50}, {' 开' : 46,
