FgArea: [' C5' ]  
NJ15 L1  
2026-03-10 (Day 155)

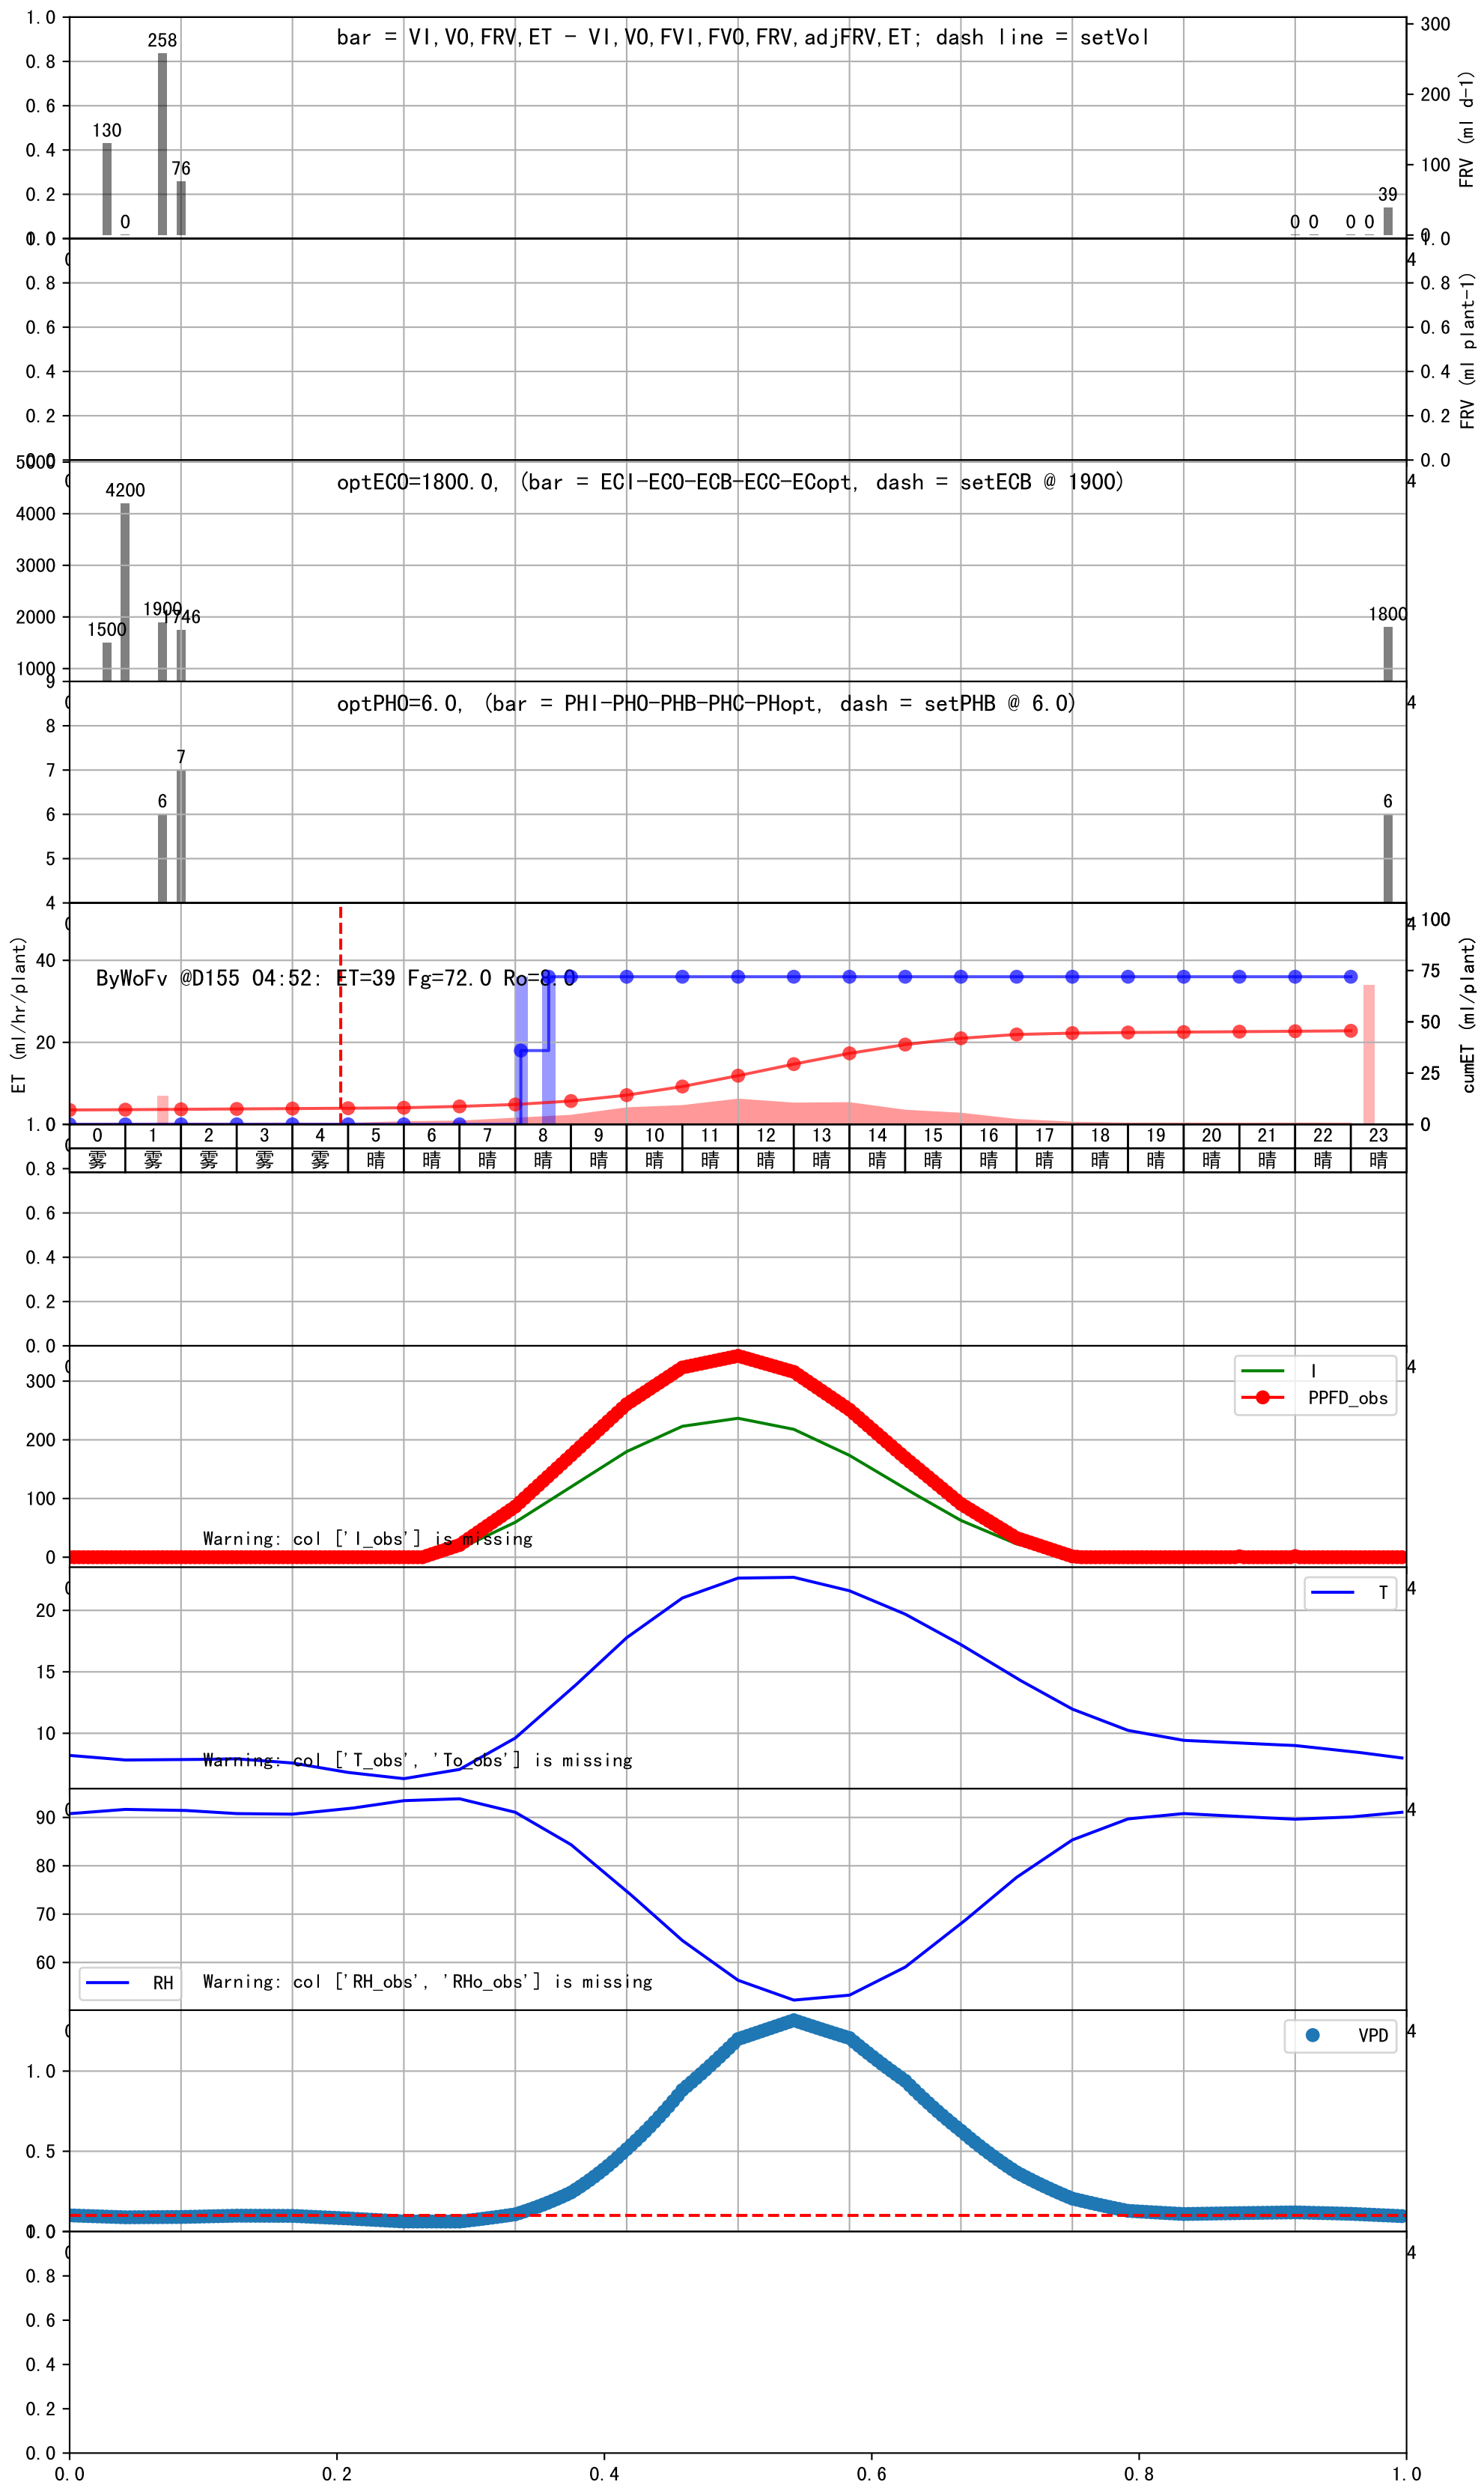
上次灌溉流速比过去5天平均小 (0.21 vs 0.7), 可能管道压力异常或有管道堵塞  
 施肥机灌溉量与预期值不符 (15.0 : 36.0), 可能水表需要校准

上次灌溉施肥机流速0.207736092068636与平均值0.7偏差较大, 请检查。

默认实际灌溉36.0 ml.

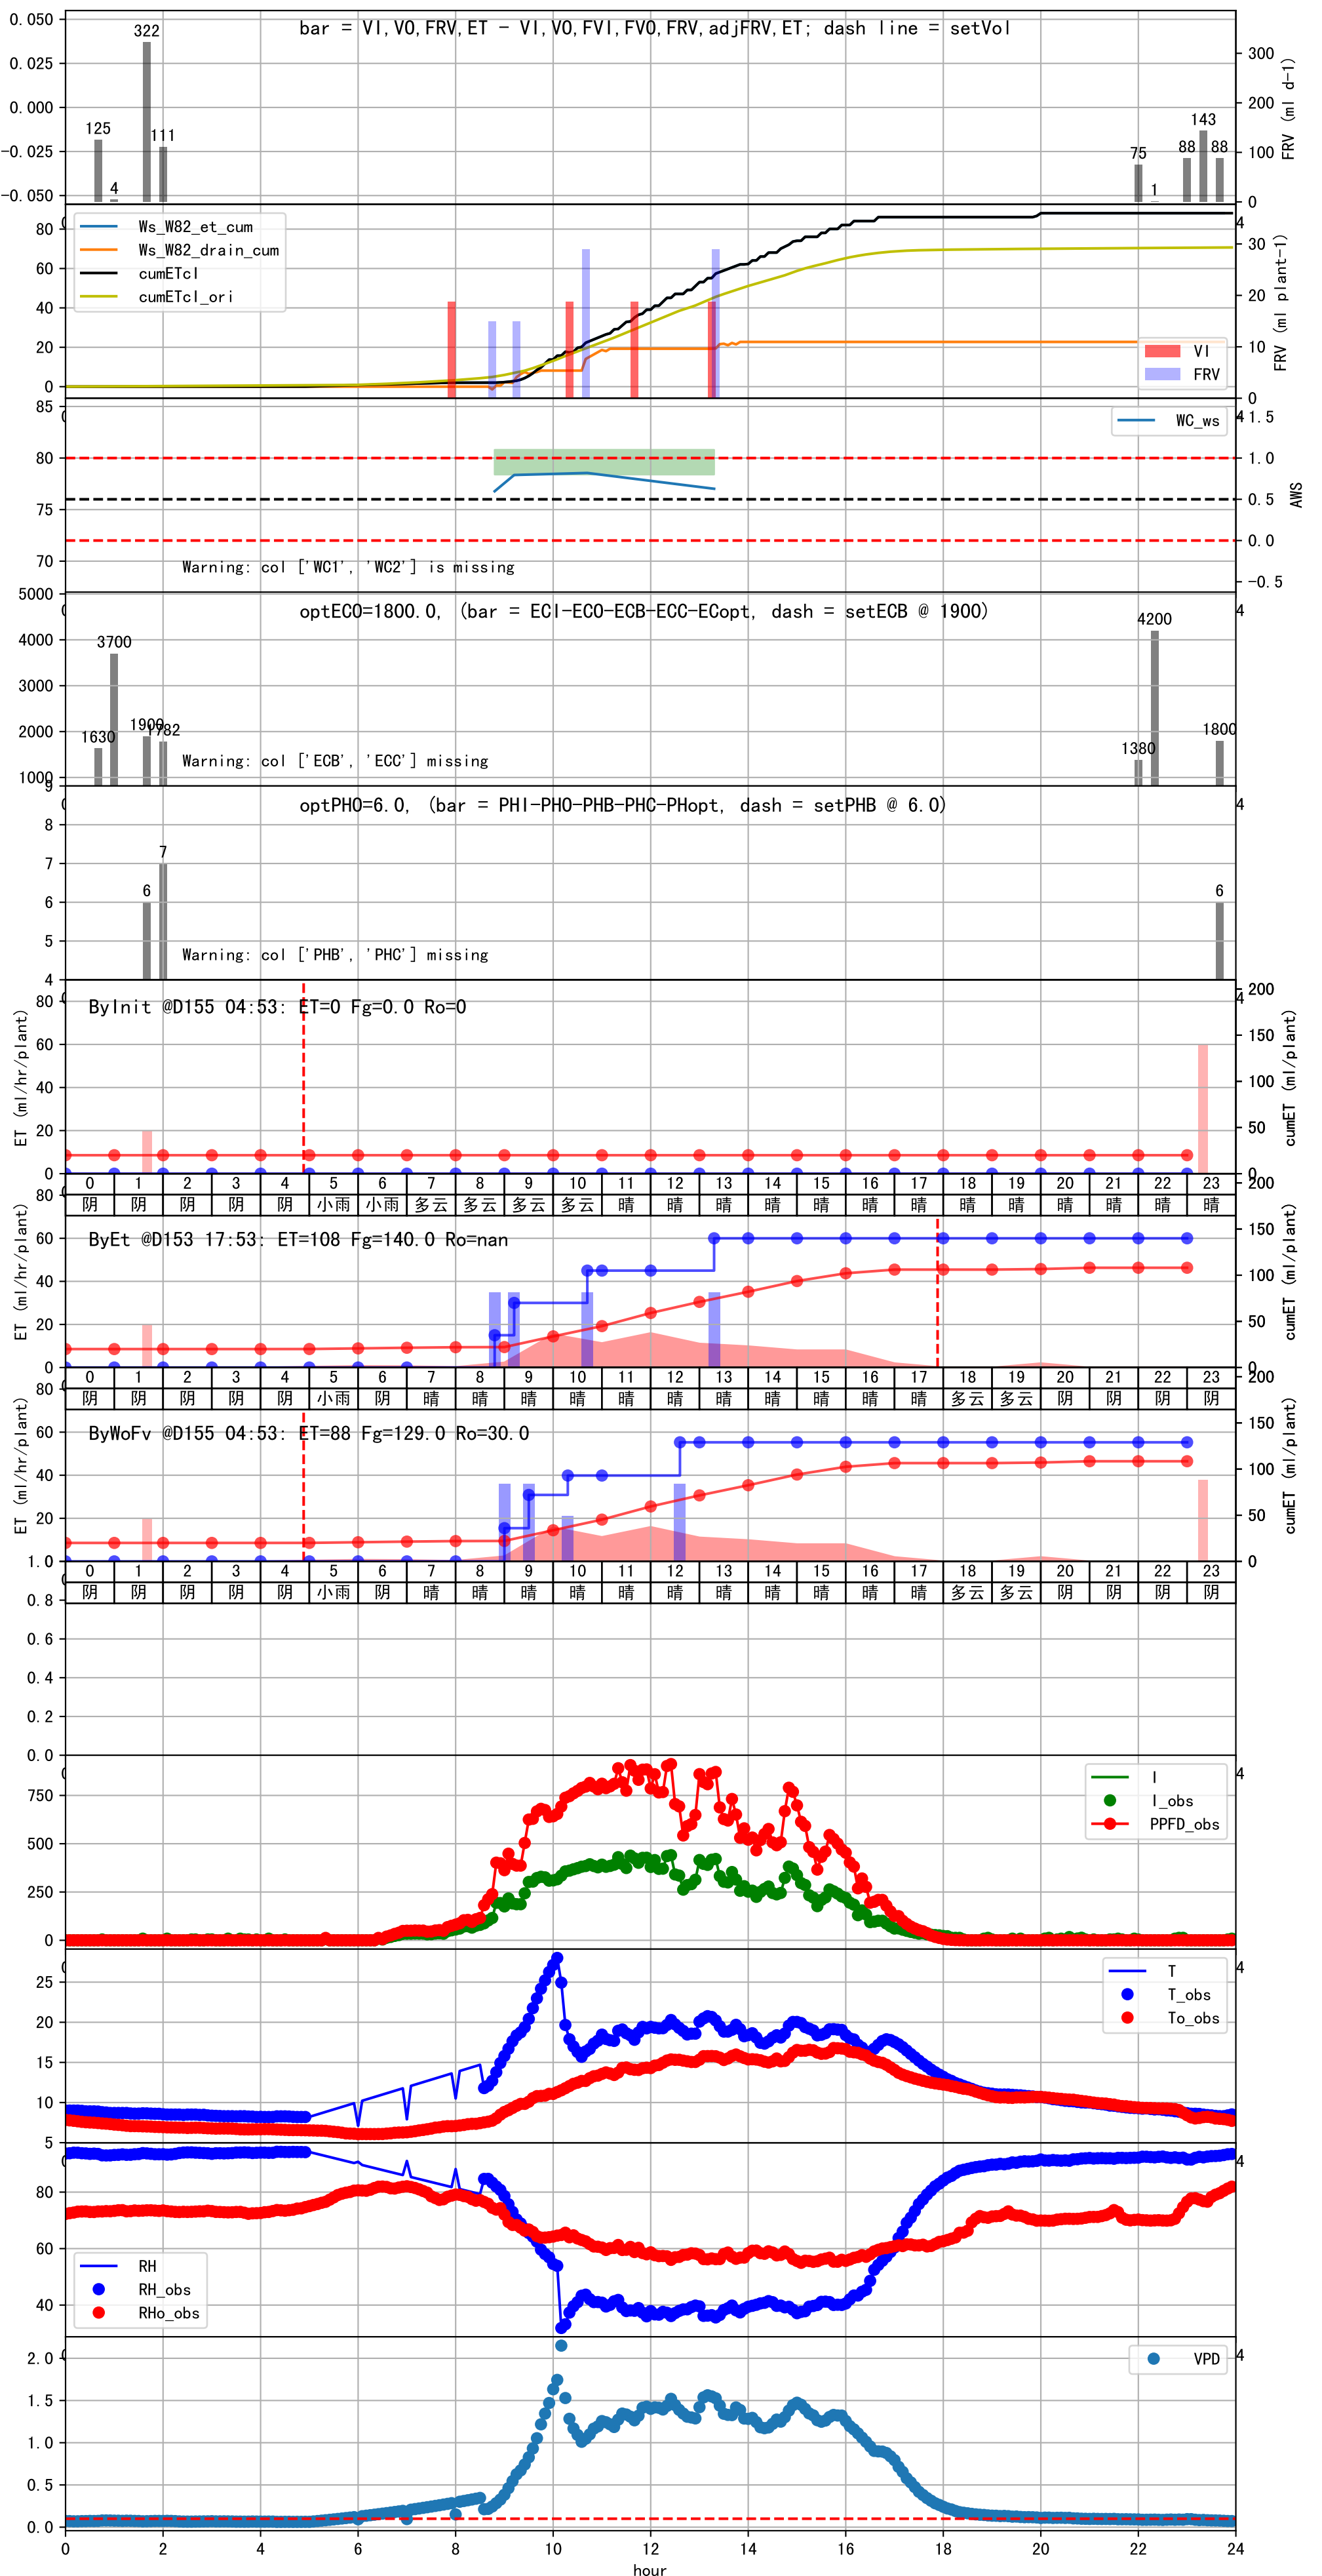
上次灌溉流速比过去5天平均小 (0.42 vs 0.6), 可能管道压力异常或有管道堵塞  
 施肥机灌溉量与预期值不符 (29.0 : 36.0), 可能水表需要校准  
 默认实际灌溉36.0 ml.

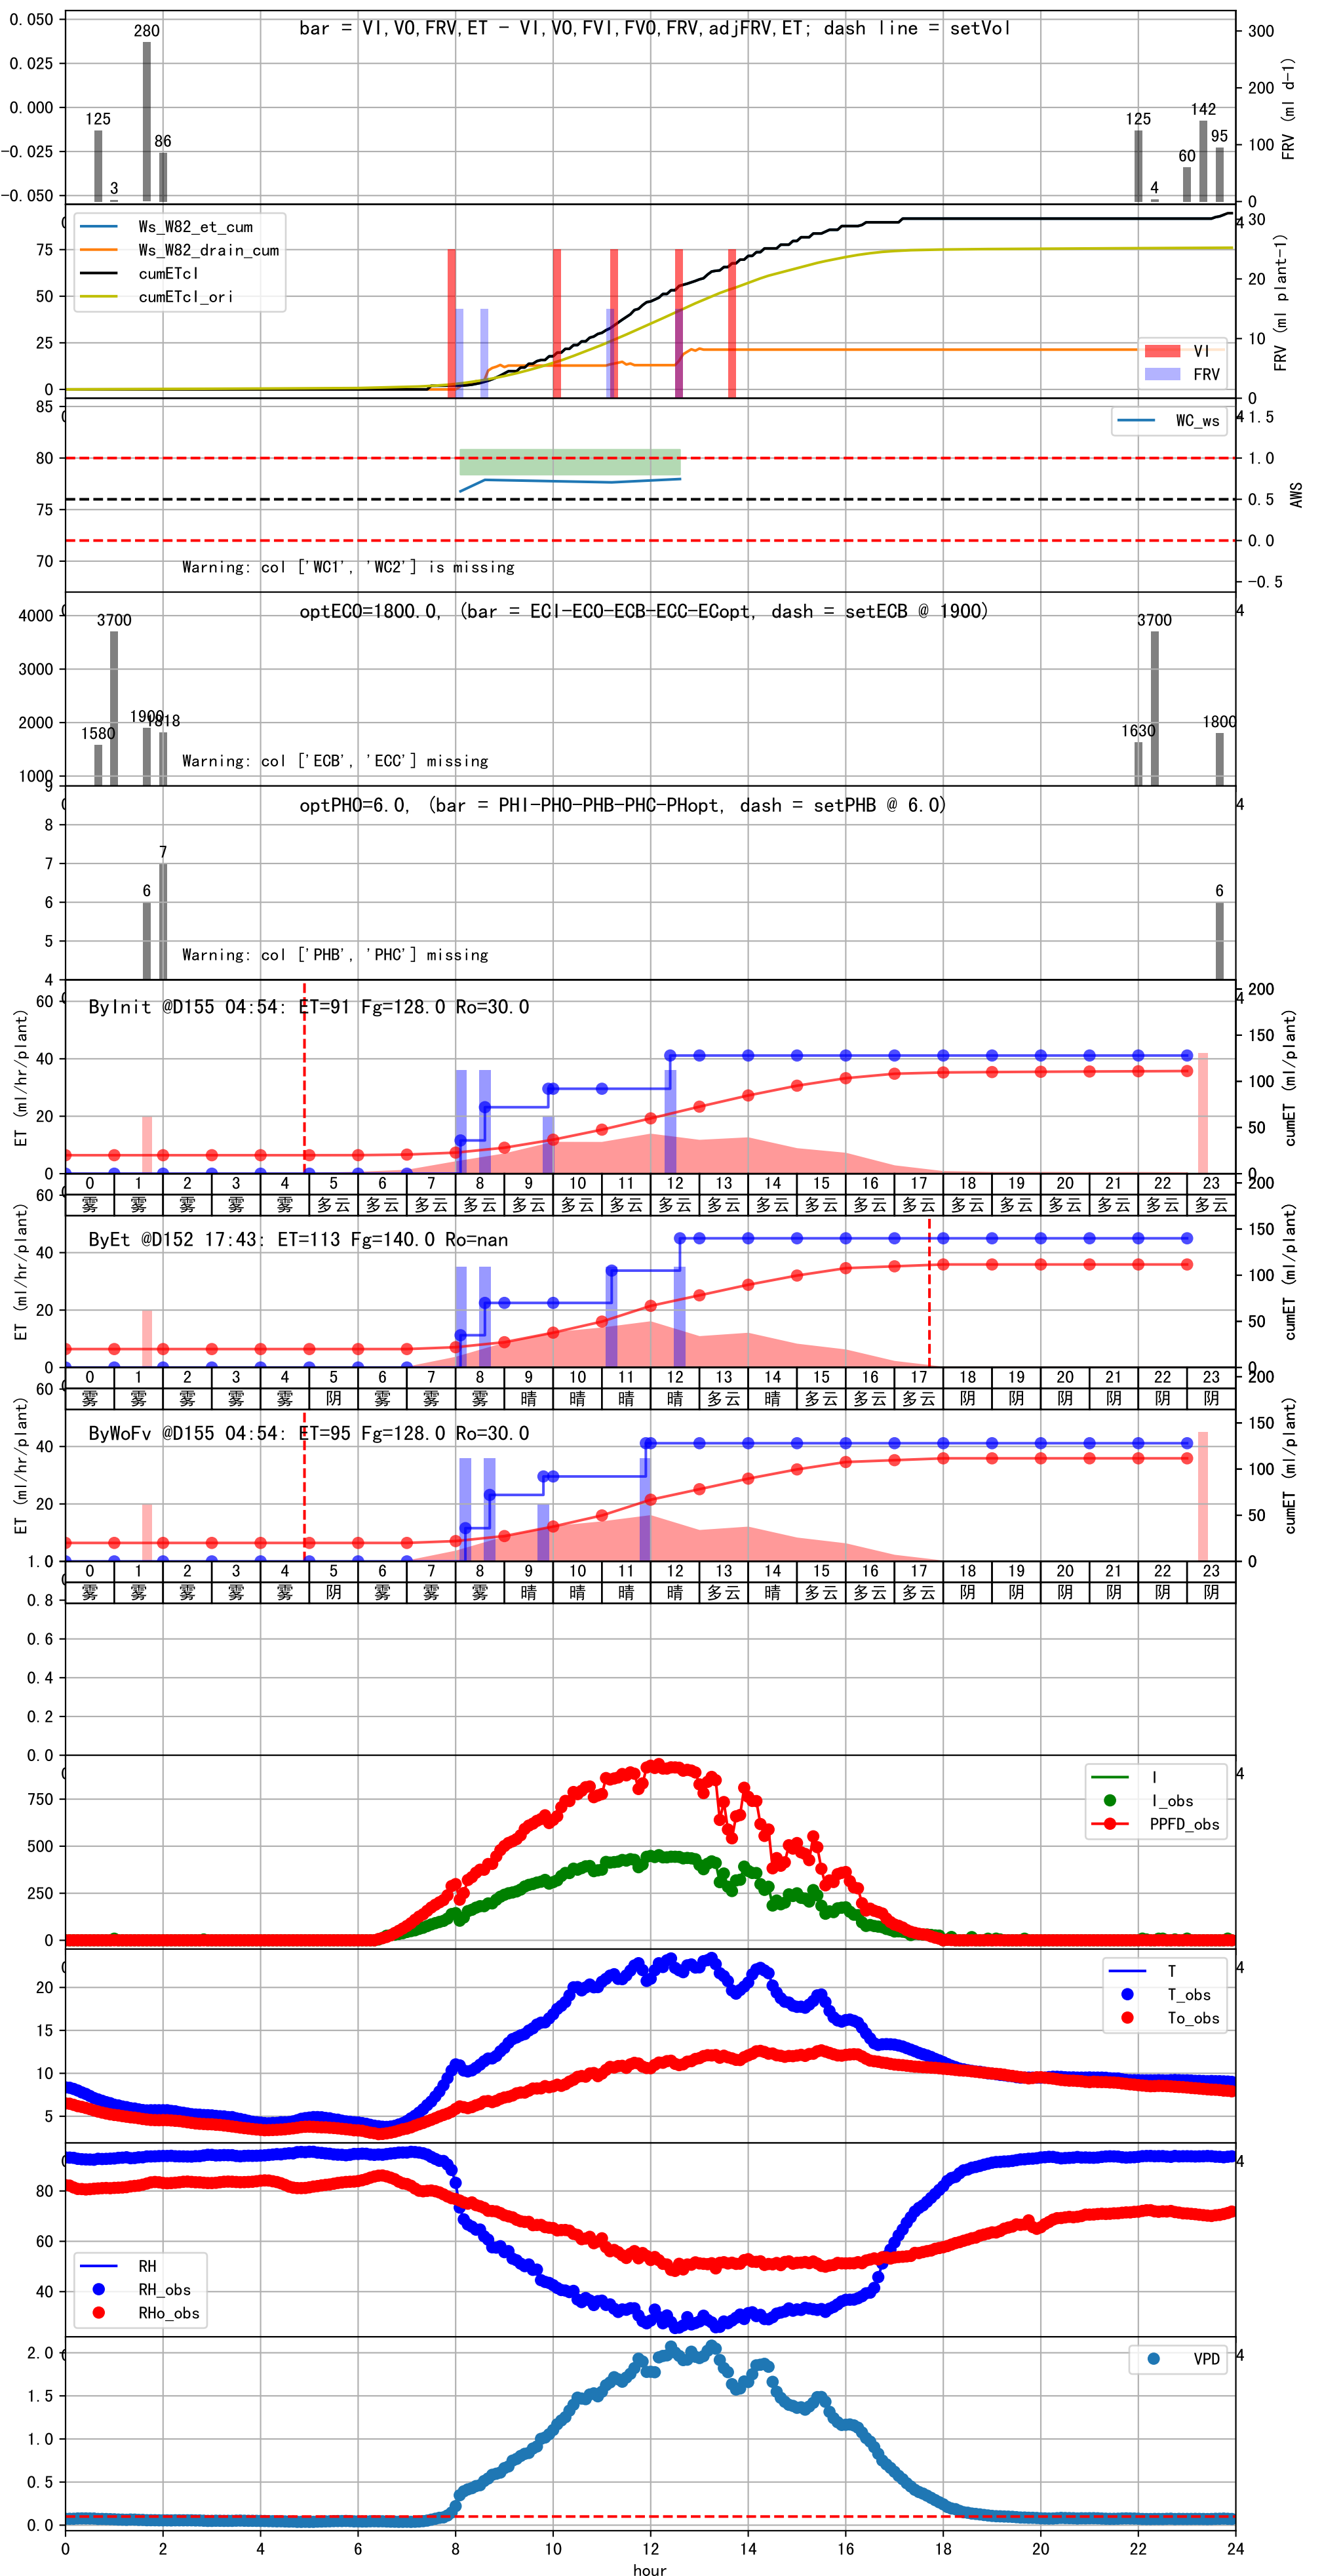
上次灌溉流速比过去5天平均小 (0.21 vs 0.6), 可能管道压力异常或有管道堵塞  
 施肥机灌溉量与预期值不符 (15.0 : 35.0), 可能水表需要校准

上次灌溉施肥机流速0.21070375052675938与平均值0.6偏差较大, 请检查。

默认实际灌溉35.0 ml.

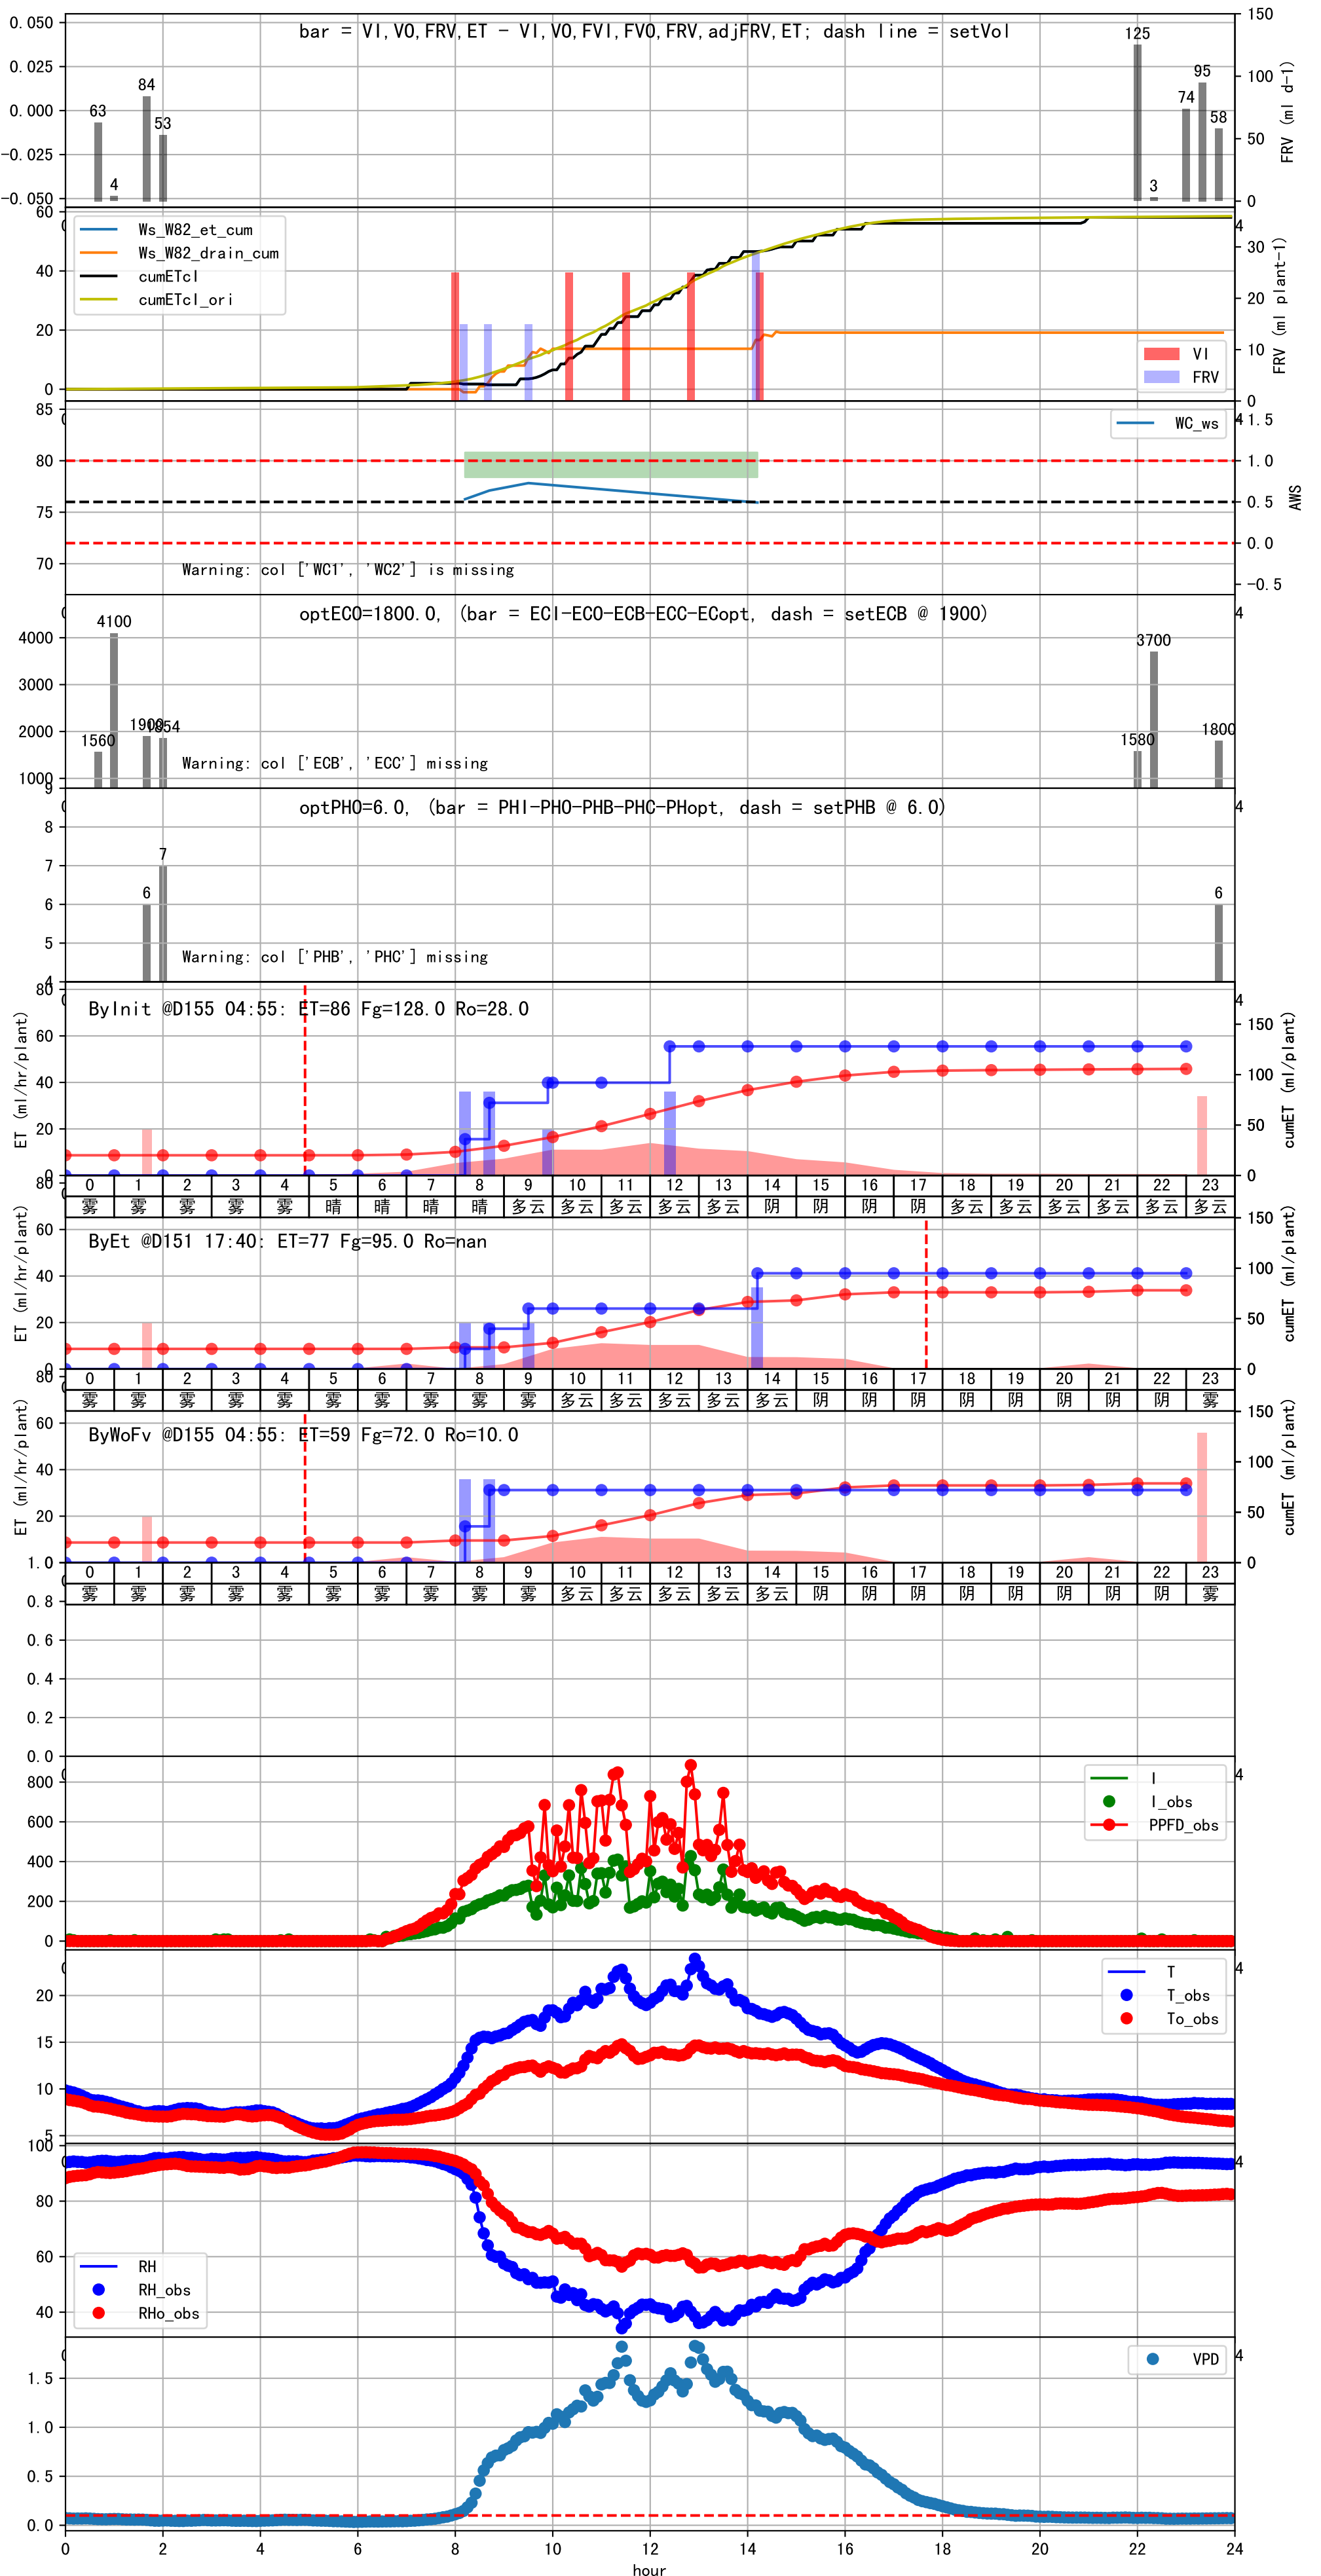
上次灌溉流速比过去5天平均小 (0.42 vs 0.6), 可能管道压力异常或有管道堵塞  
 施肥机灌溉量与预期值不符 (29.0 : 35.0), 可能水表需要校准  
 默认实际灌溉35.0 ml.
