FgArea: [' C5']
NJ15 L1
2026-03-15 (Day 160)

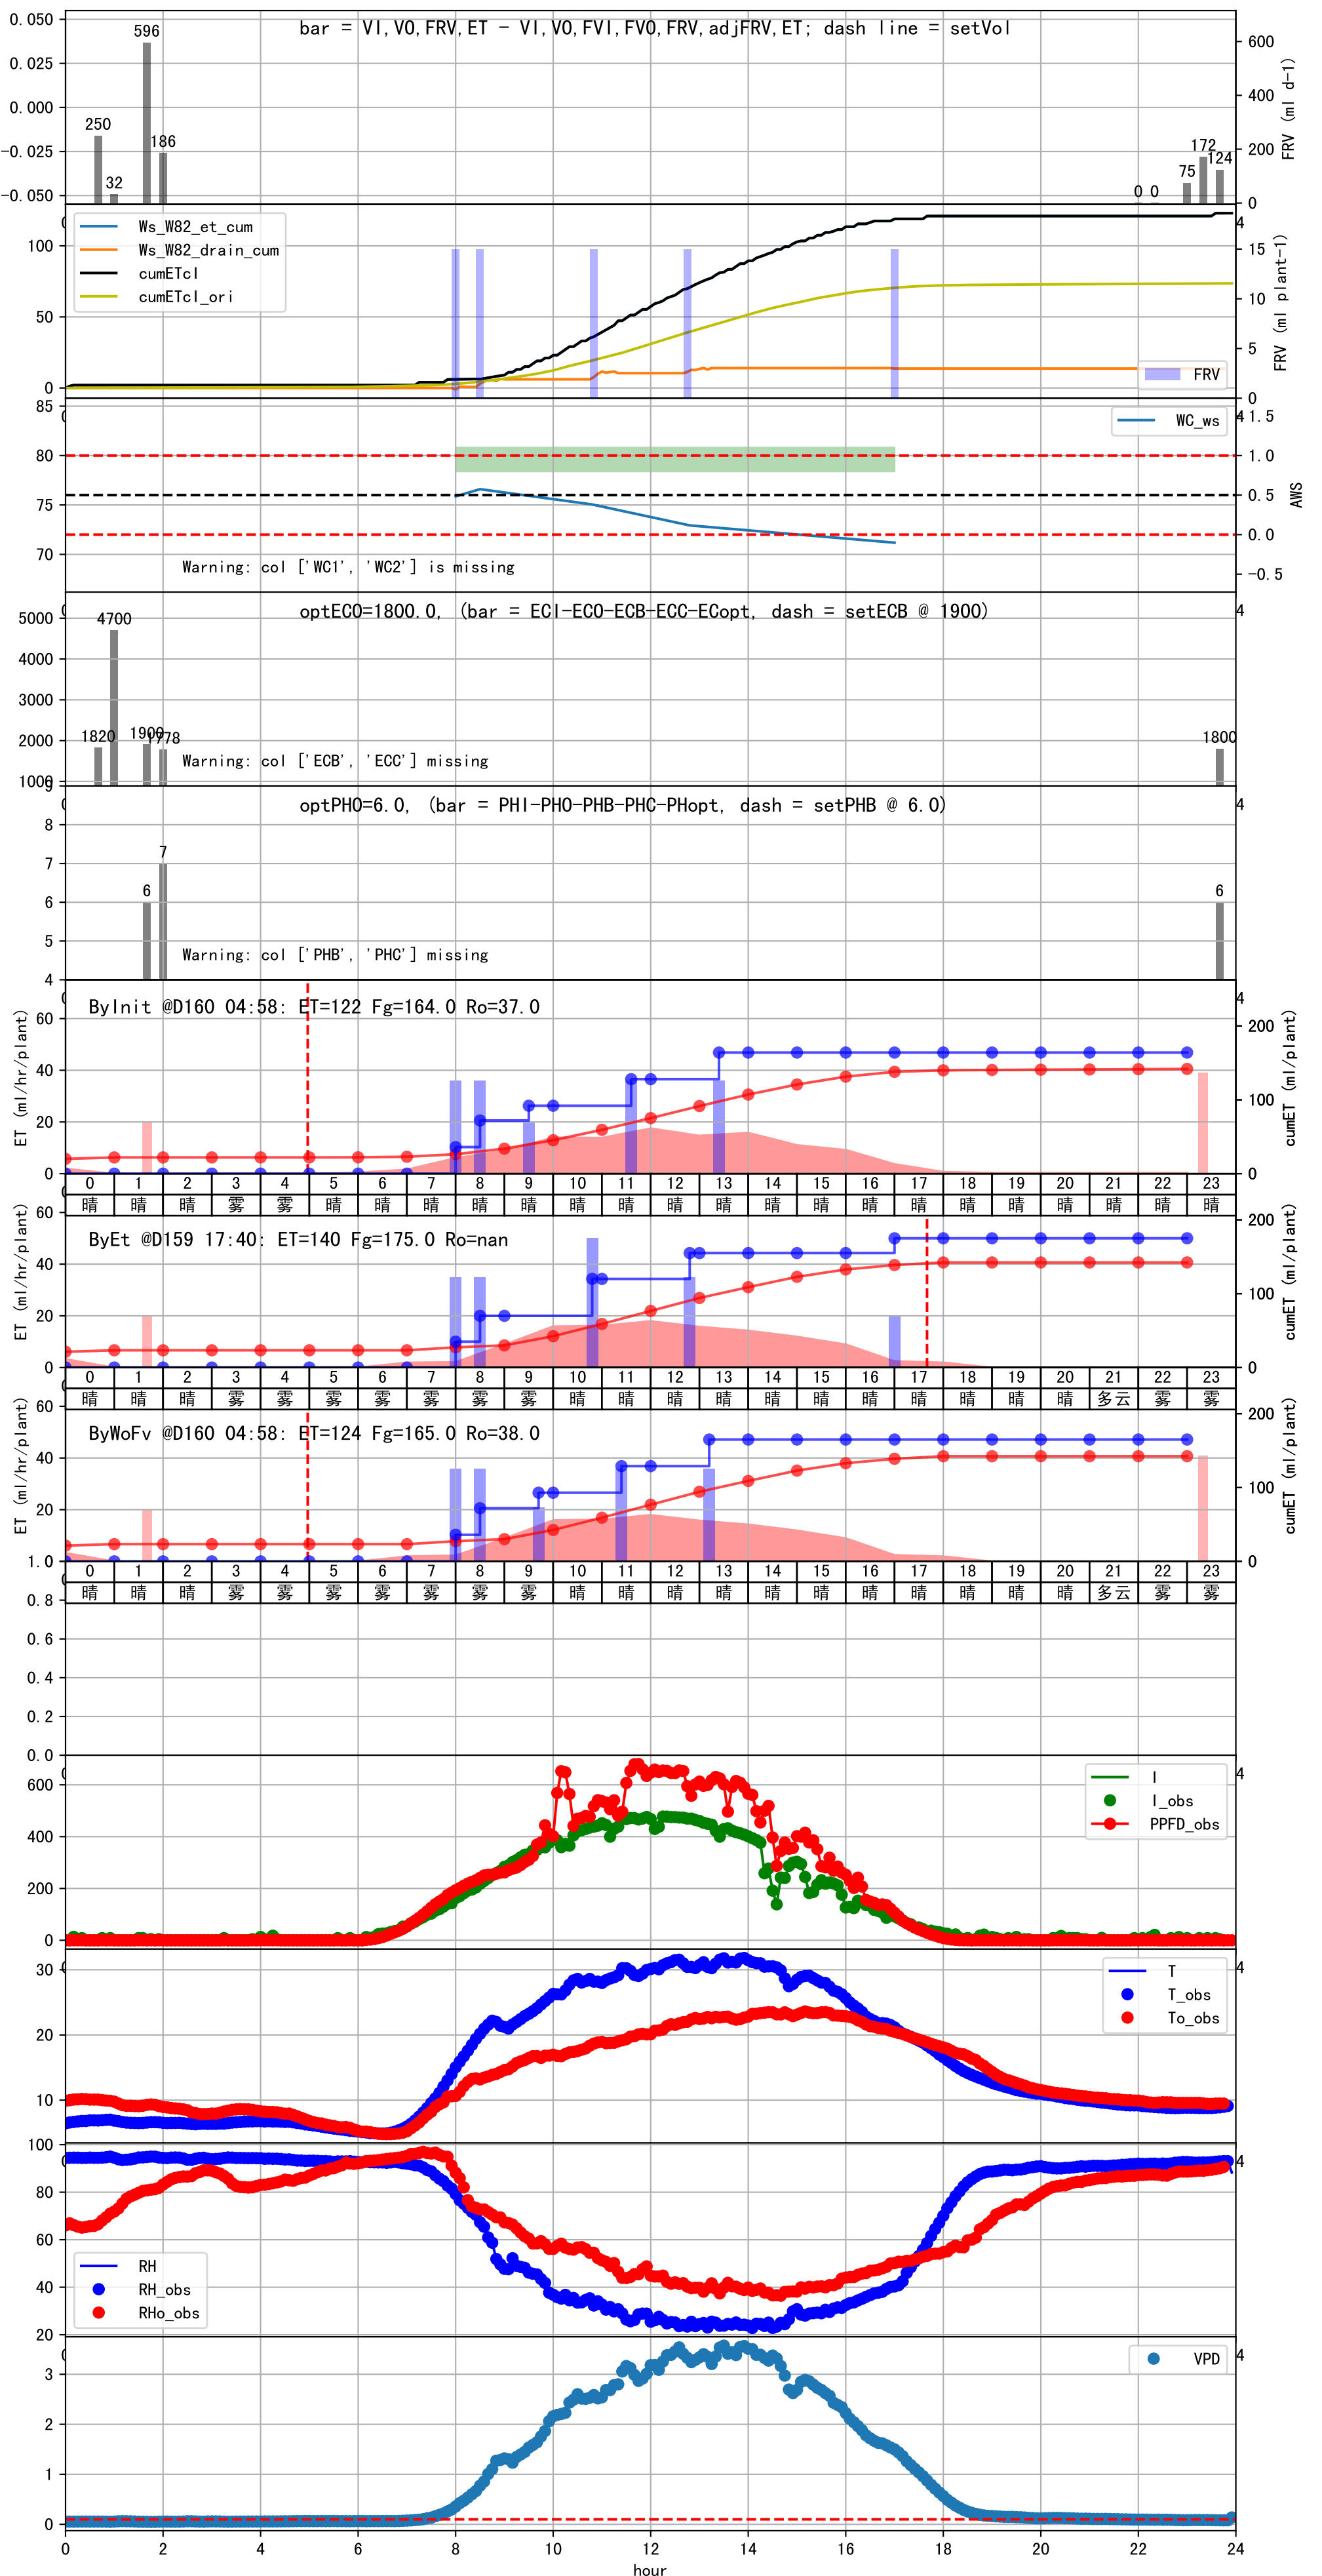
滴头平均流速偏大 (0.77 vs def 0.5), 请检查

上次灌溉流速比过去5天平均小 (0.41 vs 0.77), 可能管道压力异常或有管道堵塞

默认实际灌溉18.0 ml.

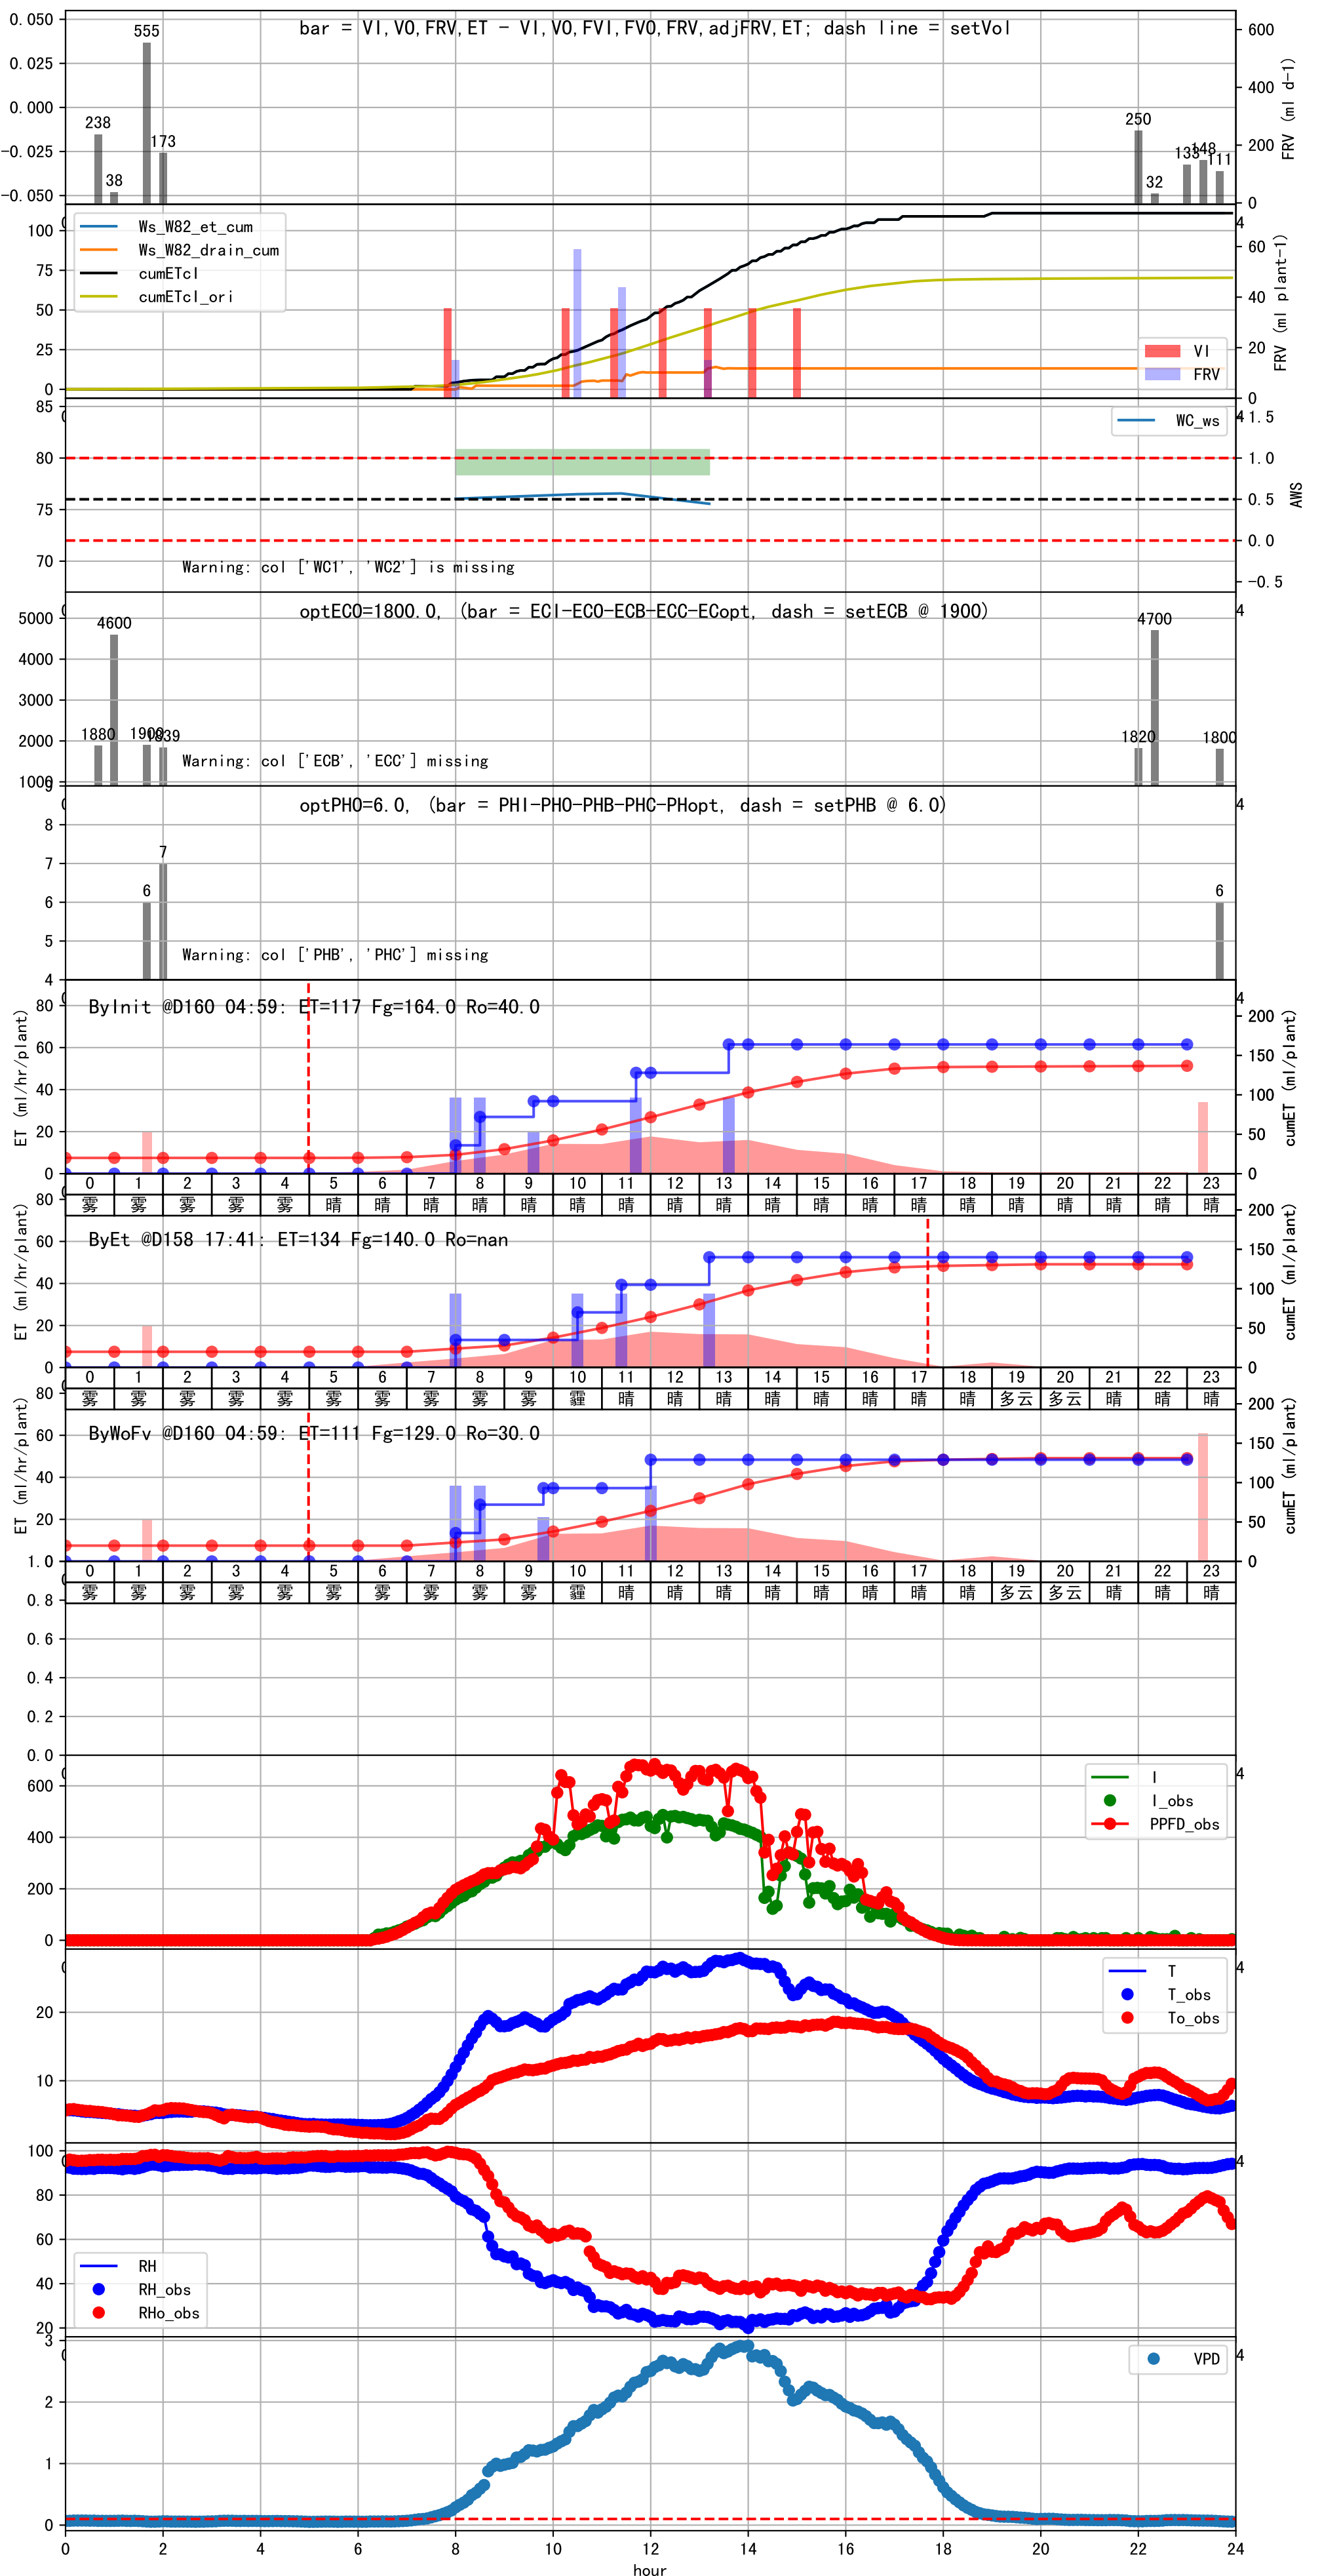
滴头平均流速偏大 (0.77 vs def 0.5), 请检查

上次灌溉流速比过去5天平均小 (0.2 vs 0.77), 可能管道压力异常或有管道堵塞

施肥机灌溉量与预期值不符 (15.0 : 37.0), 可能水表需要校准

默认实际灌溉37.0 ml.

上次灌溉施肥机流速0.19931435860639402与平均值0.77偏差较大, 请检查。

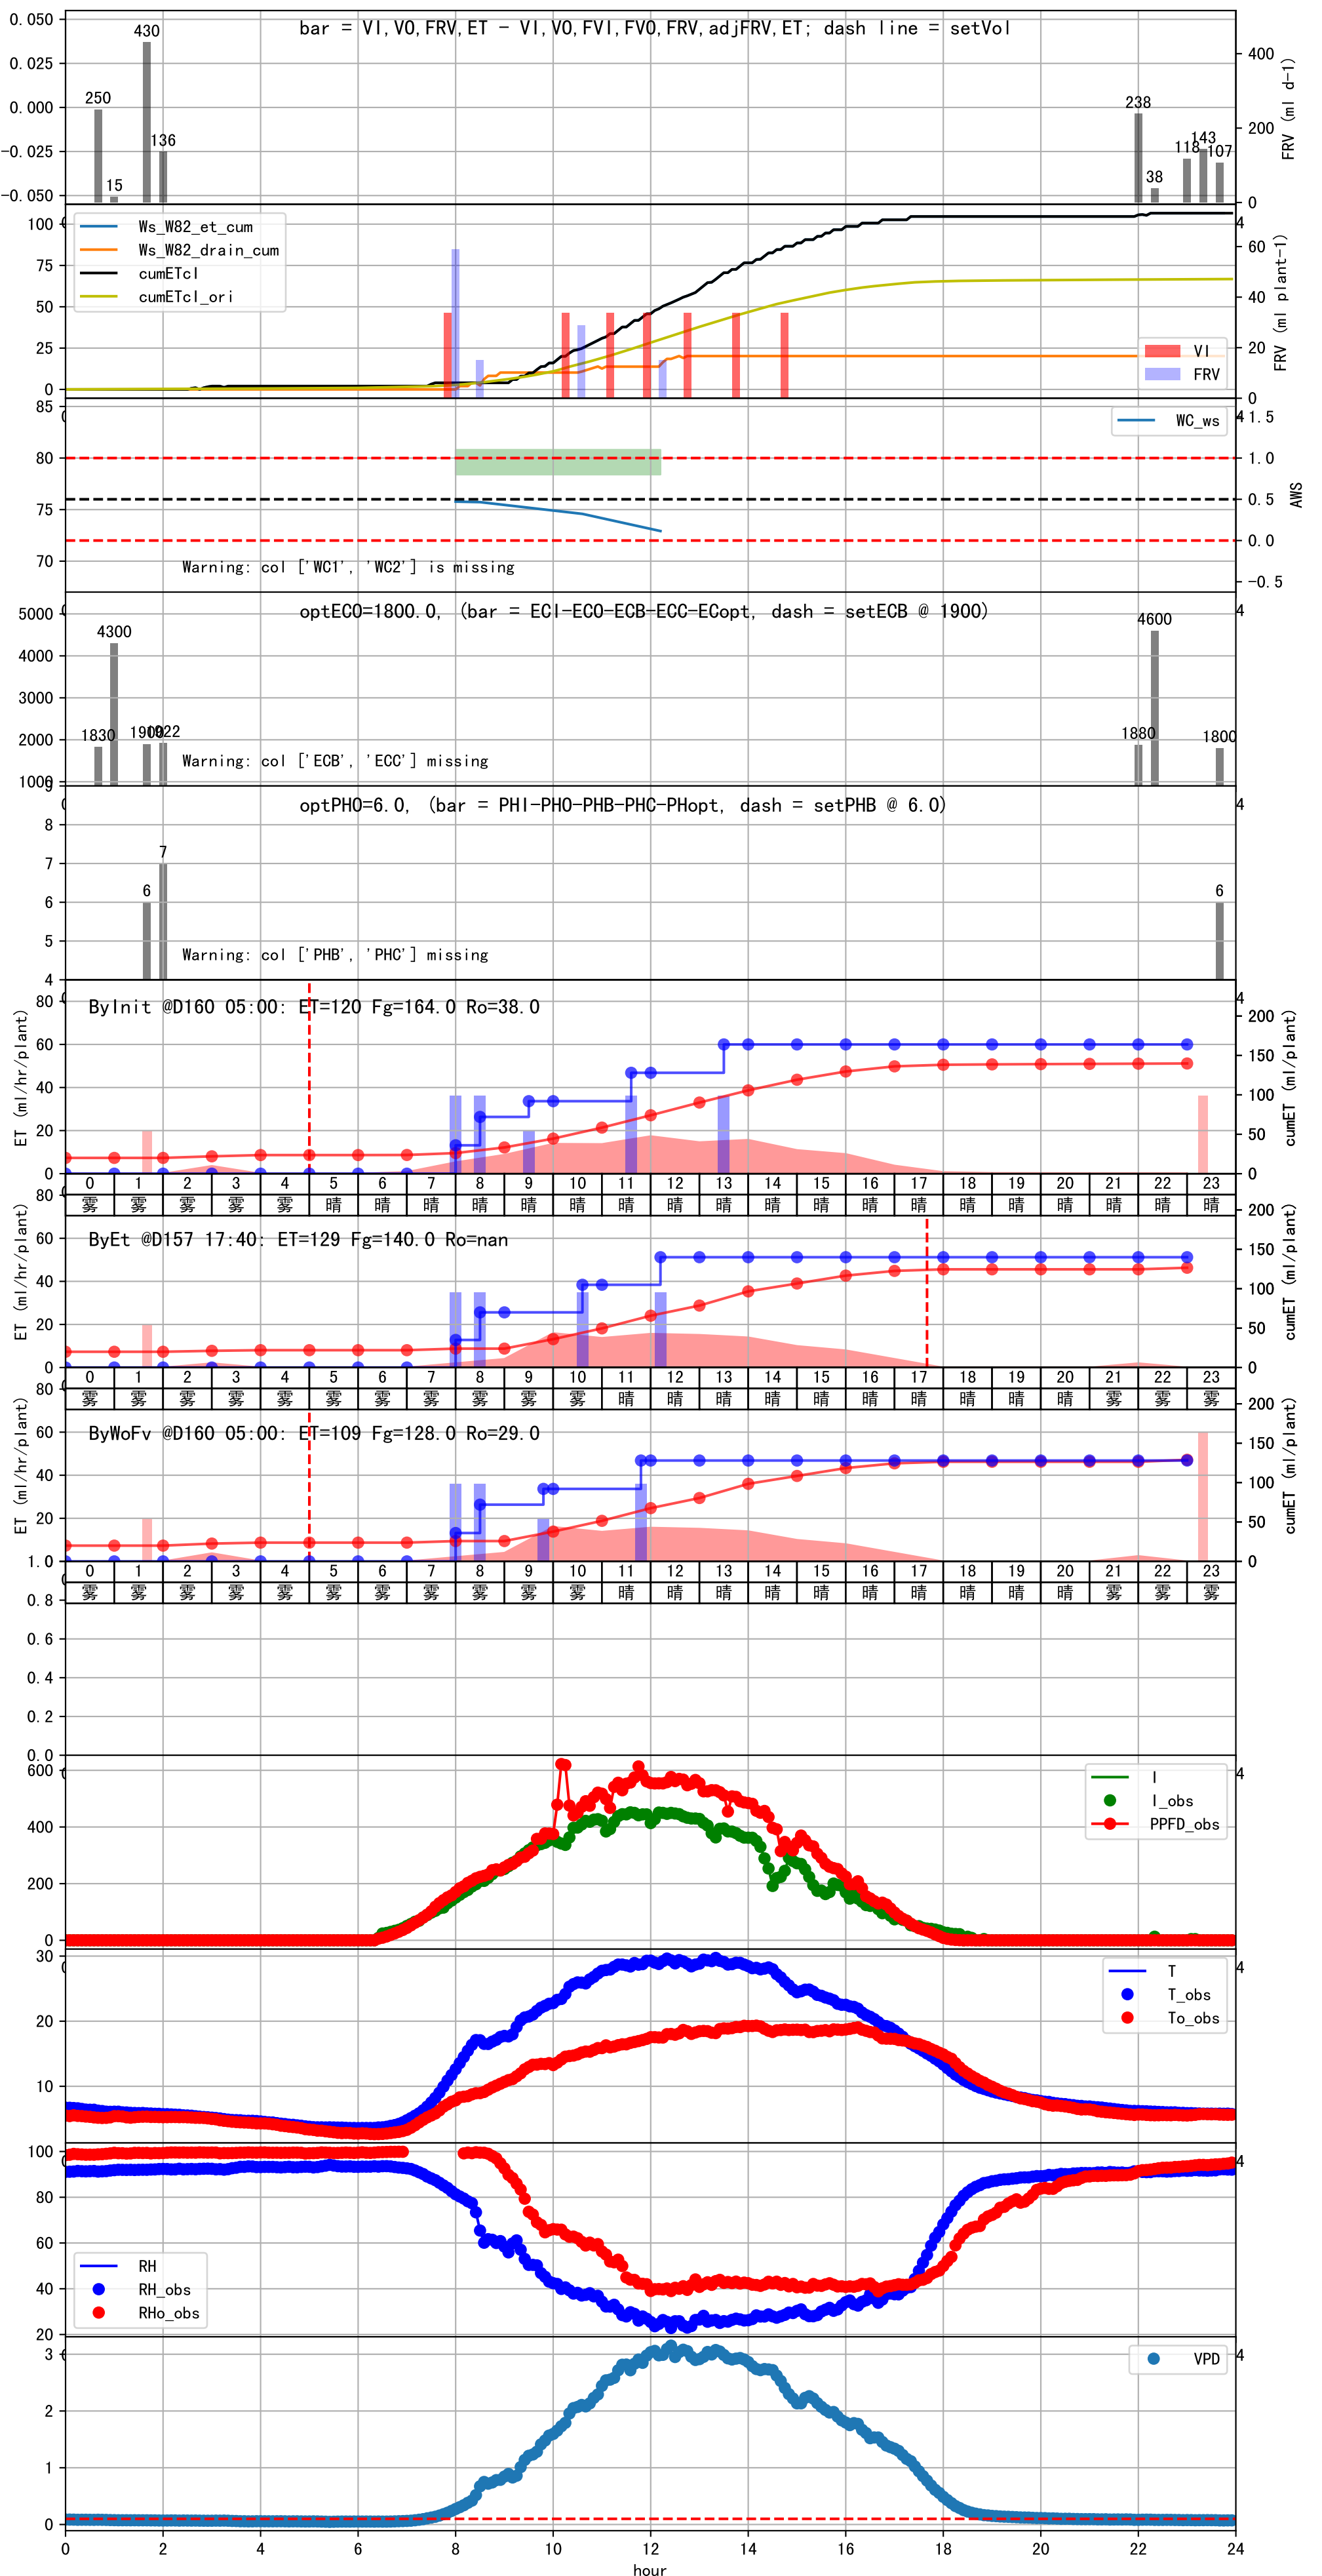
滴头平均流速偏大 (0.81 vs def 0.5), 请检查

上次灌溉流速比过去5天平均小 (0.21 vs 0.81), 可能管道压力异常或有管道堵塞

施肥机灌溉量与预期值不符 (15.0 : 35.0), 可能水表需要校准

默认实际灌溉35.0 ml.

上次灌溉施肥机流速0.21070375052675938与平均值0.81偏差较大, 请检查。

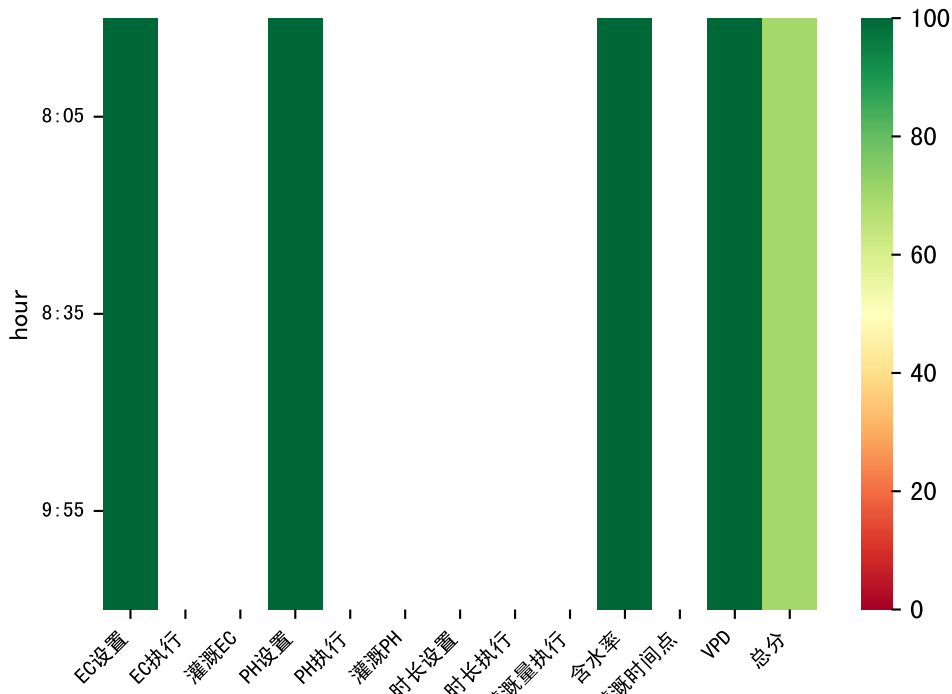
滴头平均流速偏大 (0.81 vs def 0.5), 请检查

上次灌溉流速比过去5天平均小 (0.21 vs 0.81), 可能管道压力异常或有管道堵塞

施肥机灌溉量与预期值不符 (15.0 : 36.0), 可能水表需要校准

默认实际灌溉36.0 ml.

上次灌溉施肥机流速0.207736092068636与平均值0.81偏差较大, 请检查。
