FgArea: [' C5' ]  
NJ15 L1  
2026-03-20 (Day 165)

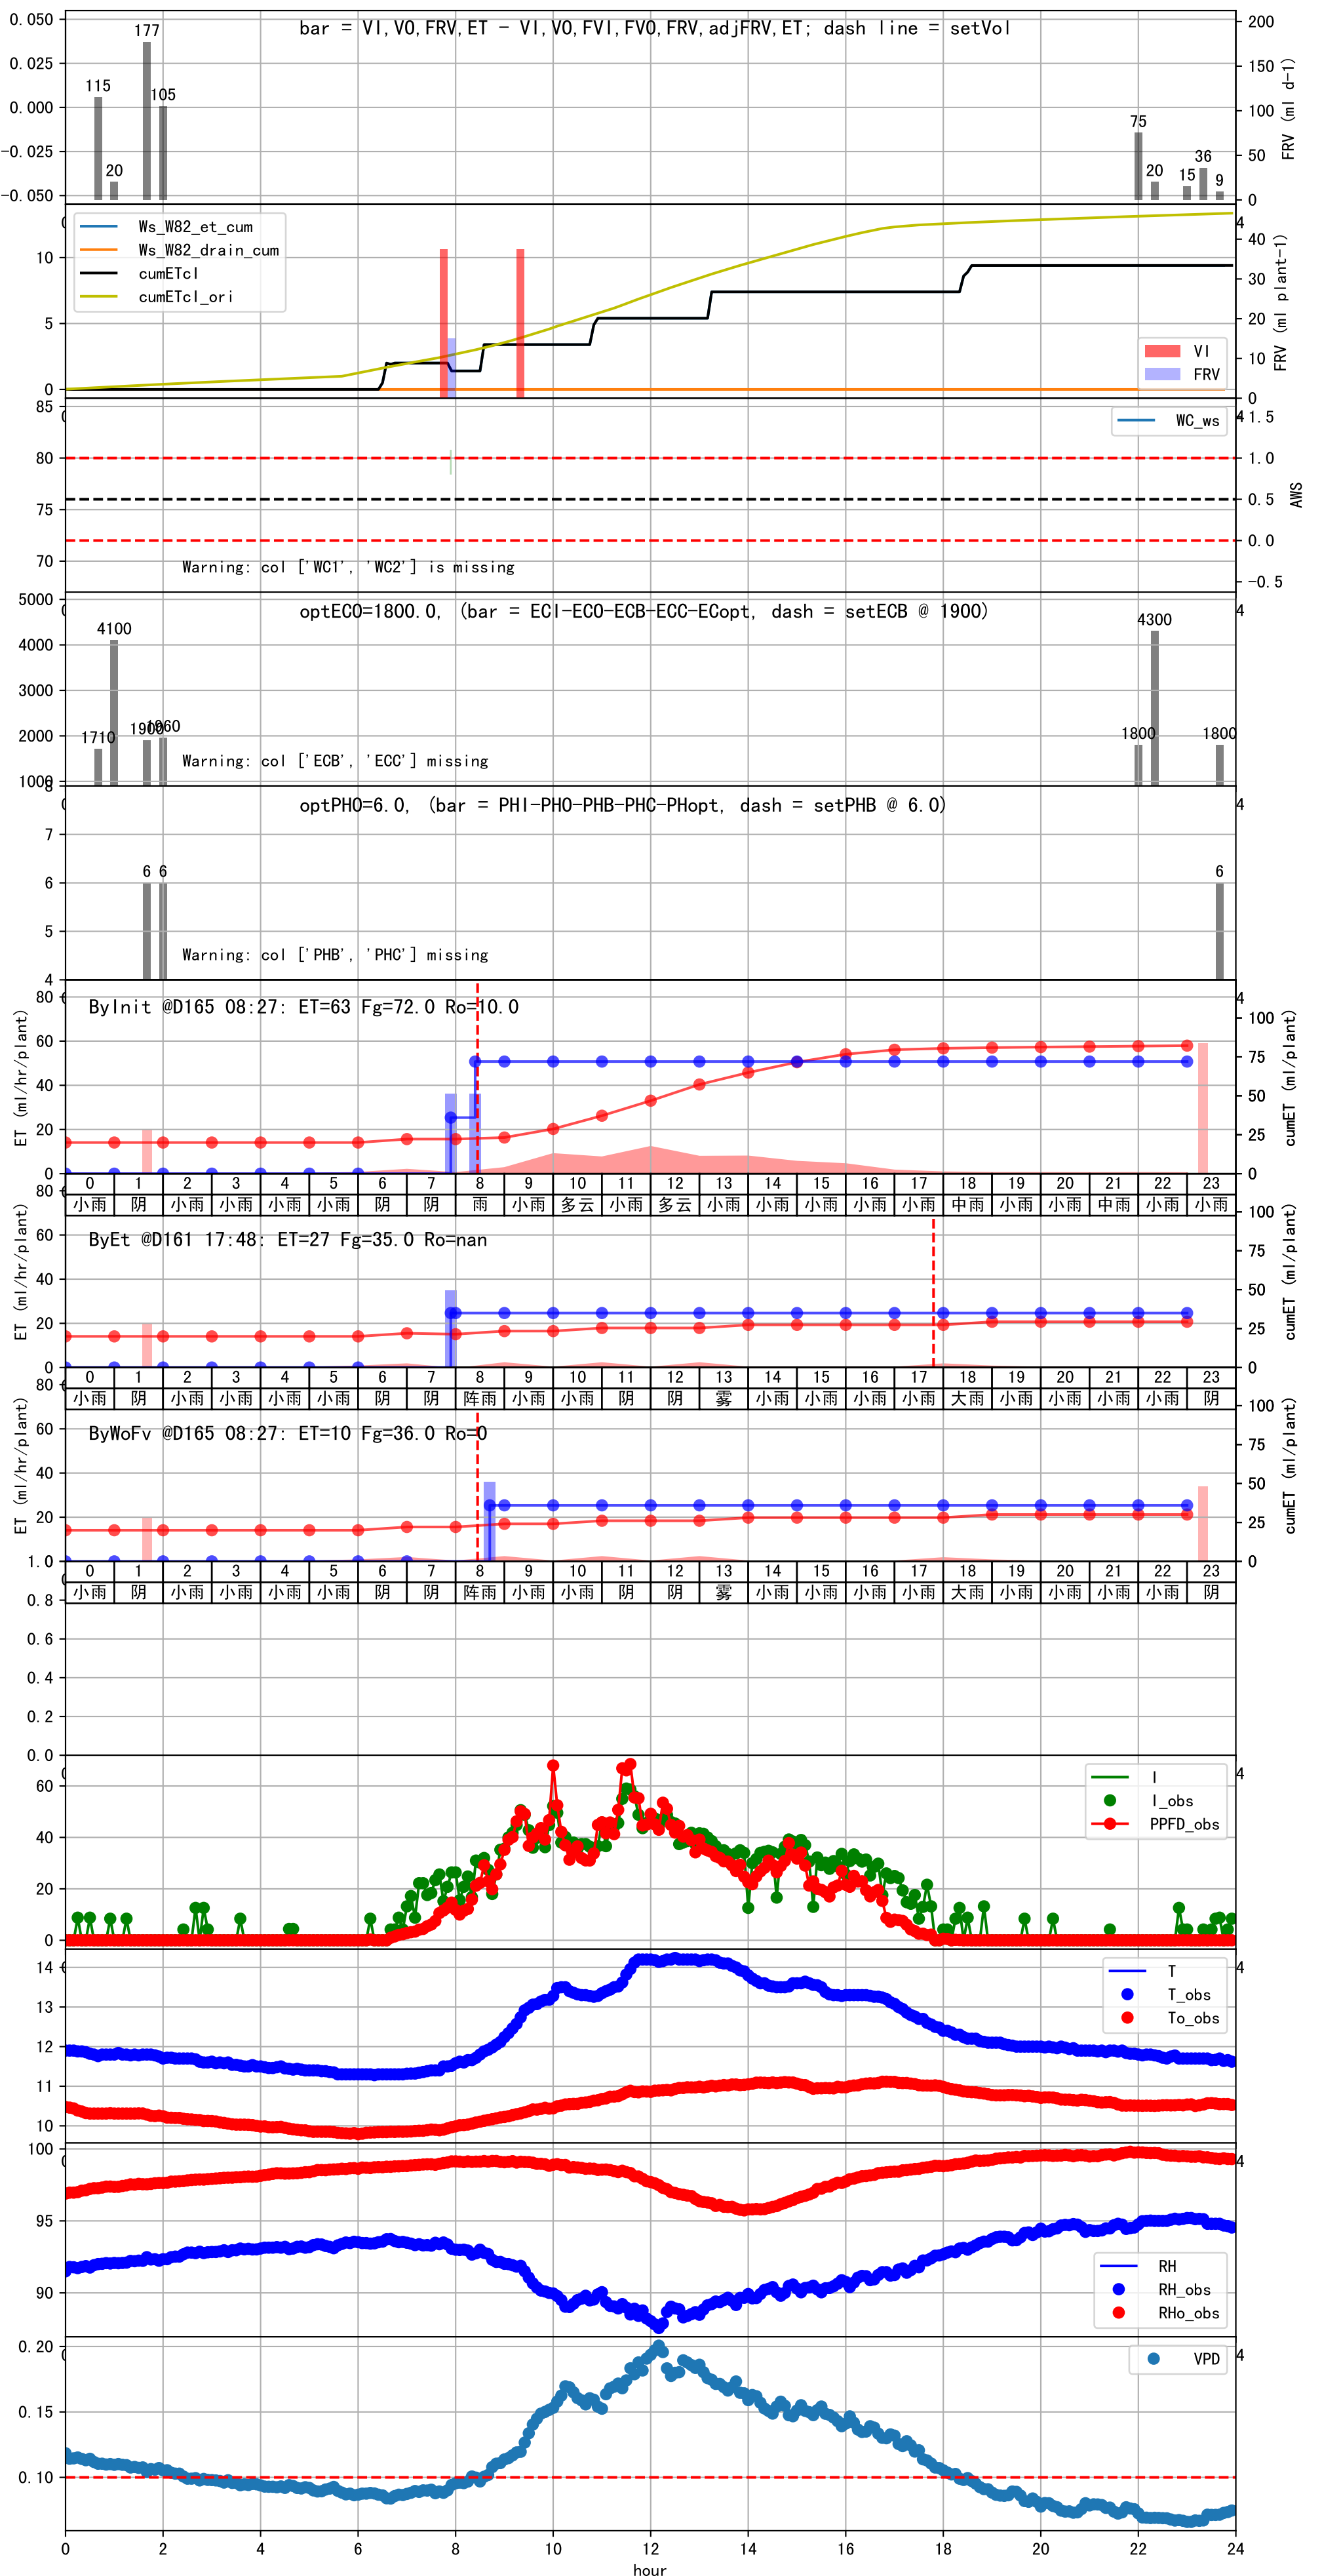
A阀开关时间(秒) '关': 14, '占空比': 50.0], {'开': 35, '关': 44, '占空比': 50.0}]	B阀开关时间(秒) [{'开': 15, '关': 24, '占空比': 50.0}, {'开': 15, '关': 24, '占空比': 50.0}]
--	---

上次灌溉流速比过去5天平均小 (0.2 vs 0.7), 可能管道压力异常或有管道堵塞  
 施肥机灌溉量与预期值不符 (15.0 : 36.0), 可能水表需要校准  
 默认实际灌溉36.0 ml.
