FgArea: [' C7']
NJ15 L1
2026-02-28 (Day 145)

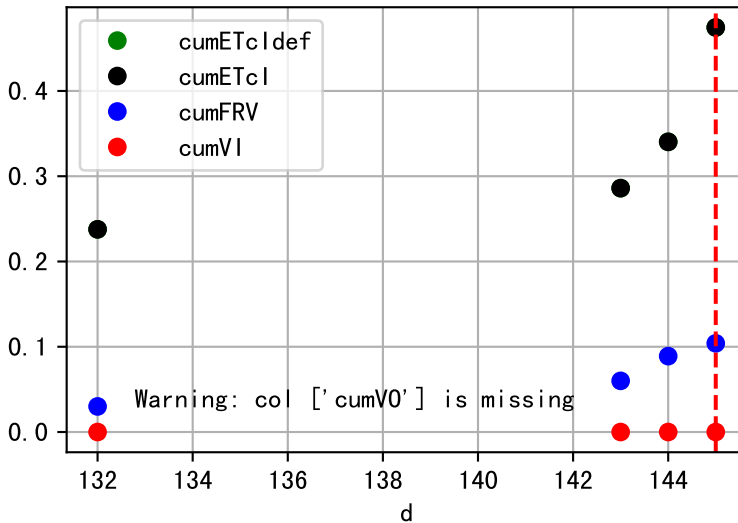
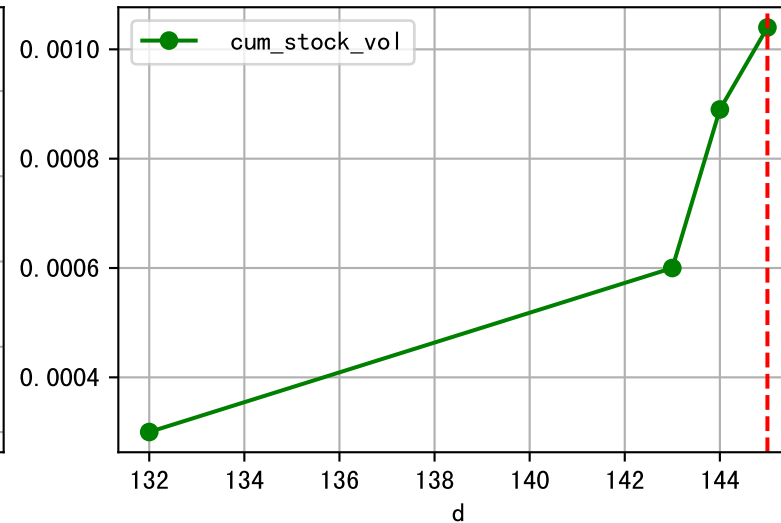
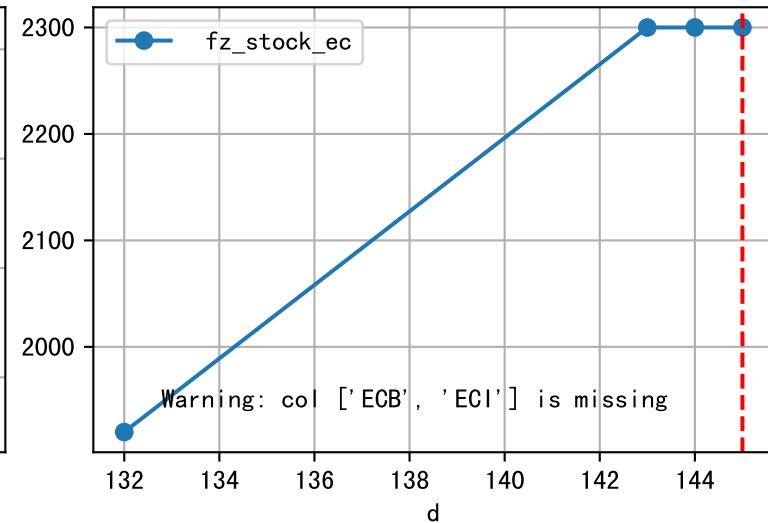
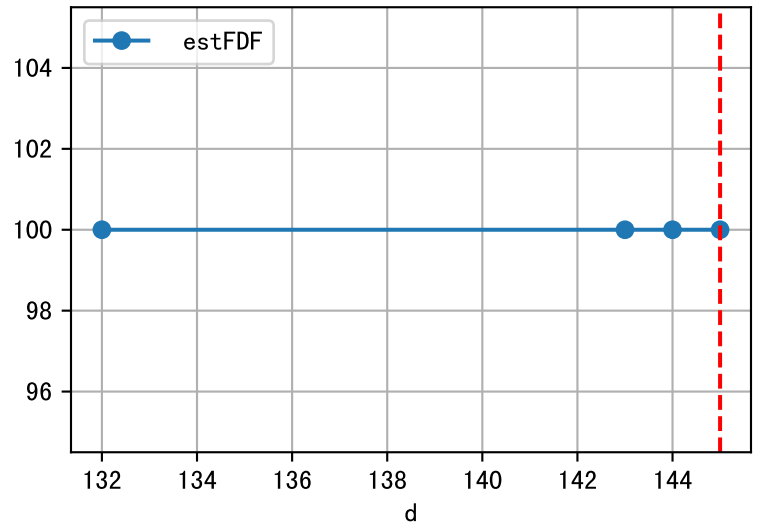
Plot Fv and fertilizer usage

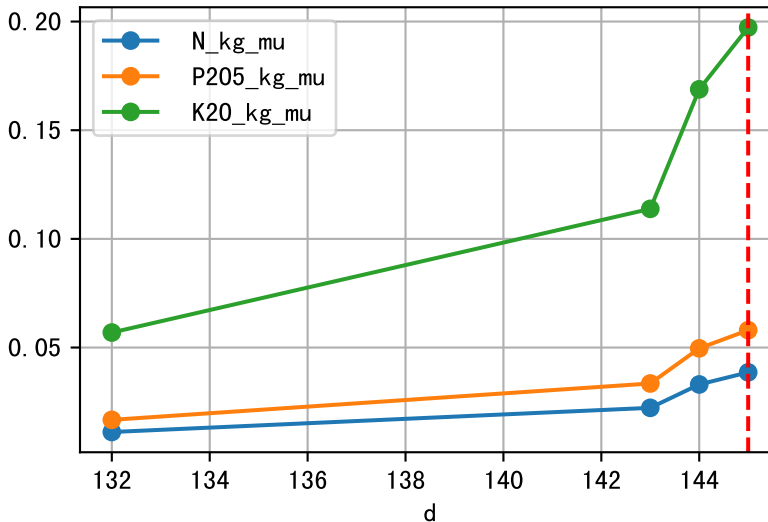
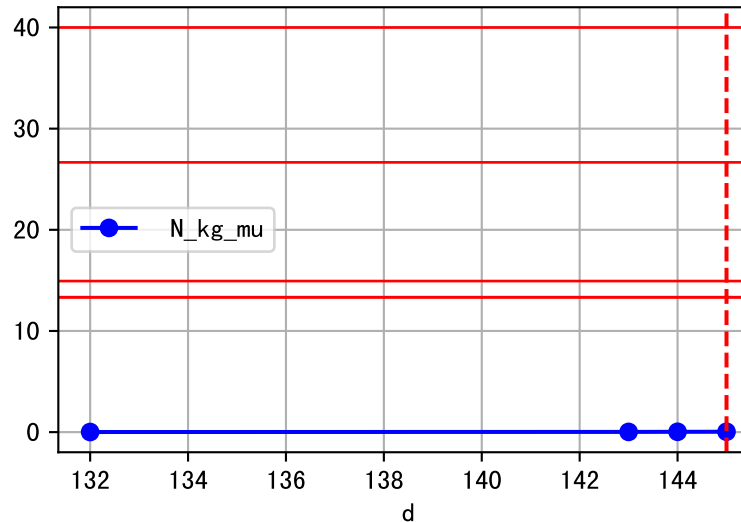
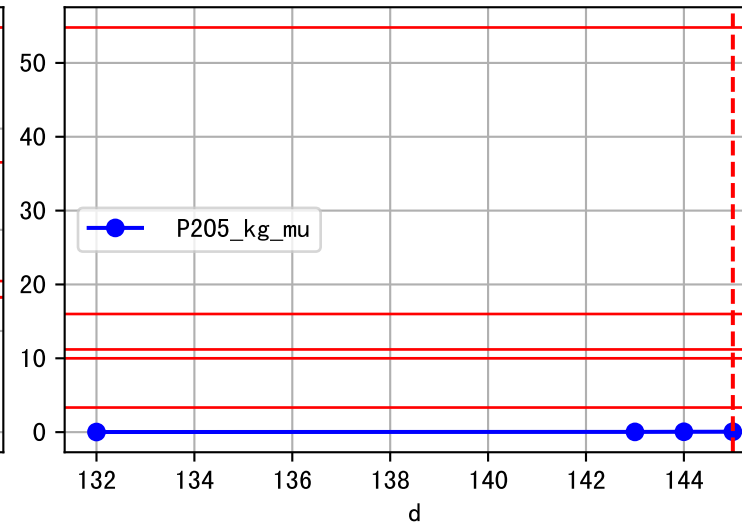
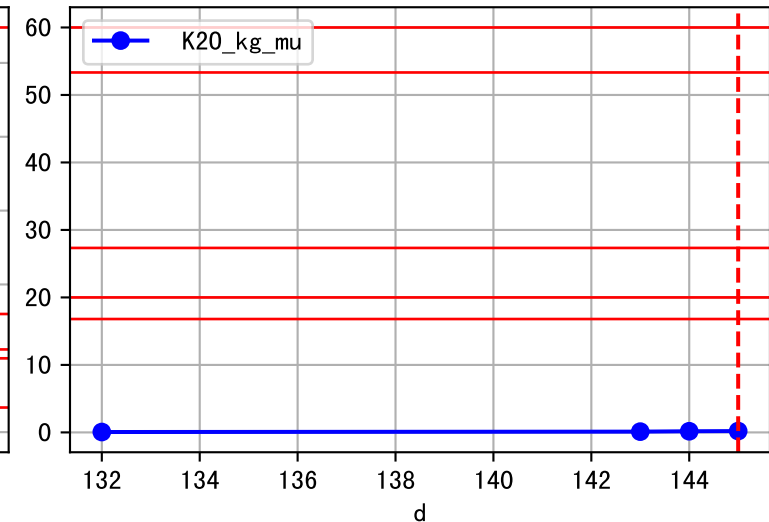
Fertilizer Range Source: kerleyL, kerleyH, UnivFL, TNAI, Haifa

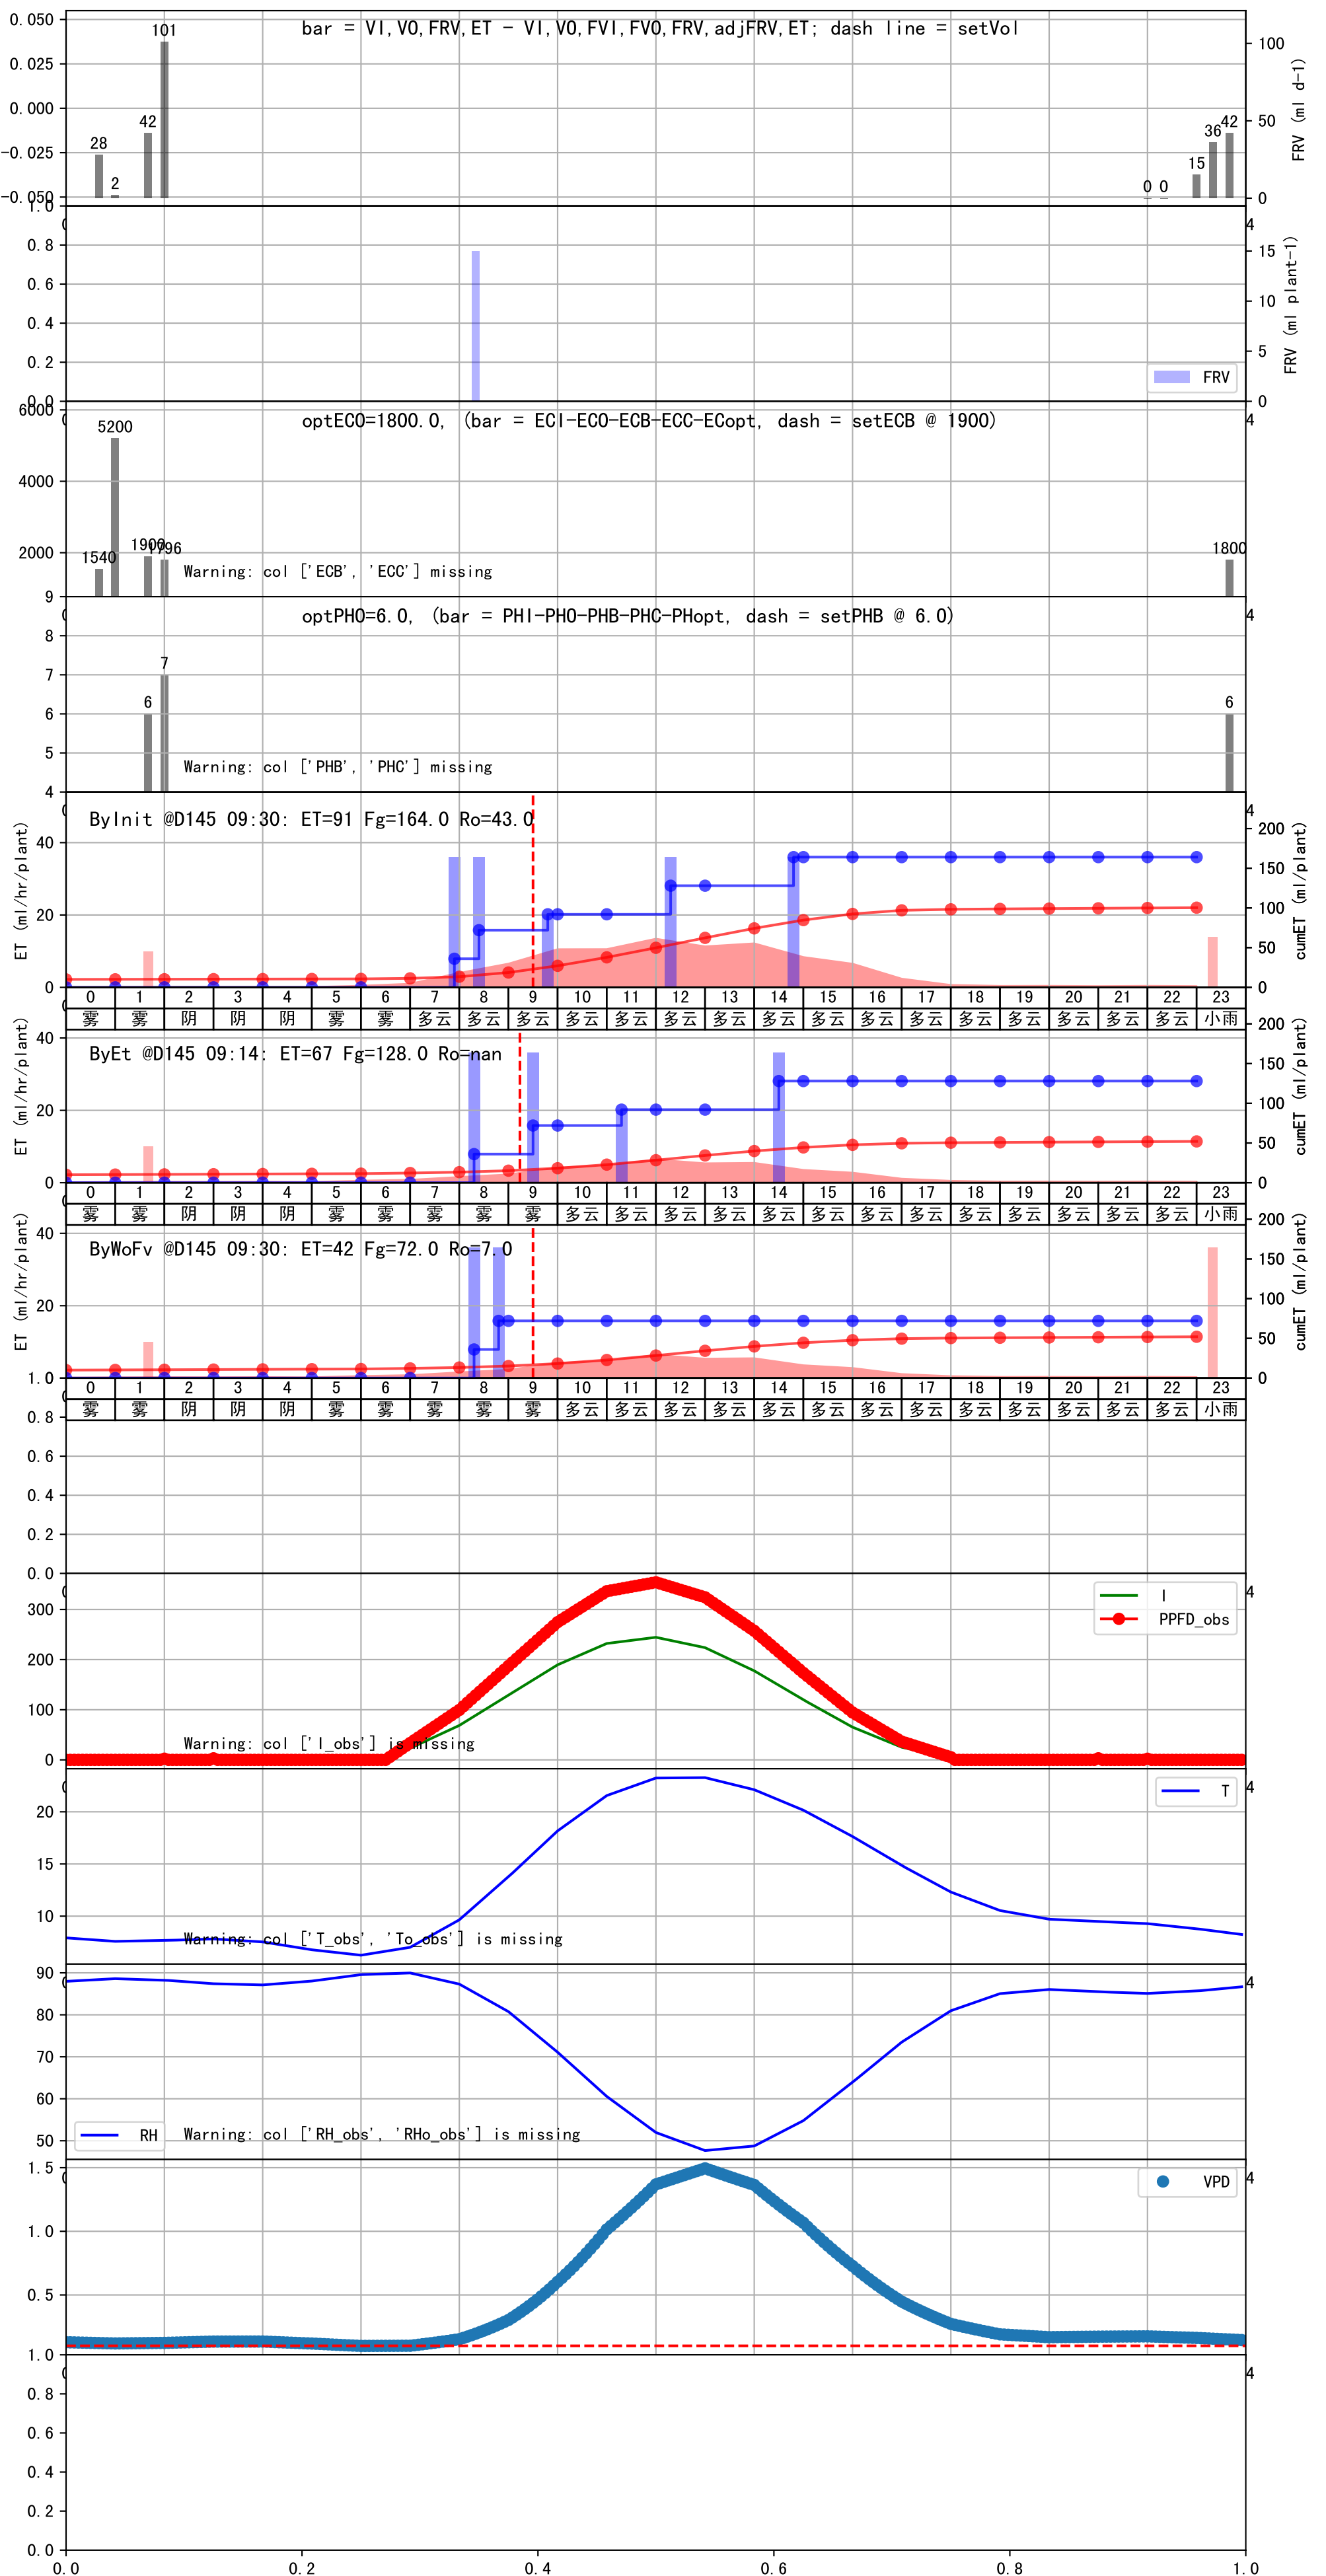
A 阀开关时间 (秒)	B 阀开关时间 (秒)
关' : 13, ' 占空比' : 50}, {' 开' : 35, ' 关' : 43, ' 占空比' : 50}]	[{' 开' : 16, ' 关' : 24, ' 占空比' : 50}, {' 开' : 46,
关' : 13, ' 占空比' : 50}, {' 开' : 35, ' 关' : 43, ' 占空比' : 50}]	[{' 开' : 16, ' 关' : 24, ' 占空比' : 50}, {' 开' : 46,

上次灌溉流速比过去5天平均小 (0.2 vs 0.59), 可能管道压力异常或有管道堵塞
 施肥机灌溉量与预期值不符 (15.0 : 36.0), 可能水表需要校准
 默认实际灌溉36.0 ml.

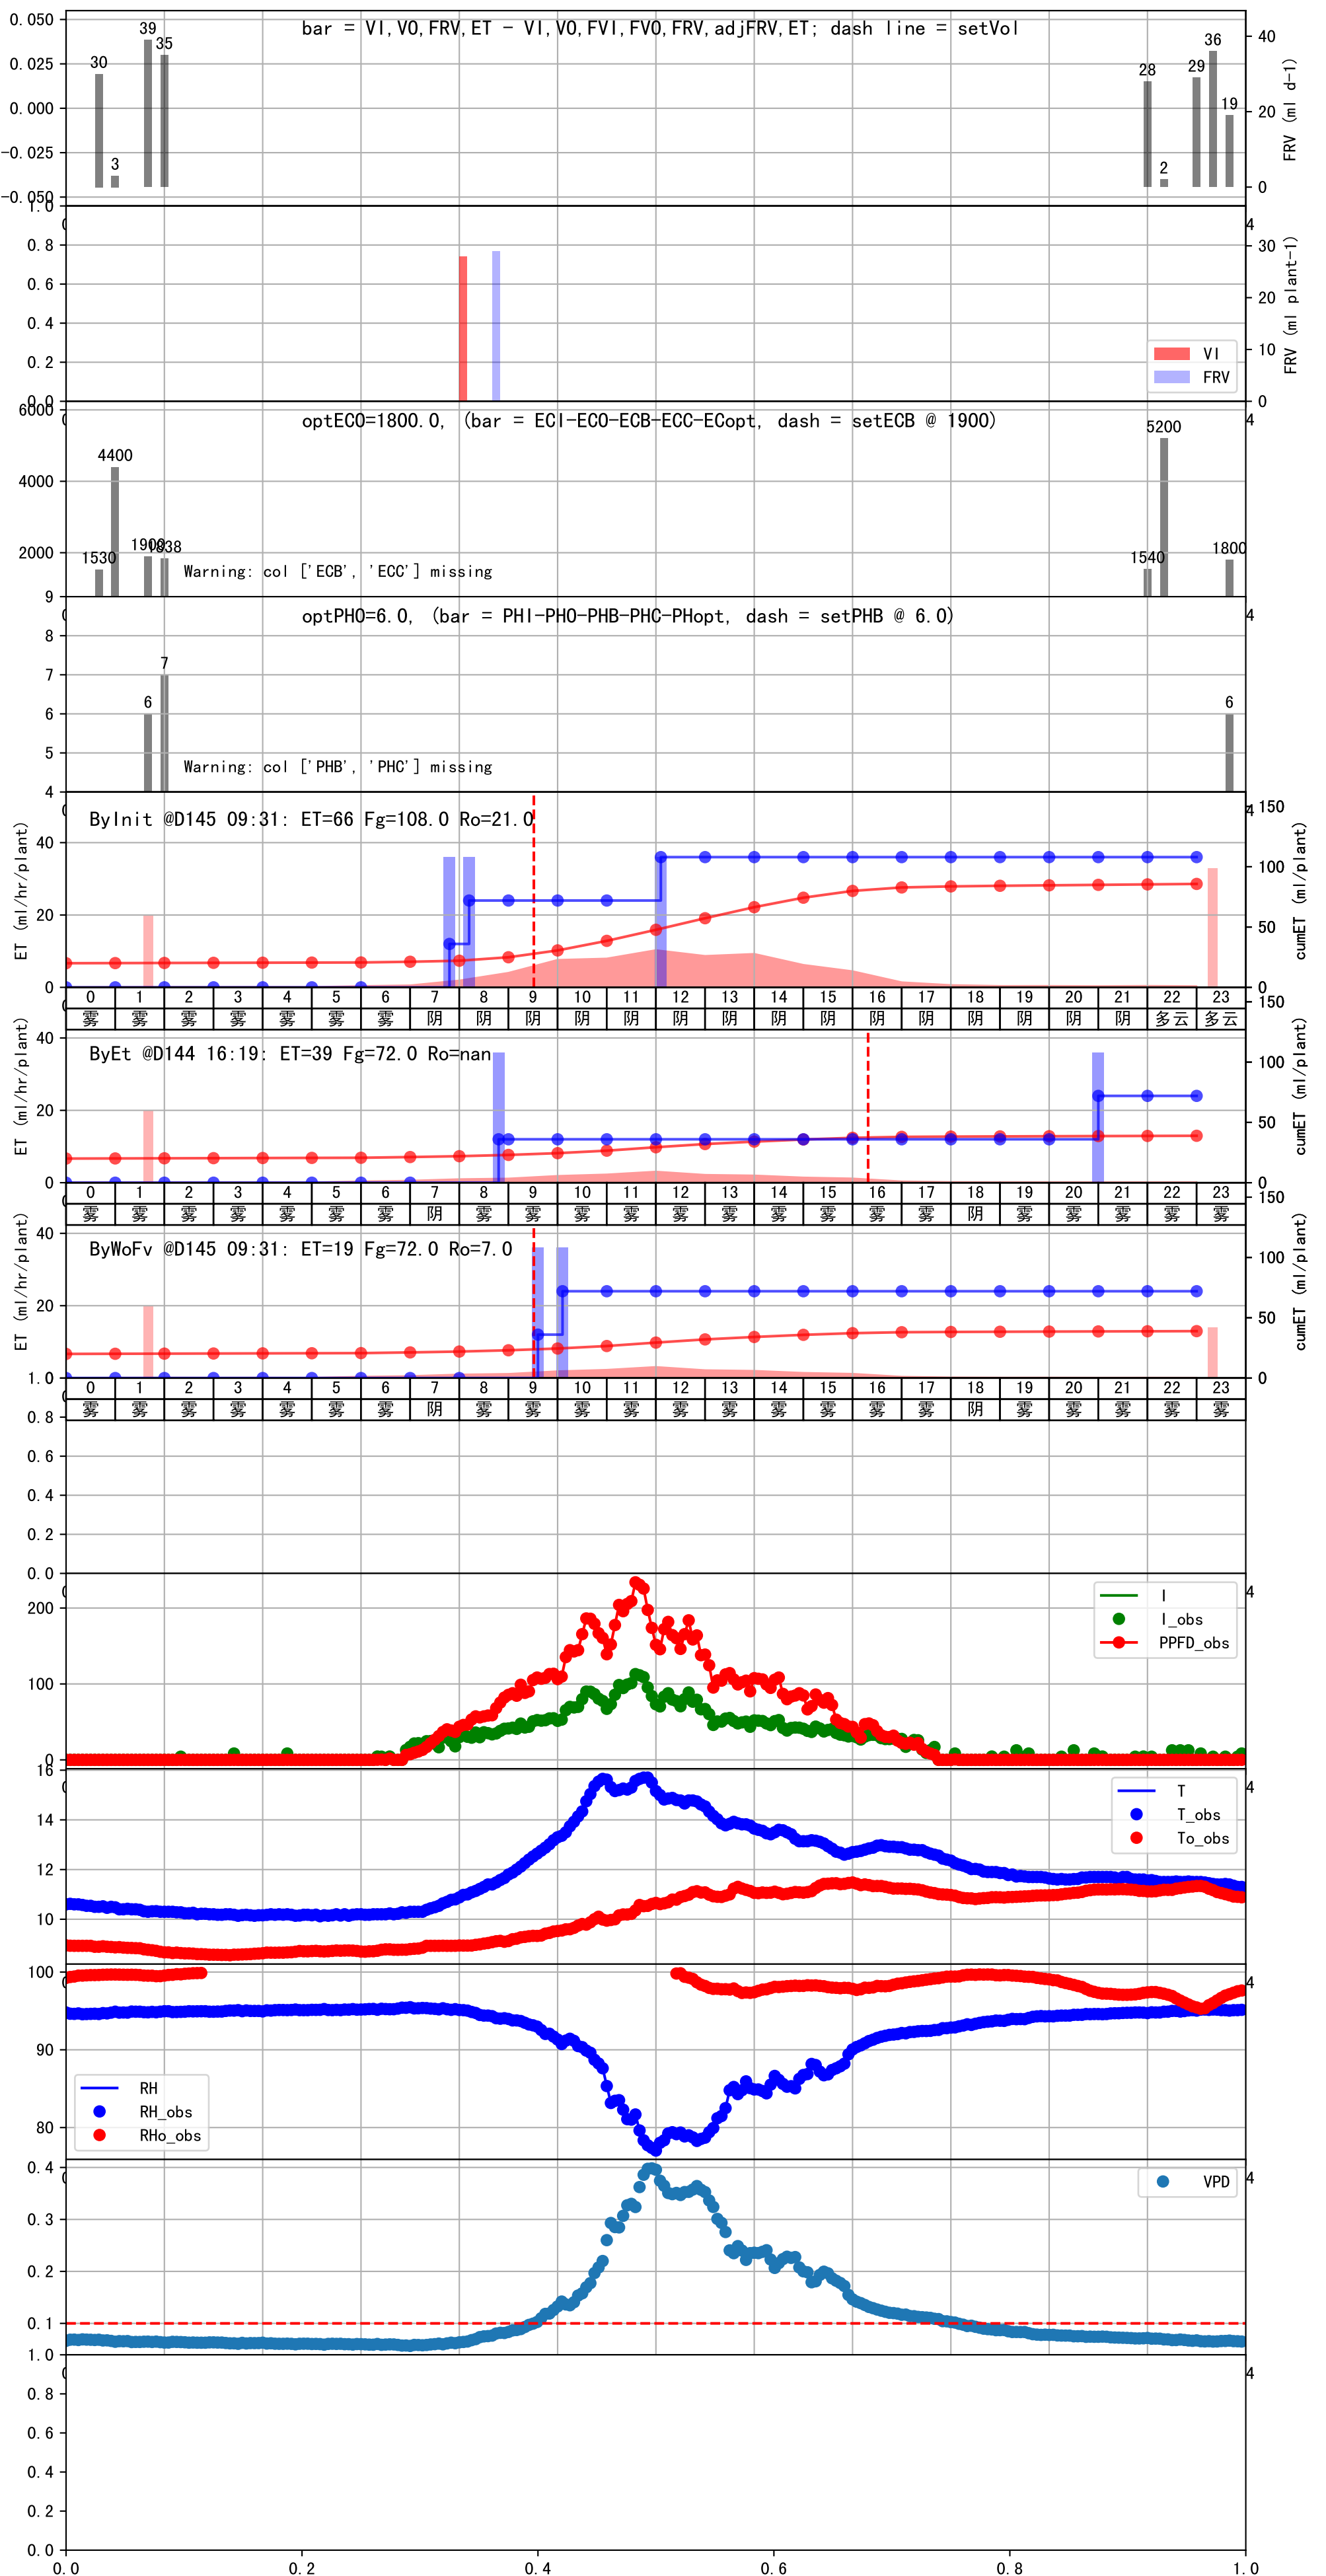
A 阀开关时间 (秒)	B 阀开关时间 (秒)
关' : 13, ' 占空比' : 50}, {' 开' : 35, ' 关' : 43, ' 占空比' : 50}]	[{' 开' : 16, ' 关' : 24, ' 占空比' : 50}, {' 开' : 46,
关' : 13, ' 占空比' : 50}, {' 开' : 35, ' 关' : 43, ' 占空比' : 50}]	[{' 开' : 16, ' 关' : 24, ' 占空比' : 50}, {' 开' : 46,

上次灌溉流速比过去5天平均小 (0.41 vs 0.59), 可能管道压力异常或有管道堵塞
 施肥机灌溉量与预期值不符 (29.0 : 36.0), 可能水表需要校准
 默认实际灌溉36.0 ml.

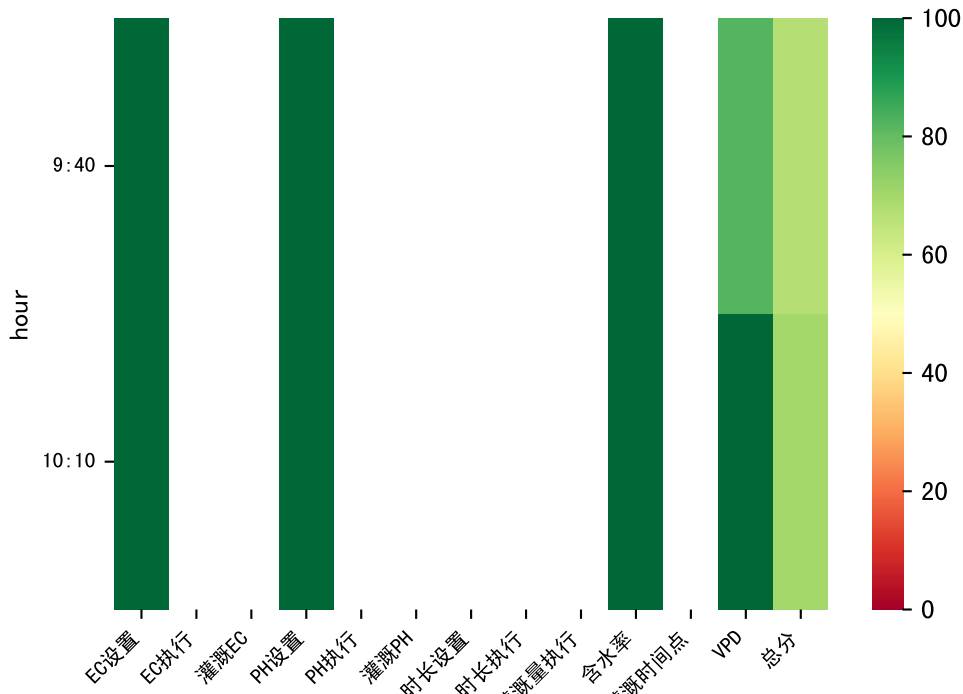
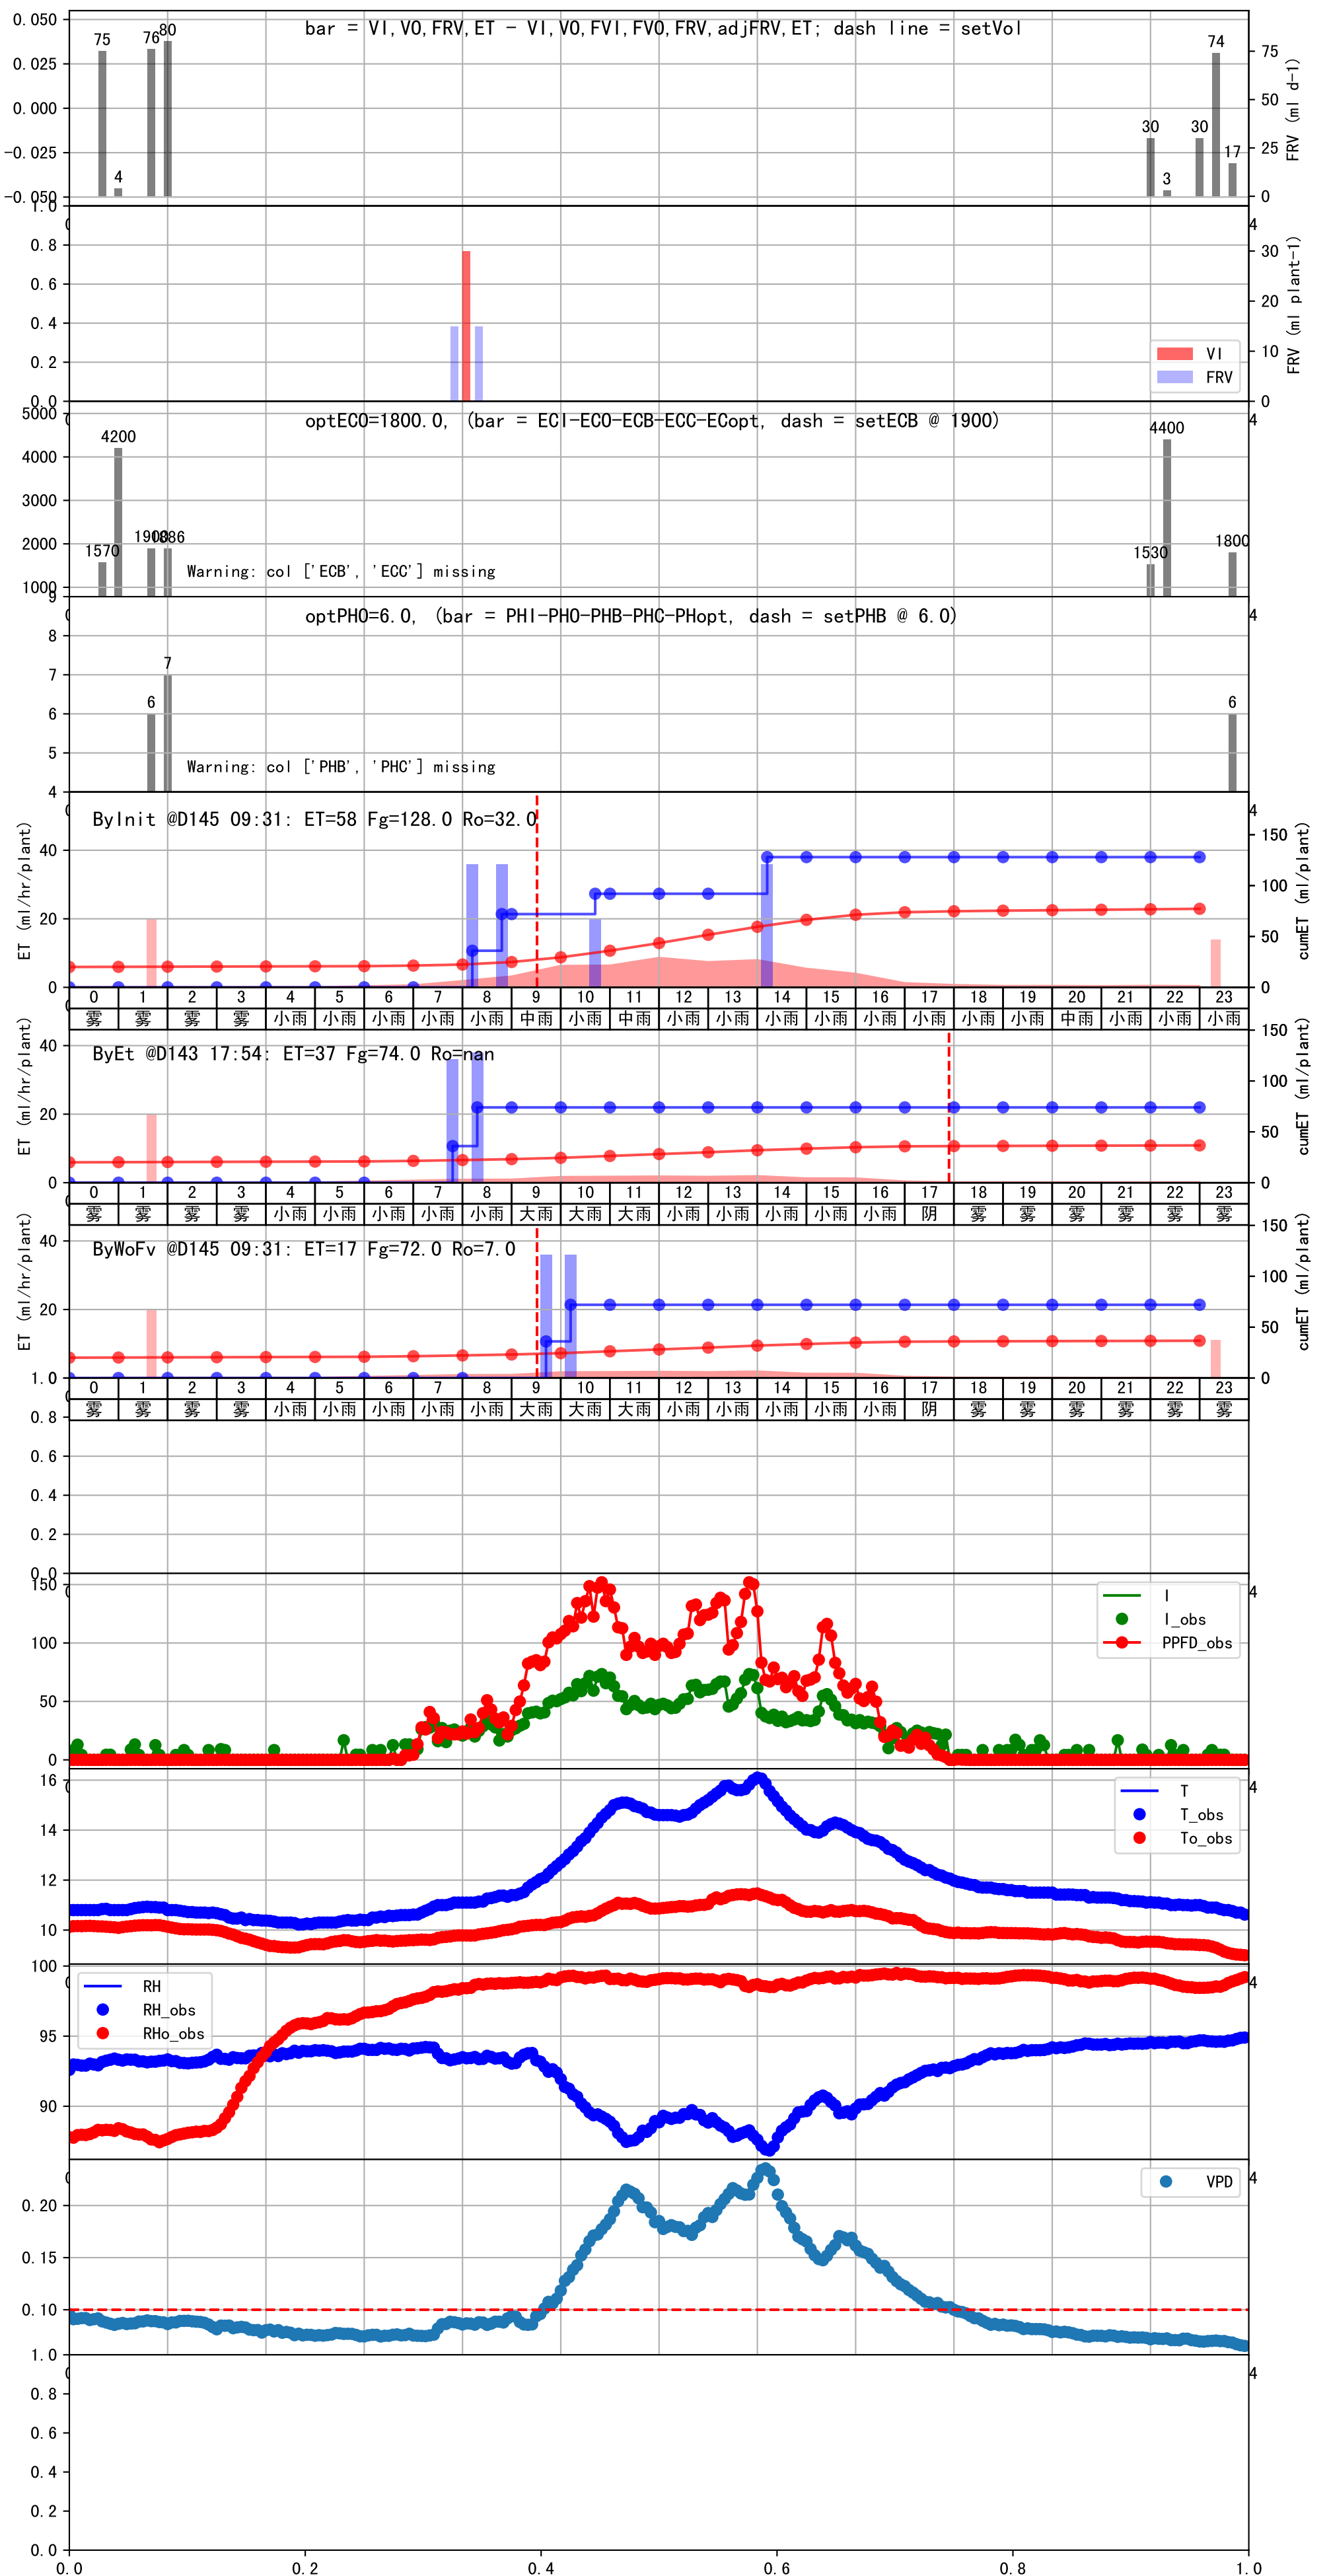
A阀开关时间(秒)	B阀开关时间(秒)
关' : 13, ' 占空比' : 50}, {' 开' : 35, ' 关' : 43, ' 占空比' : 50}]	[{' 开' : 16, ' 关' : 24, ' 占空比' : 50}, {' 开' : 46,
关' : 13, ' 占空比' : 50}, {' 开' : 35, ' 关' : 43, ' 占空比' : 50}]	[{' 开' : 16, ' 关' : 24, ' 占空比' : 50}, {' 开' : 46,

上次灌溉流速比过去5天平均小 (0.2 vs 0.6)，可能管道压力异常或有管道堵塞
 施肥机灌溉量与预期值不符 (15.0 : 38.0)，可能水表需要校准
 默认实际灌溉38.0 ml.
 上次灌溉施肥机流速0.19665683382497542与平均值0.6偏差较大，请检查。
