NC11 P3-10

2025-04-15 (Day 13)

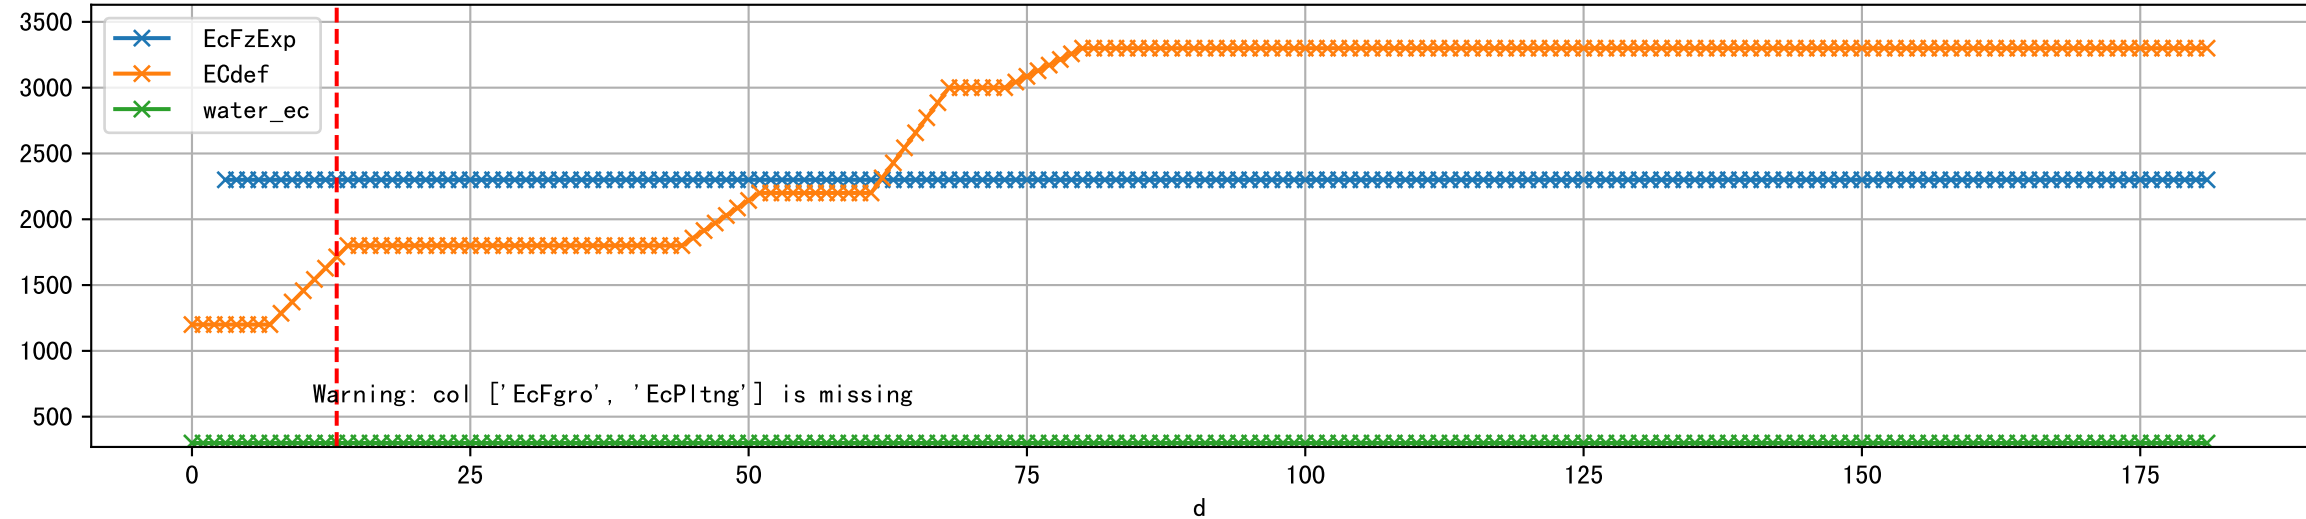
Plot [['EcFgro', 'EcFzExp', 'EcPltng', 'ECdef', 'water\_ec']]

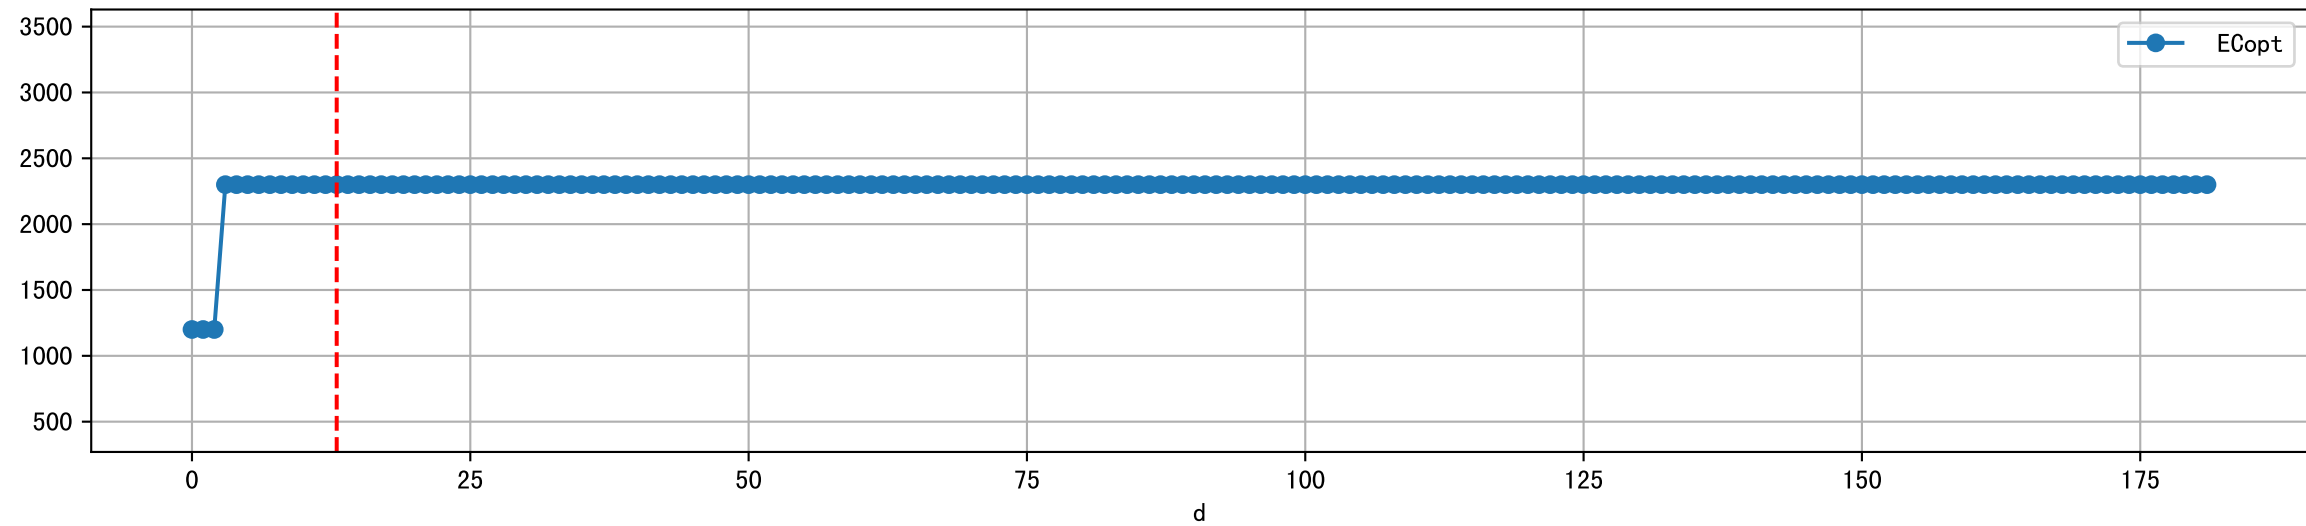
Plot [' ECopt' ]

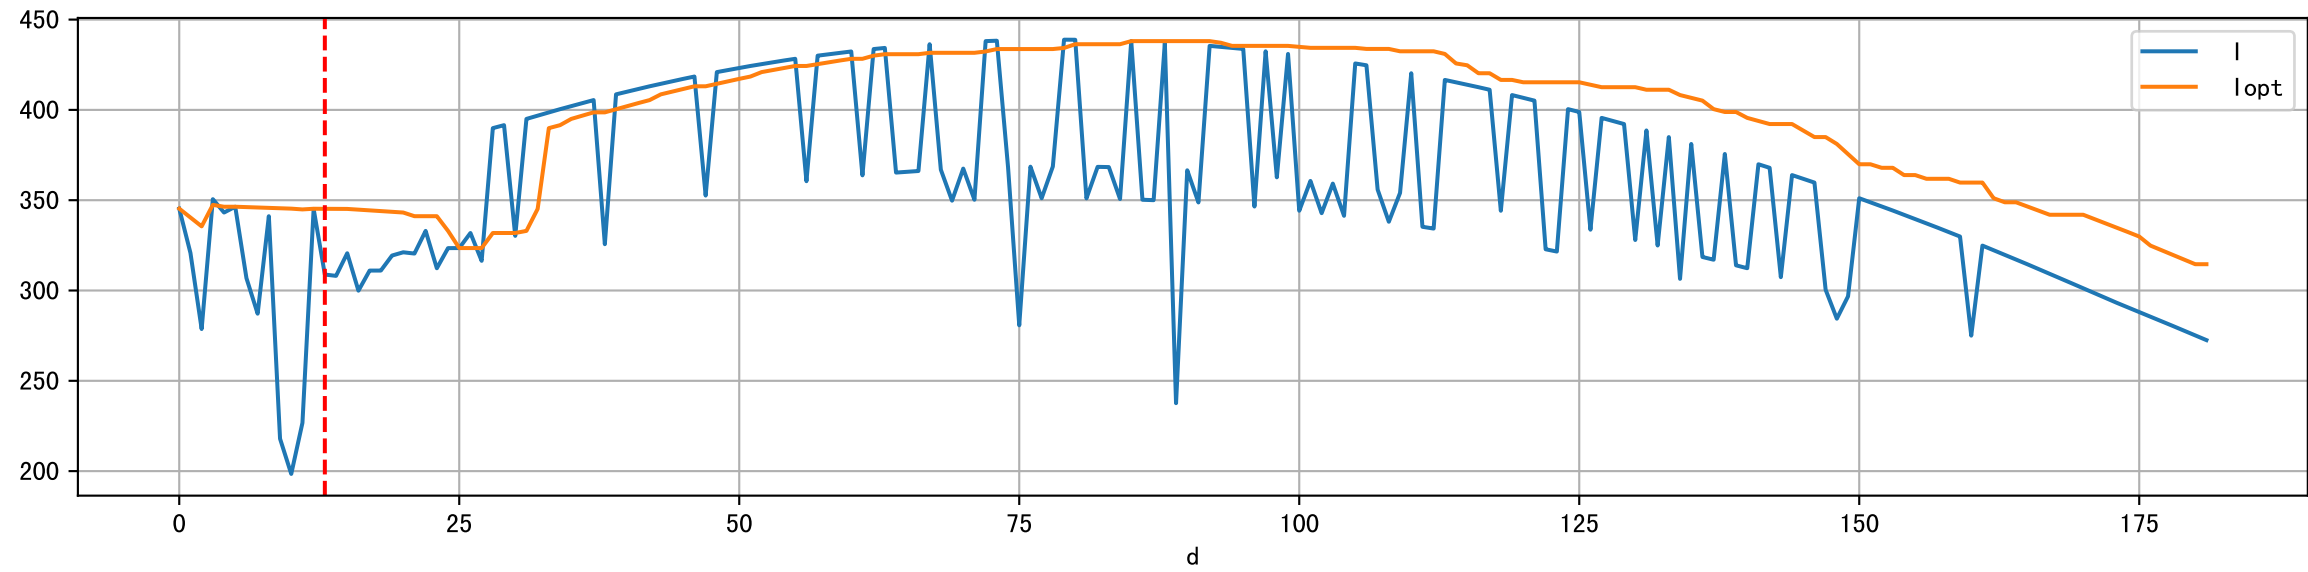
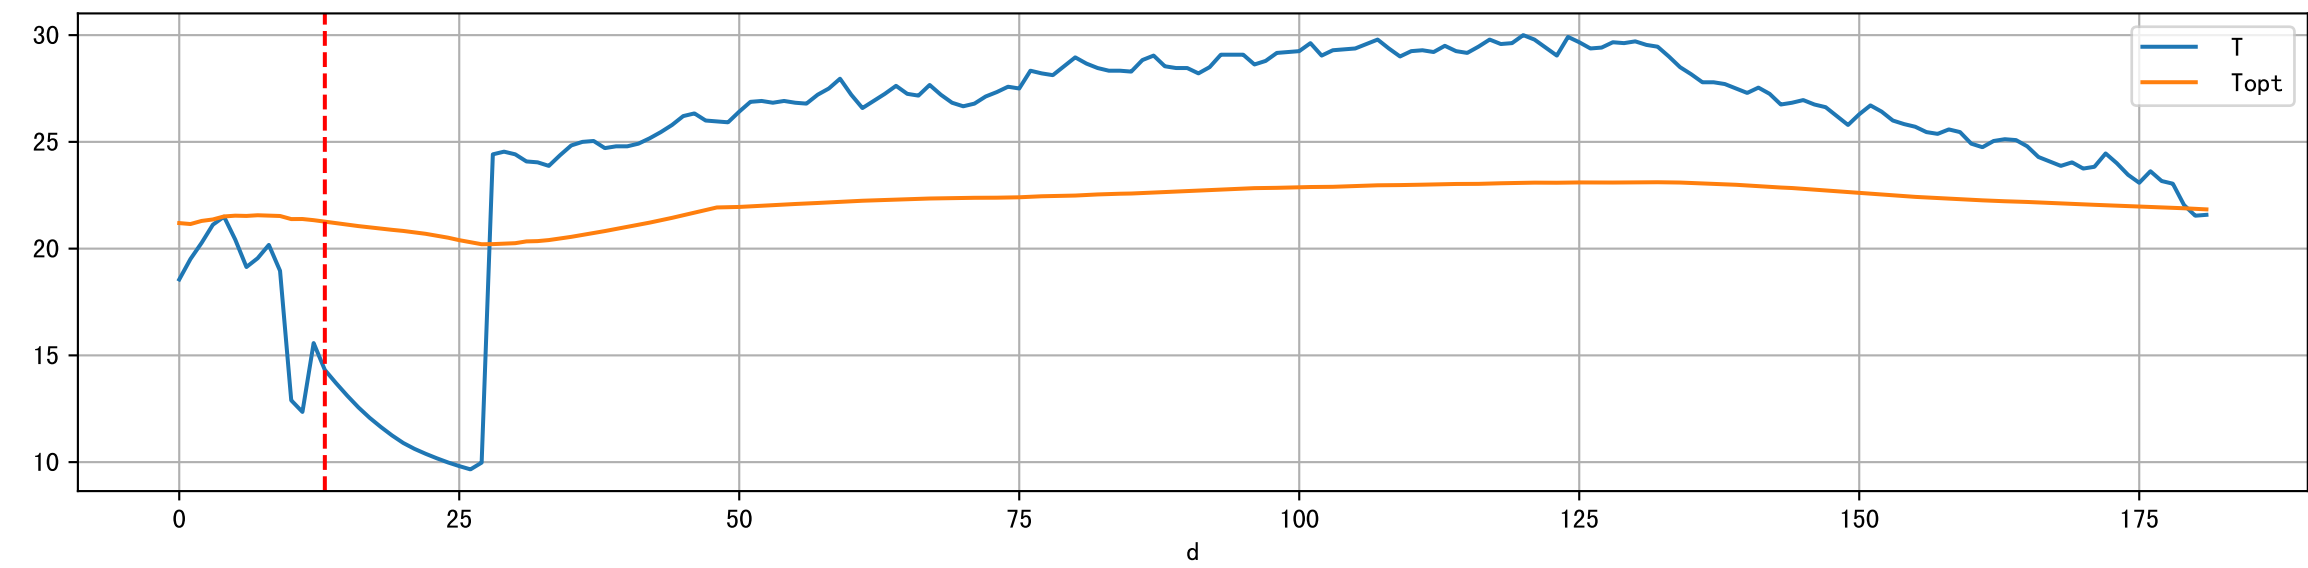
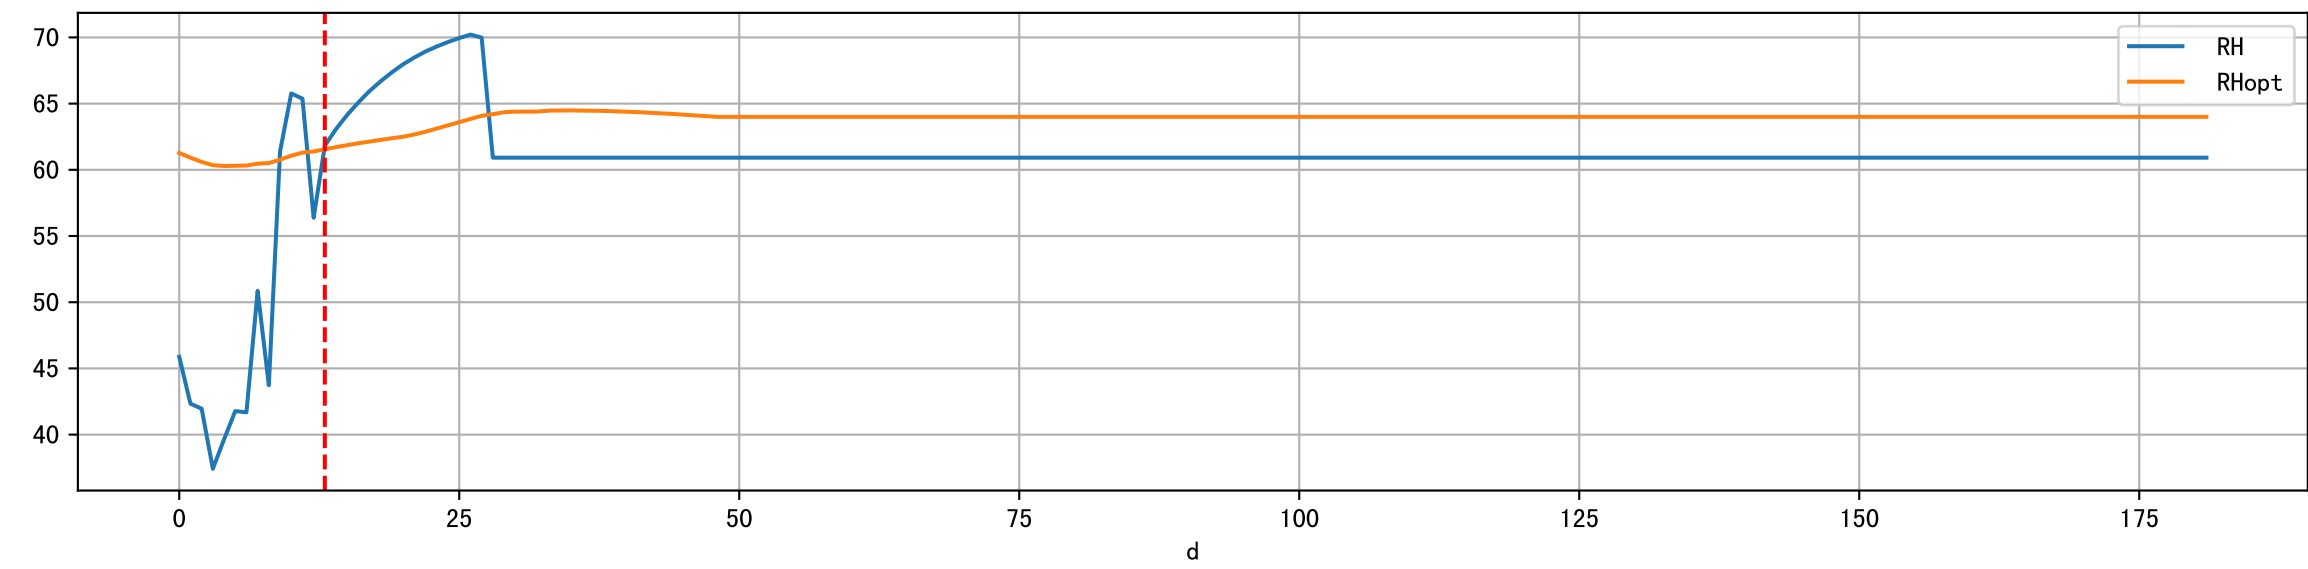
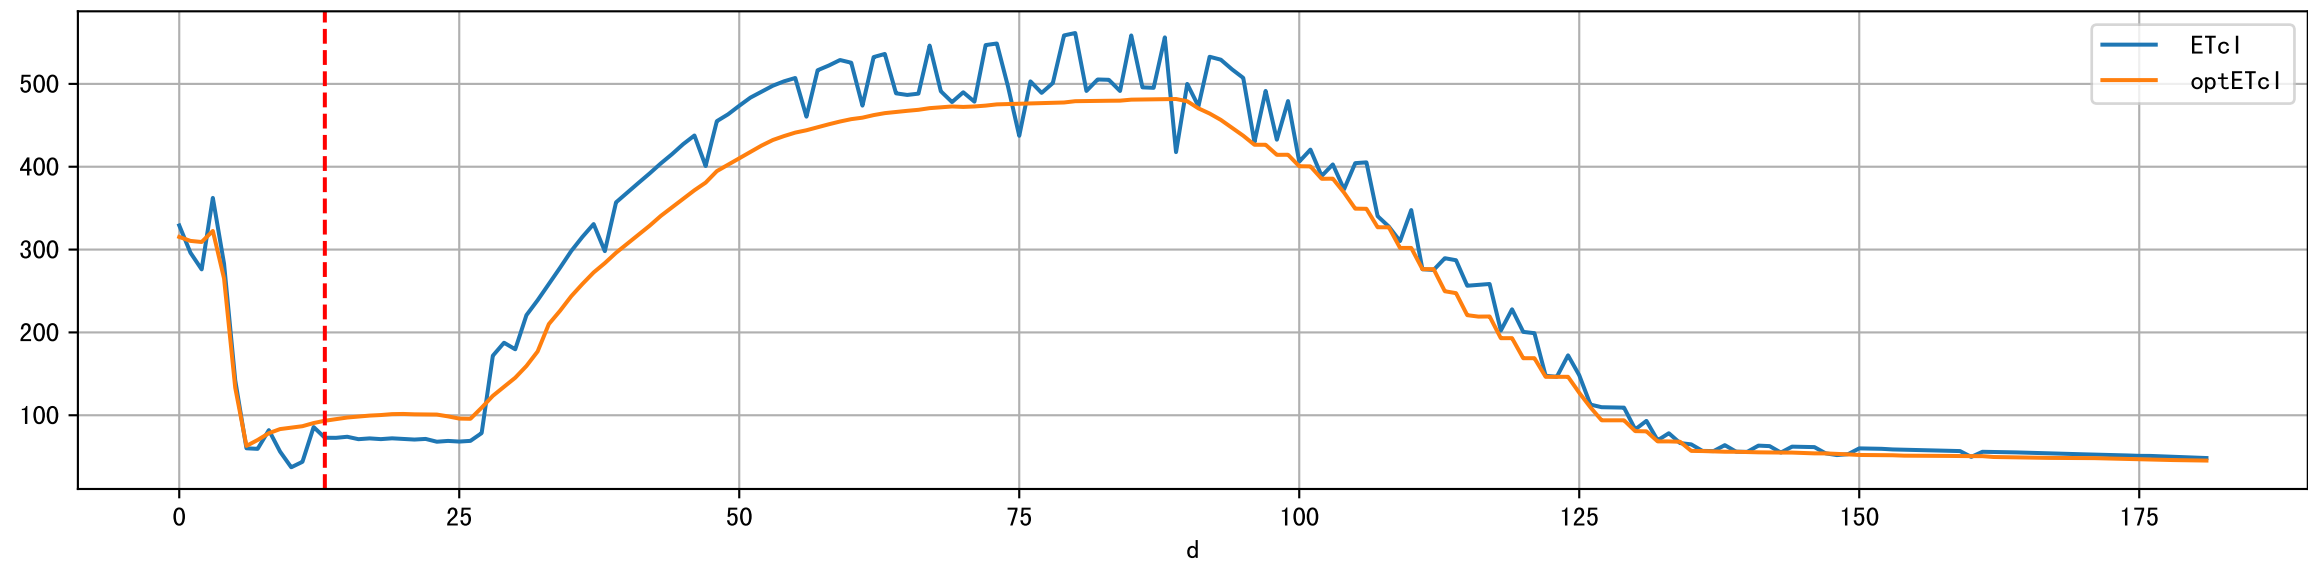
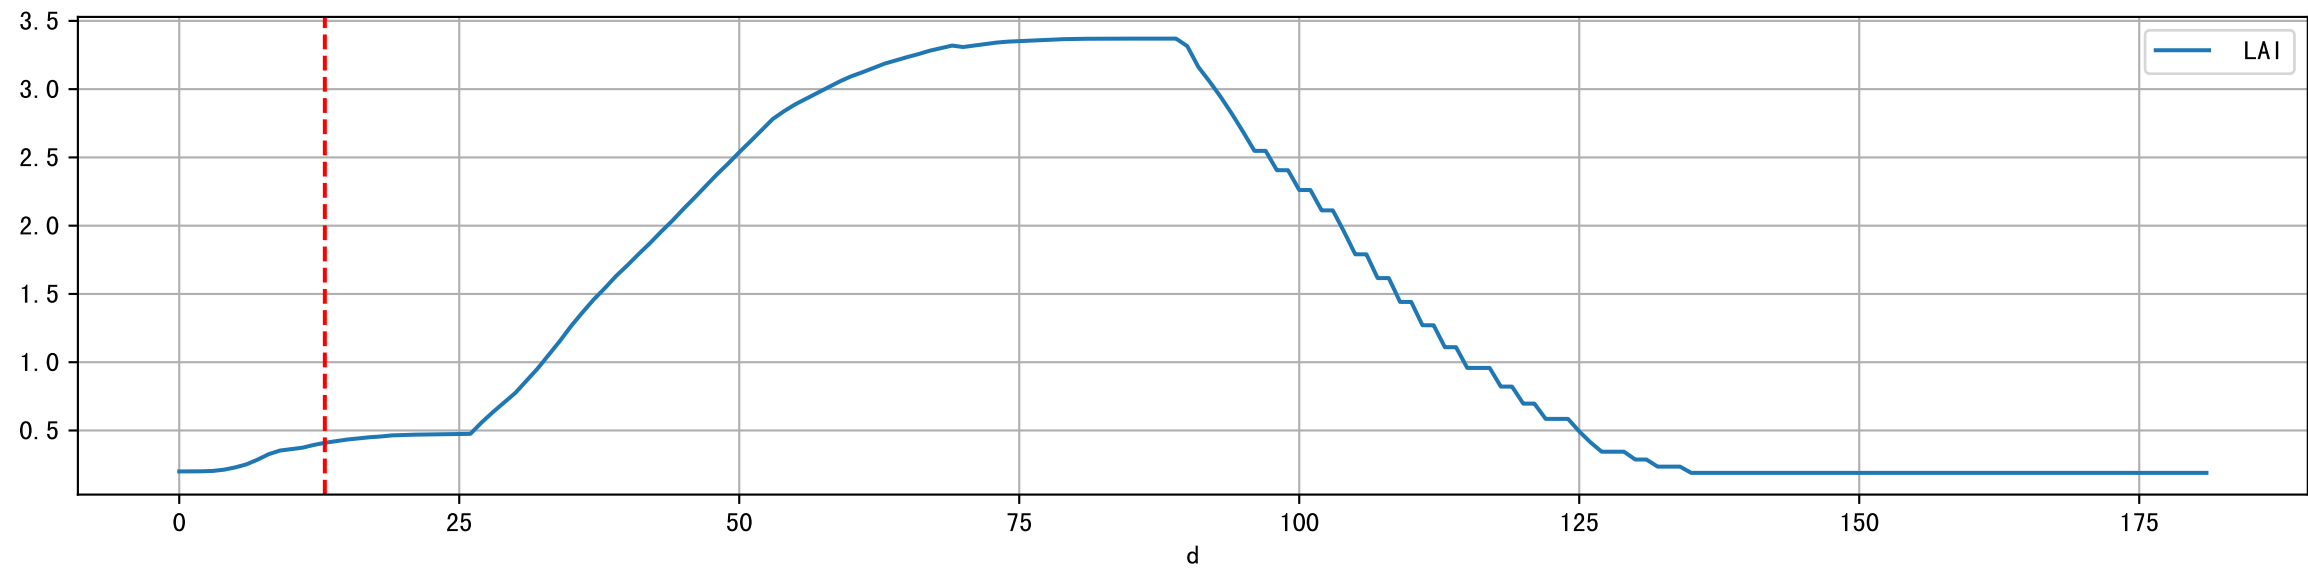
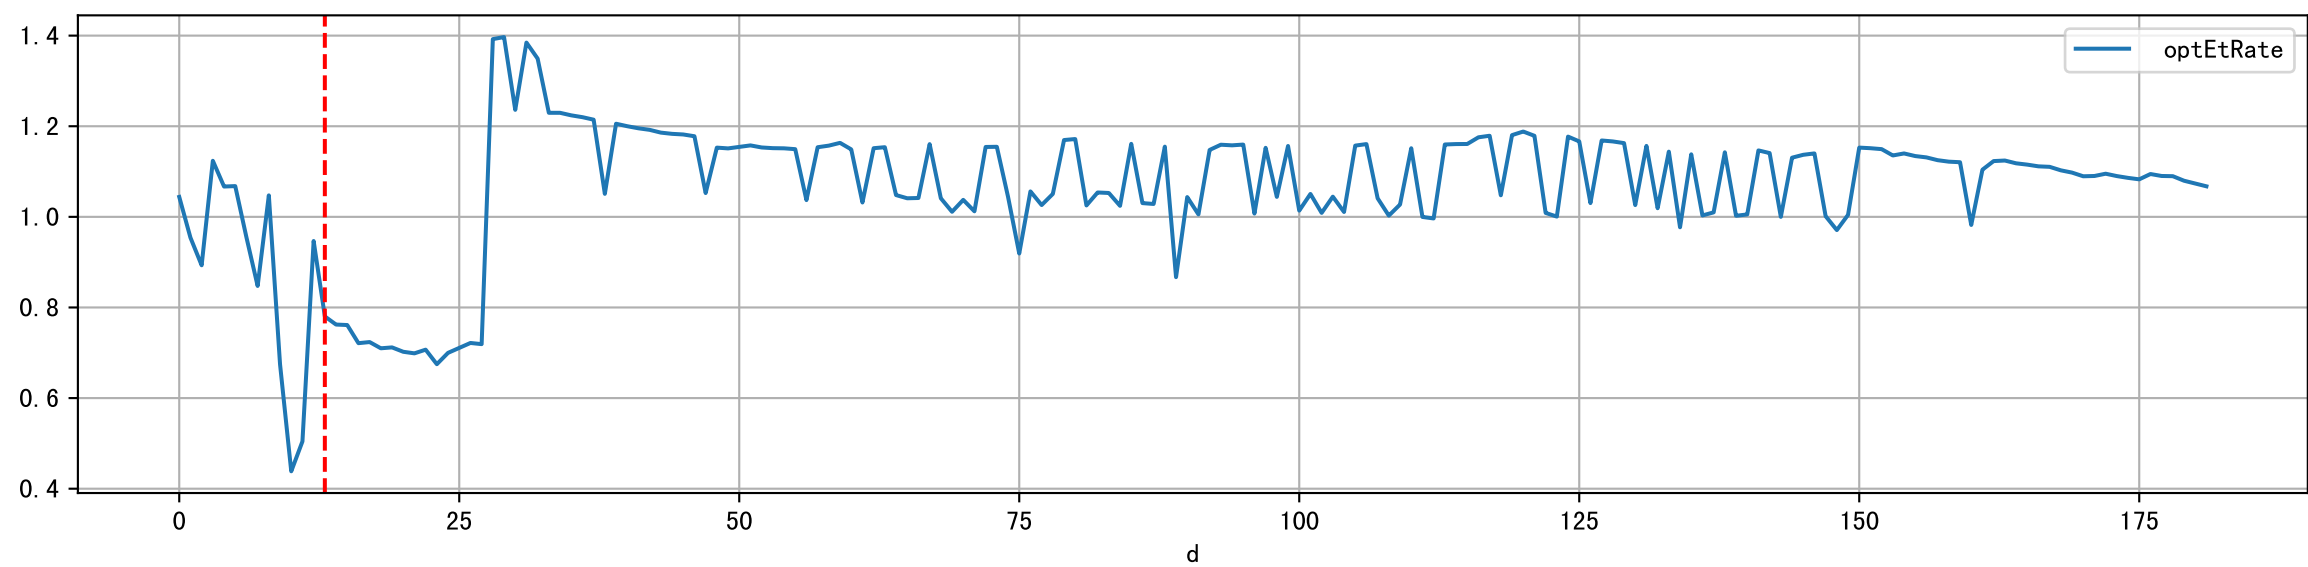
Plot [['I', 'Iopt'], ['T', 'Topt'], ['RH', 'RHopt'], ['ETcl', 'optETcl'], 'LAI', 'optEtRate']

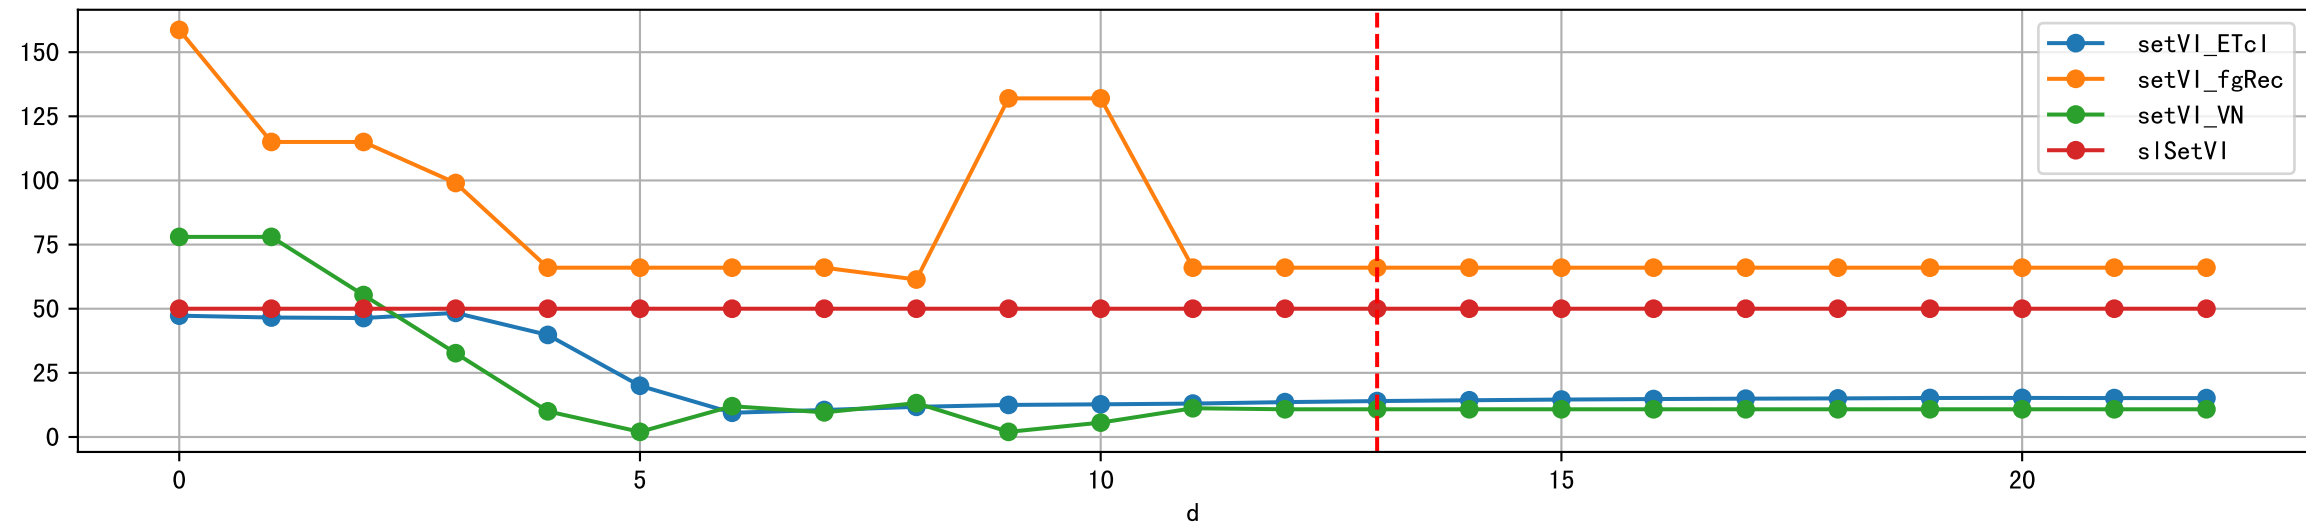
Plot [['setVI\_ETcl', 'setVI\_fgRec', 'setVI\_VN', 'sISetVI']]

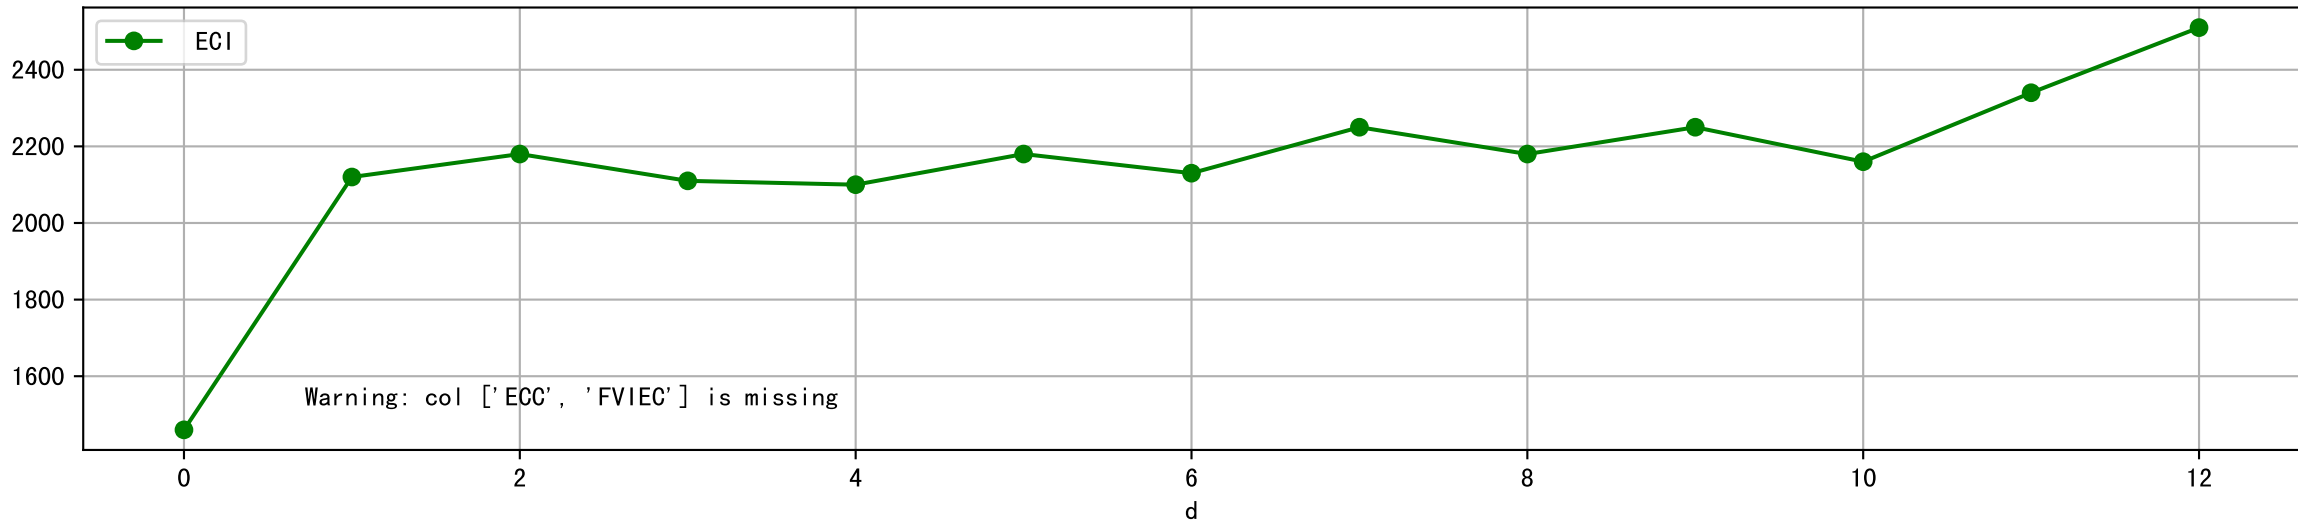
Plot [['ECC:b-o', 'FVIEC:r-o', 'ECI:g-o']]

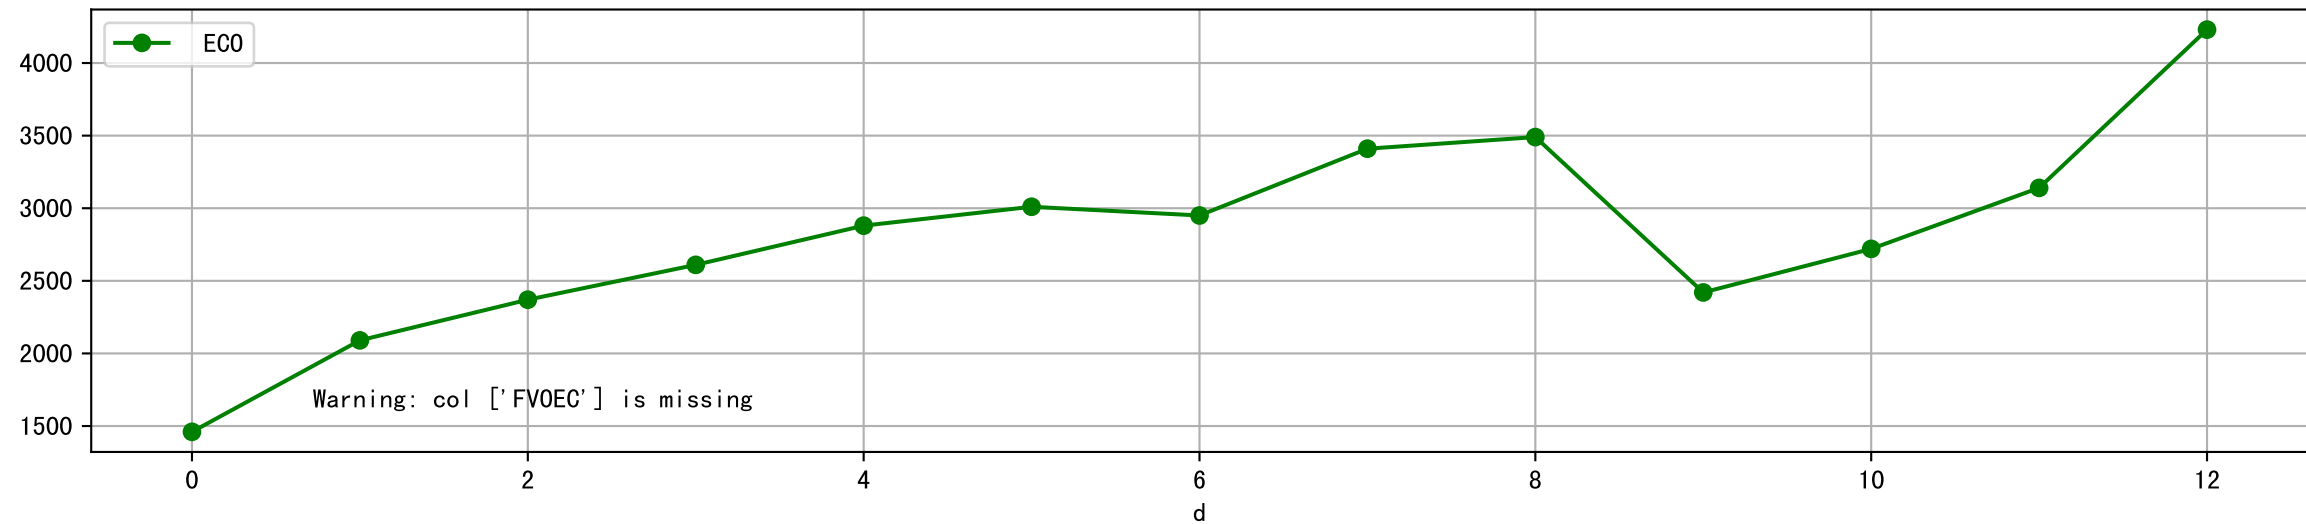
Plot [['FV0EC:r-o', 'ECO:g-o']]

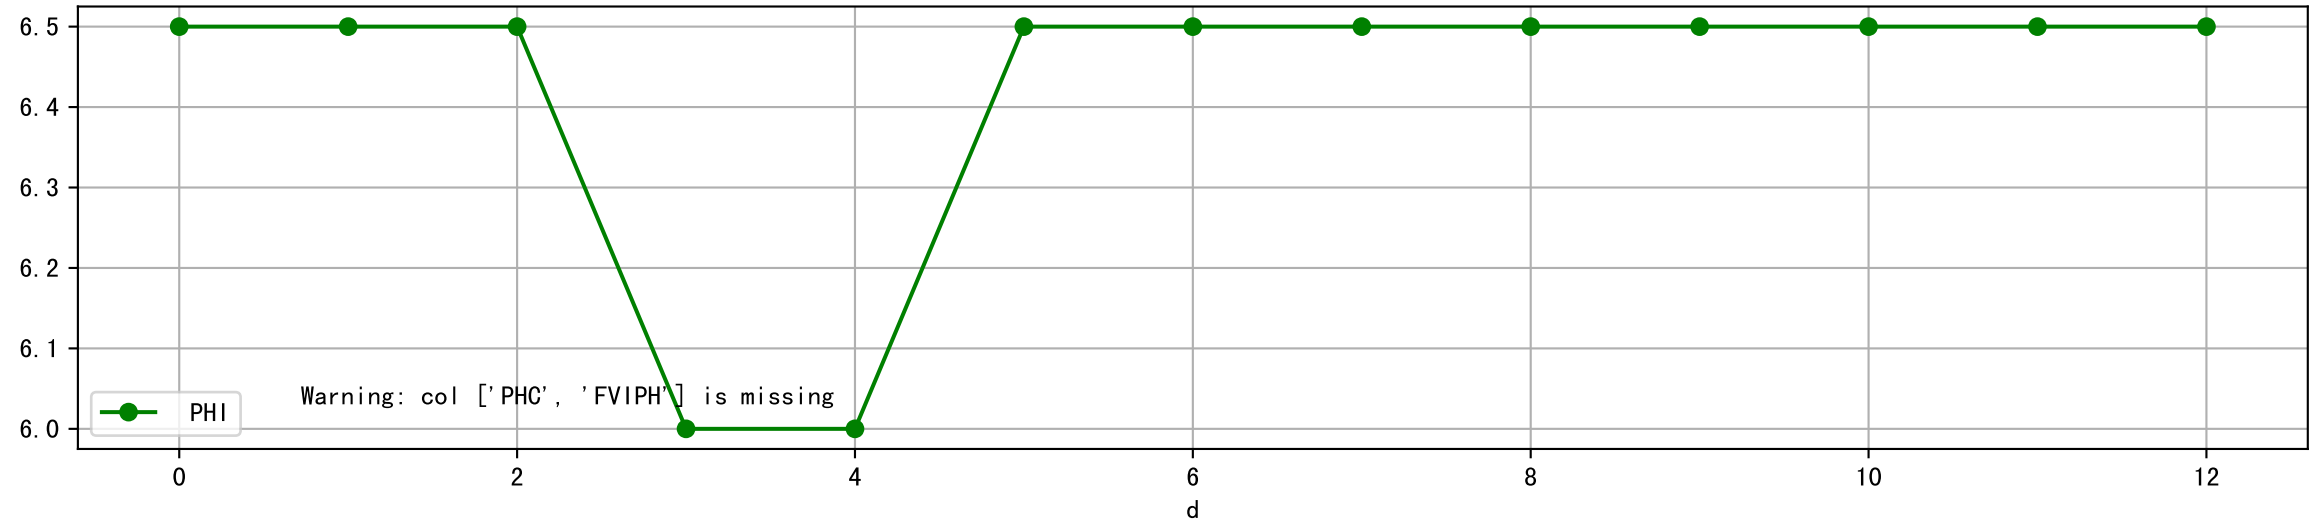
Plot [['PHC:b-o', 'FVIPH:r-o', 'PHI:g-o']]

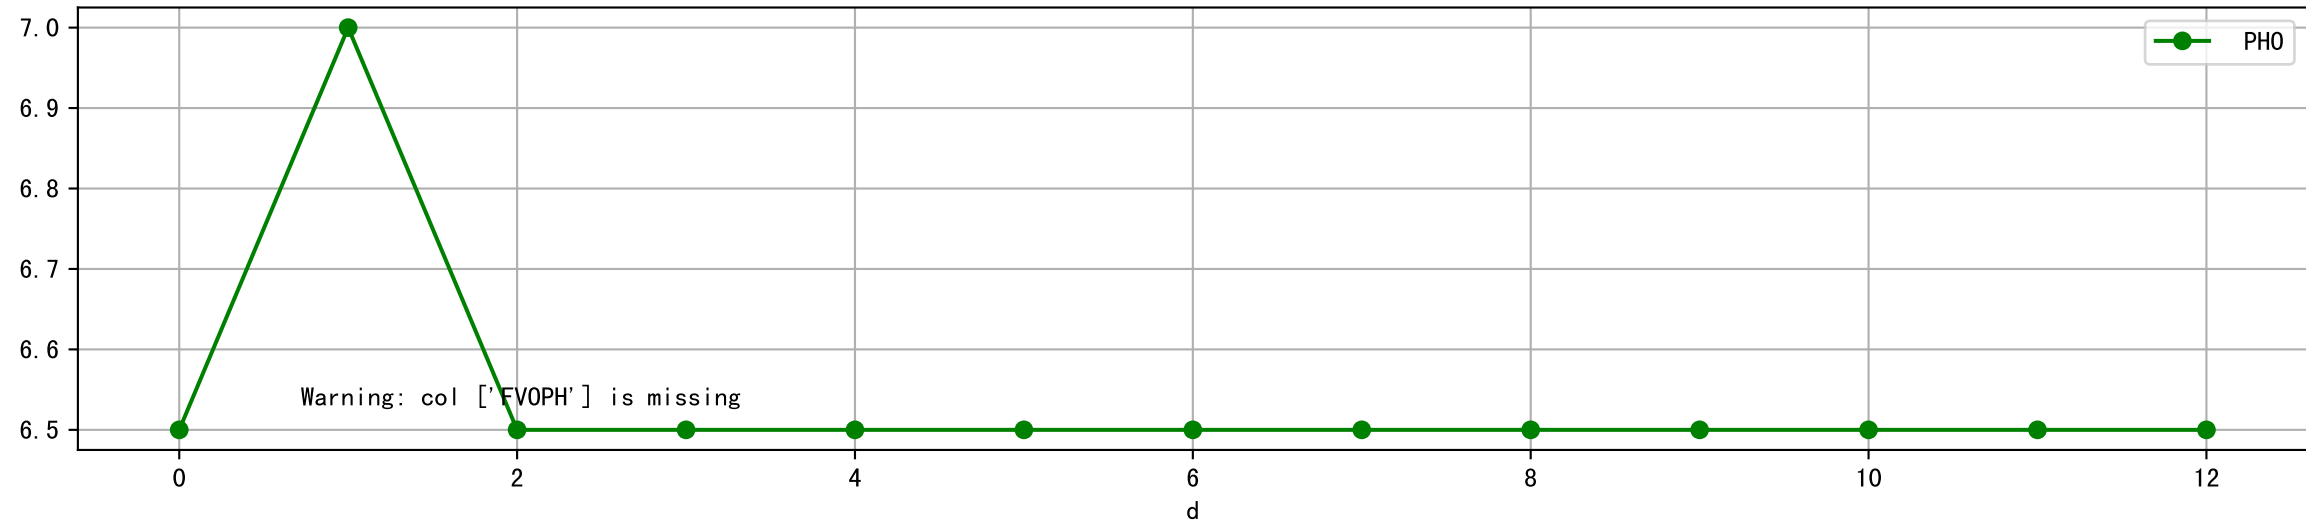
Plot [[' FVOPH:r-o' , ' PH0:g-o' ]]

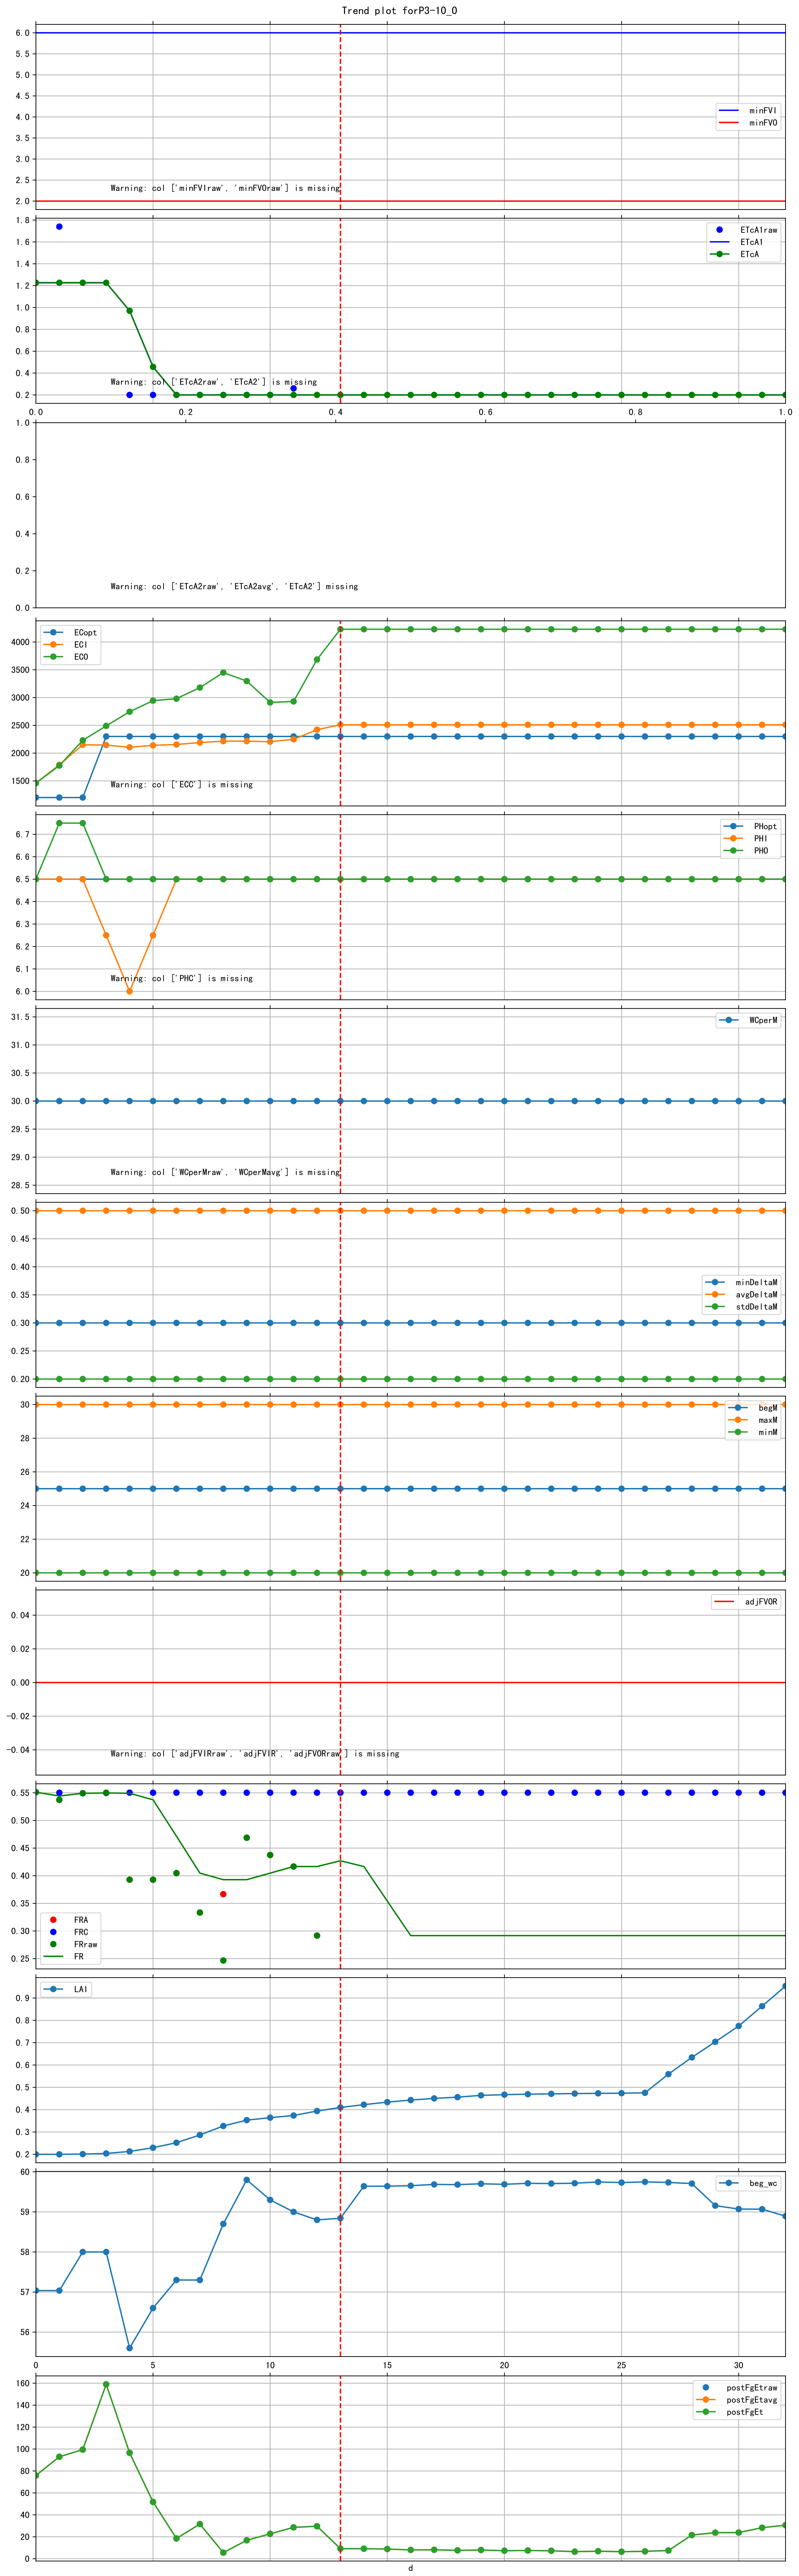
Trend plot forP3-10\_0
