NC11 P3-9

2025-04-16 (Day 14)

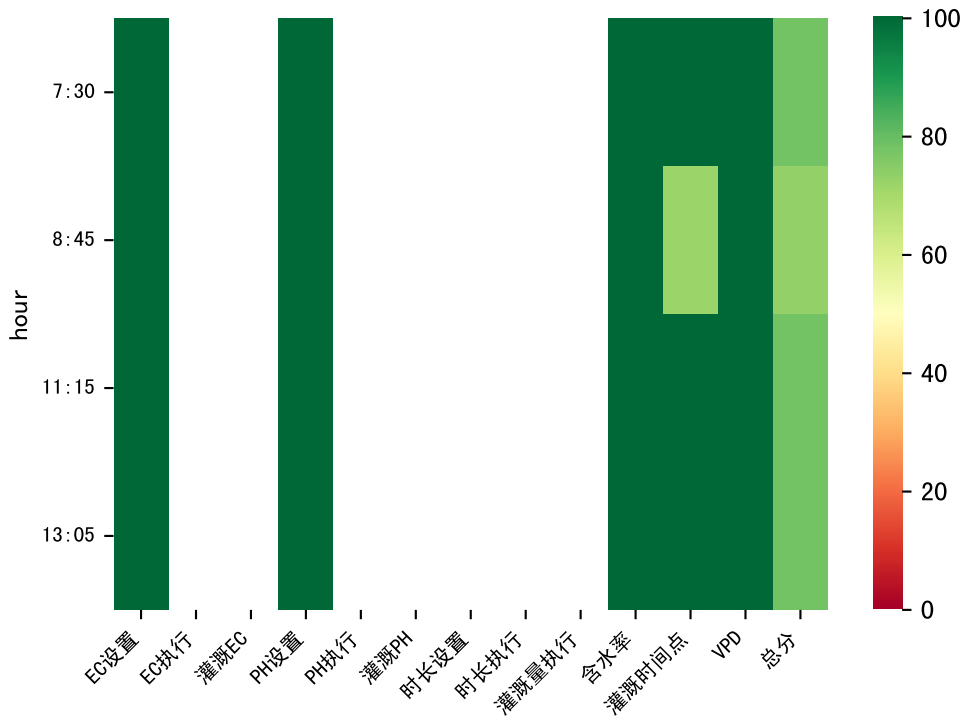
昨天灌溉EC (2510.0) 与设定EC (2000.0) 偏差较大, 请检查  
进回液EC差 (2510.0 vs 3978.0) 偏高

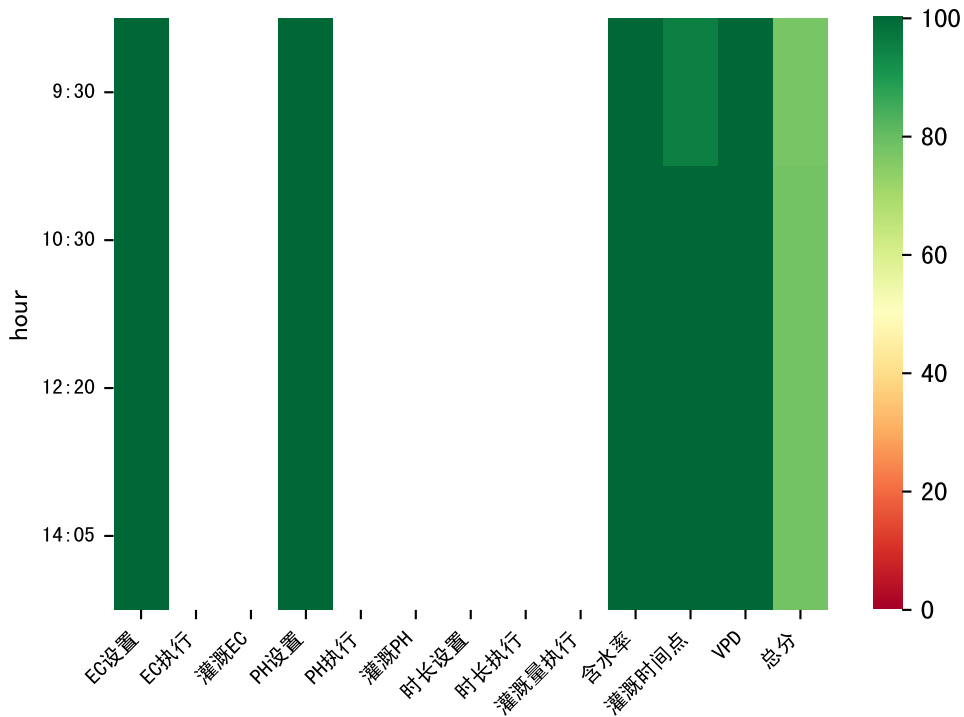
施肥机灌溉量与预期值不符（99.0：59.0），可能由于一阀多区不均匀  
上次灌溉时长(180)与预期(152.0)不符，可能由于多阀同灌按参考区灌溉  
默认实际灌溉59.0 ml.  
昨天进回液EC数据缺失.  
昨天灌溉EC（2422.0）与设定EC（2000.0）偏差较大，请检查  
昨天灌溉进排液EC/PH值缺失，可能影响模型决策

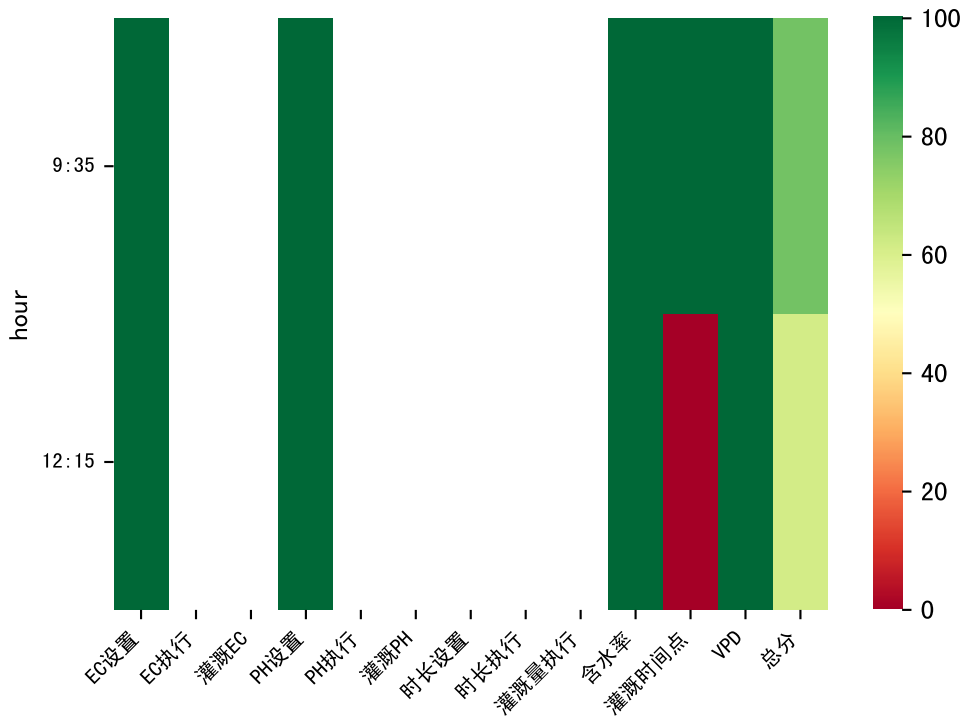
施肥机灌溉量与预期值不符（66.0 : 40.0），可能由于一阀多区不均匀  
上次灌溉时长(120)与预期(152.0)不符，可能由于多阀同灌按参考区灌溉  
默认实际灌溉40.0 ml.

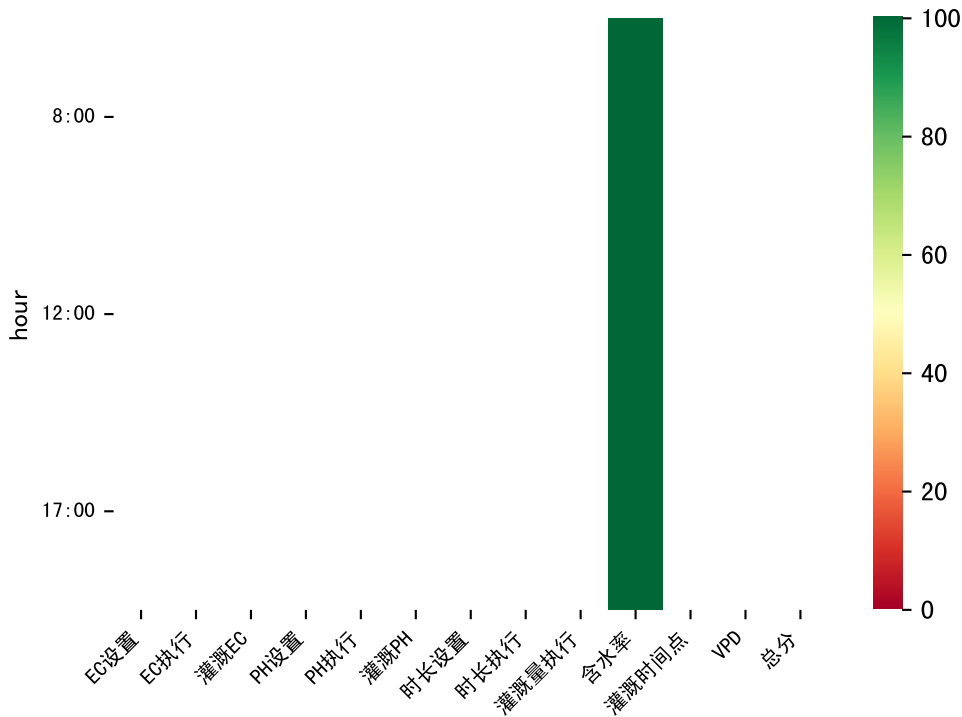
施肥机灌溉量与预期值不符 (66.0 : 46.0)，可能由于一阀多区不均匀  
默认实际灌溉46.0 ml.

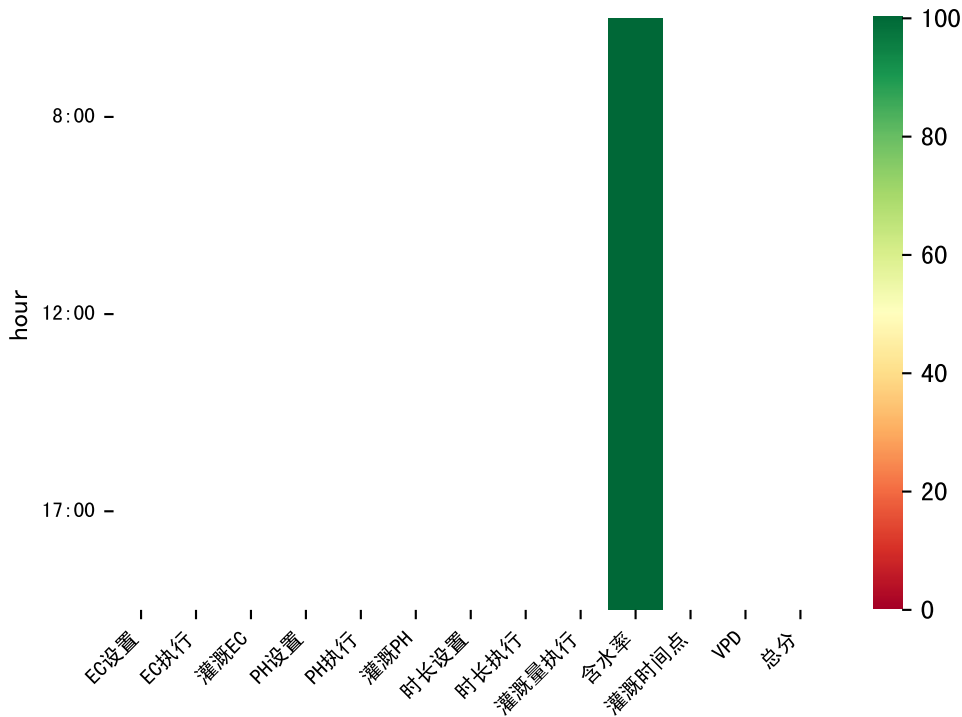
施肥机灌溉量与预期值不符 (132.0 : 91.0)，可能由于一阀多区不均匀  
上次灌溉时长(240)与预期(132.0)不符，可能由于多阀同灌按参考区灌溉  
默认实际灌溉91.0 ml.
