NC11 P3-9

2025-04-05 (Day 3)

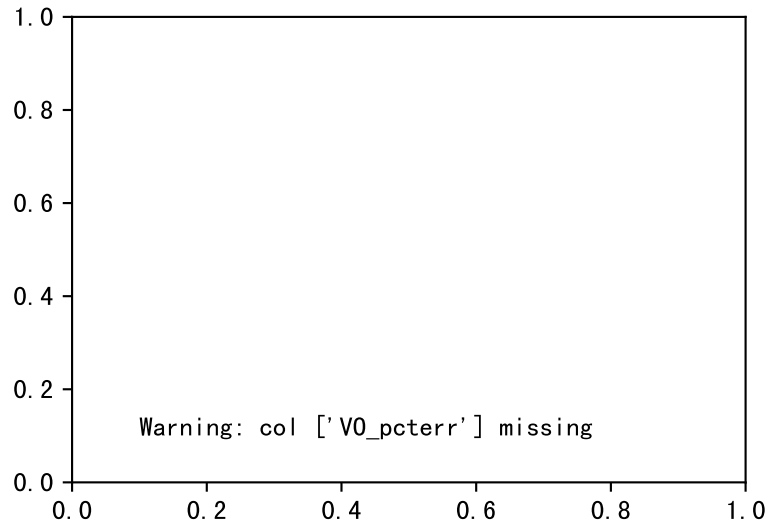
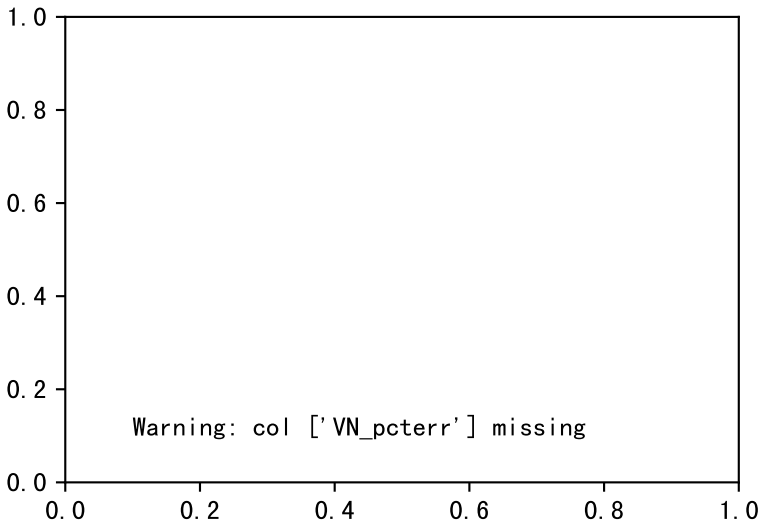
Plot ['VI\_pcterr', 'VO\_pcterr', 'VN\_pcterr']

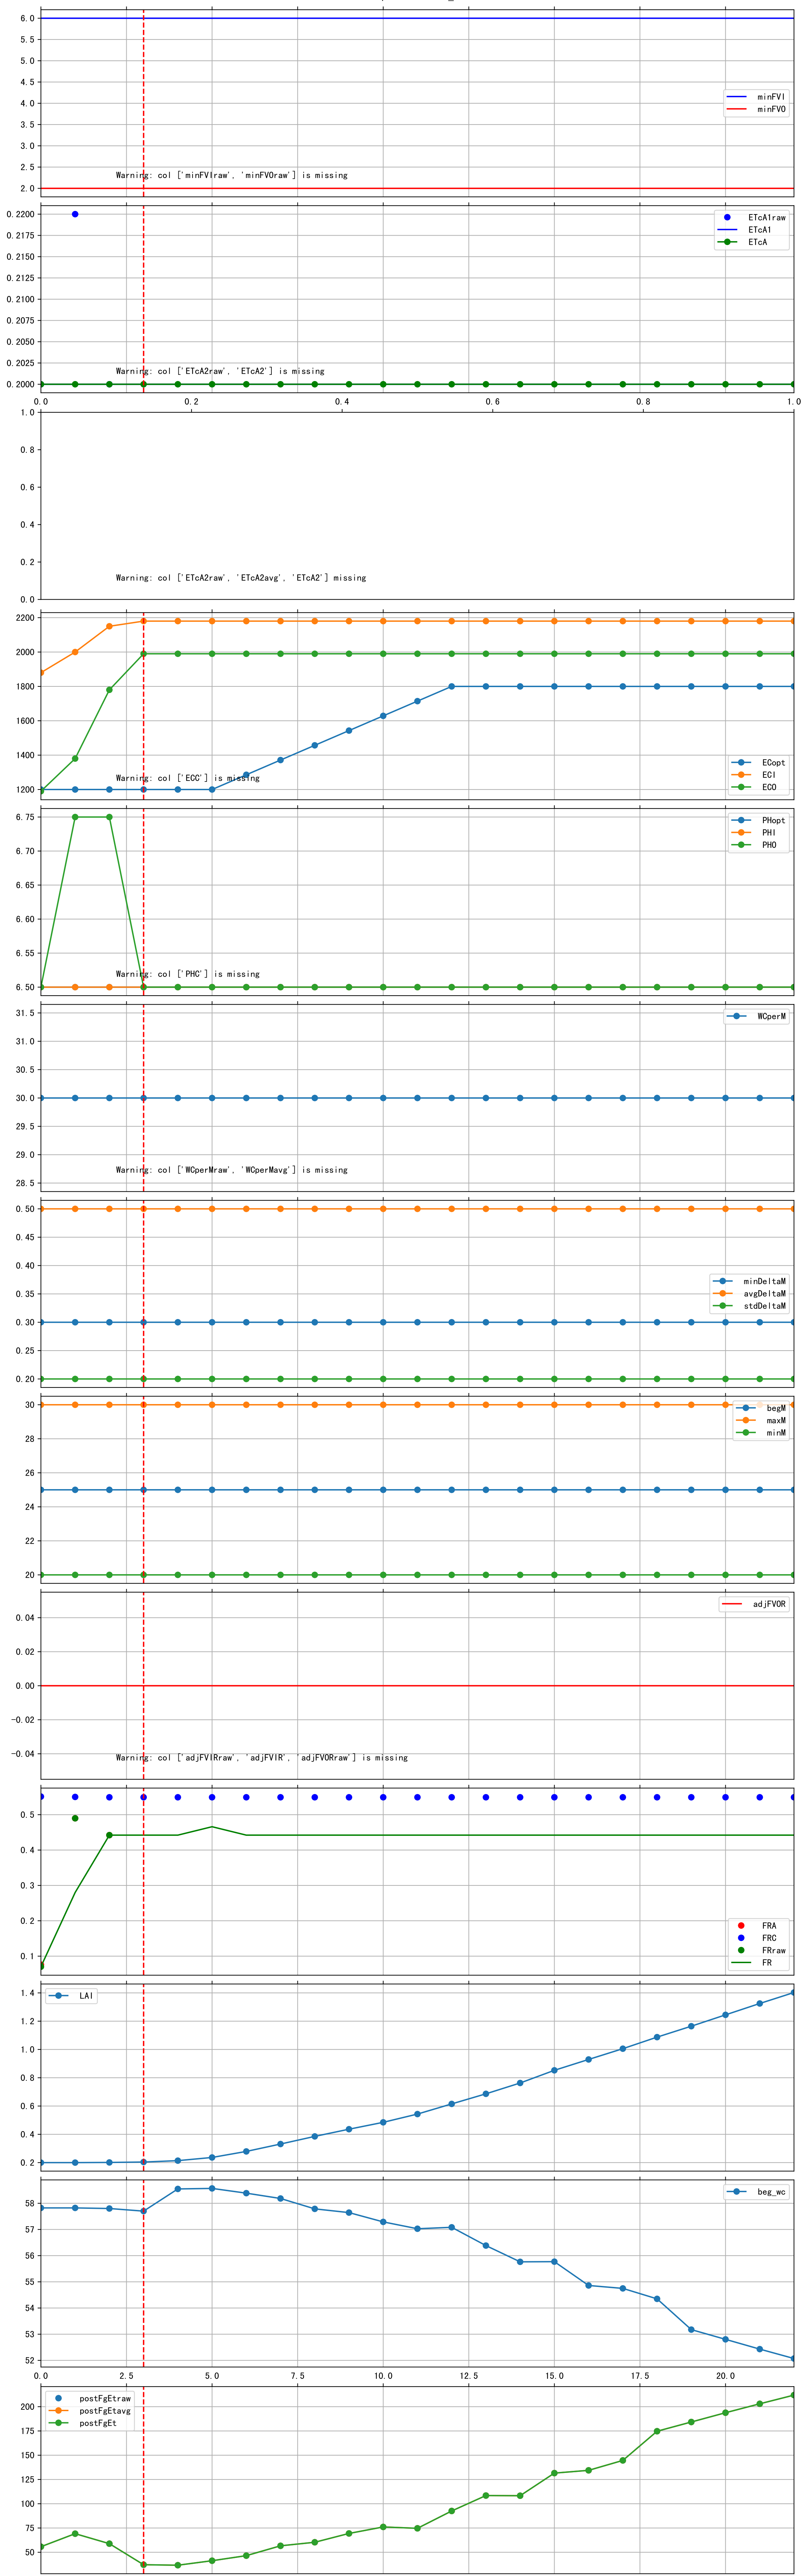
Trend plot forP3-9\_0
