NC11 P3

2025-04-21 (Day 16)

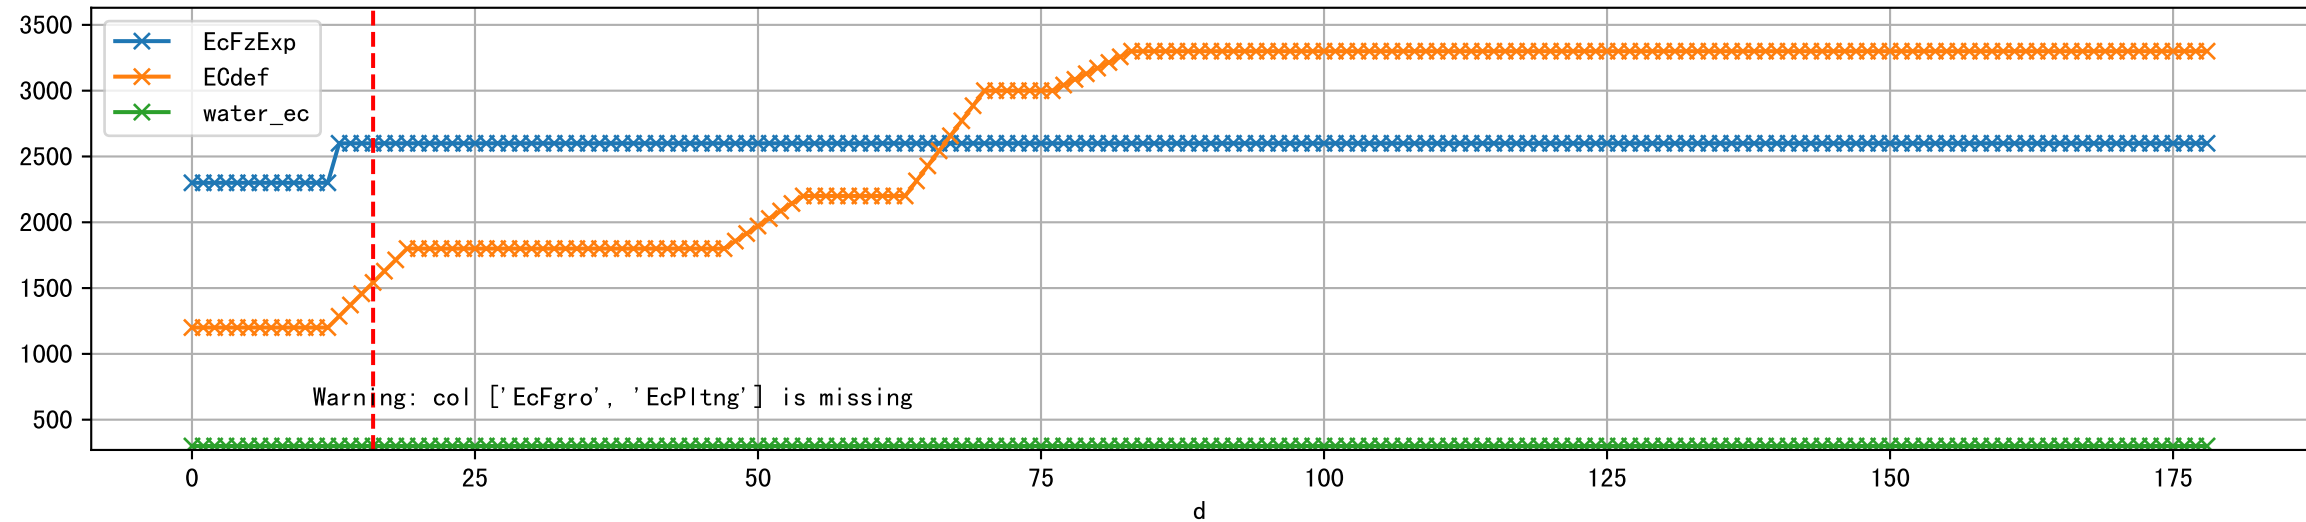
Plot [['EcFgro', 'EcFzExp', 'EcPltng', 'ECdef', 'water\_ec']]

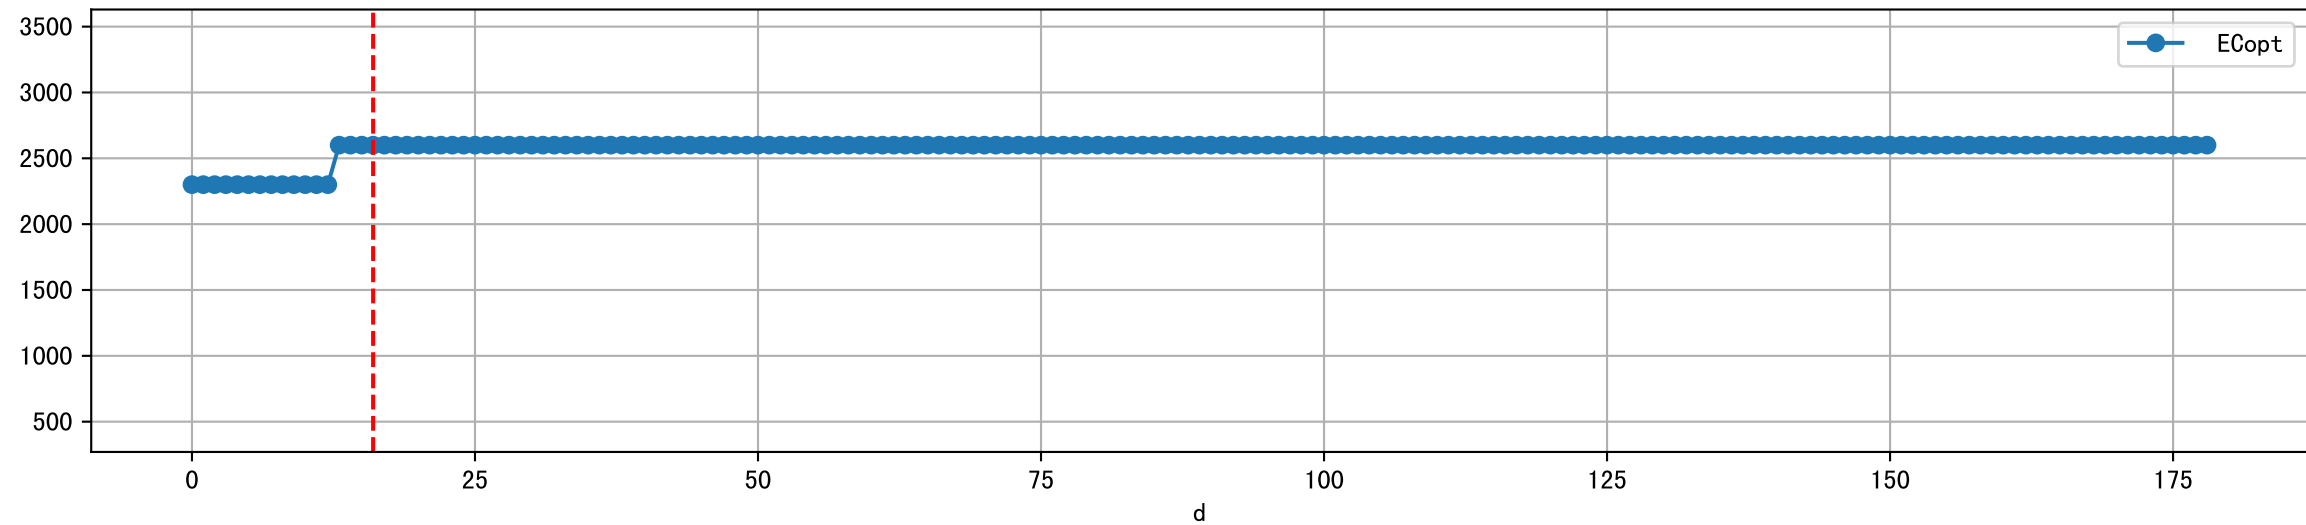
Plot [' ECopt' ]

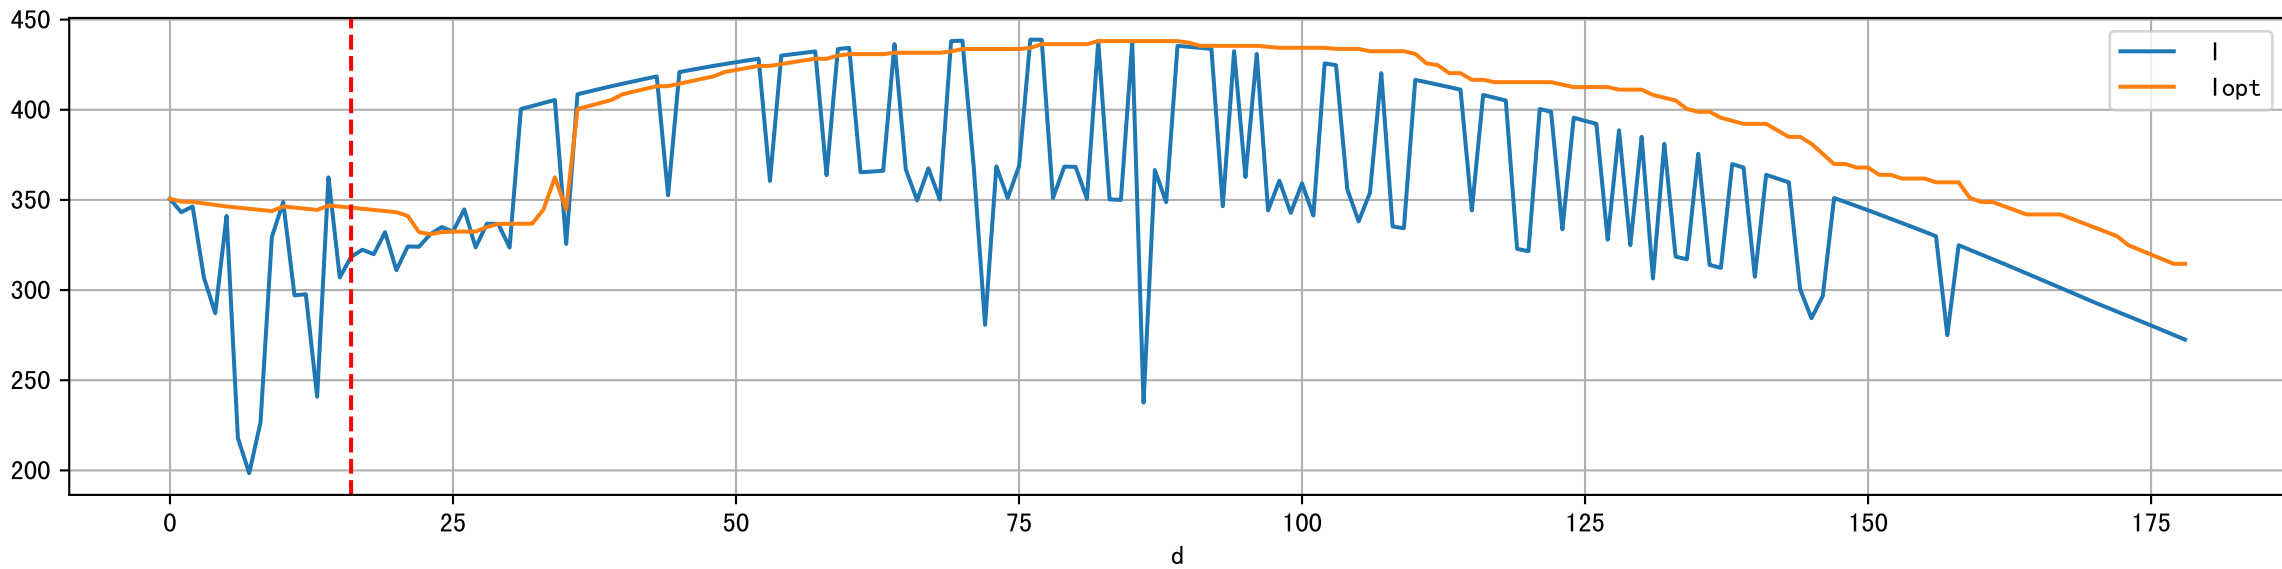
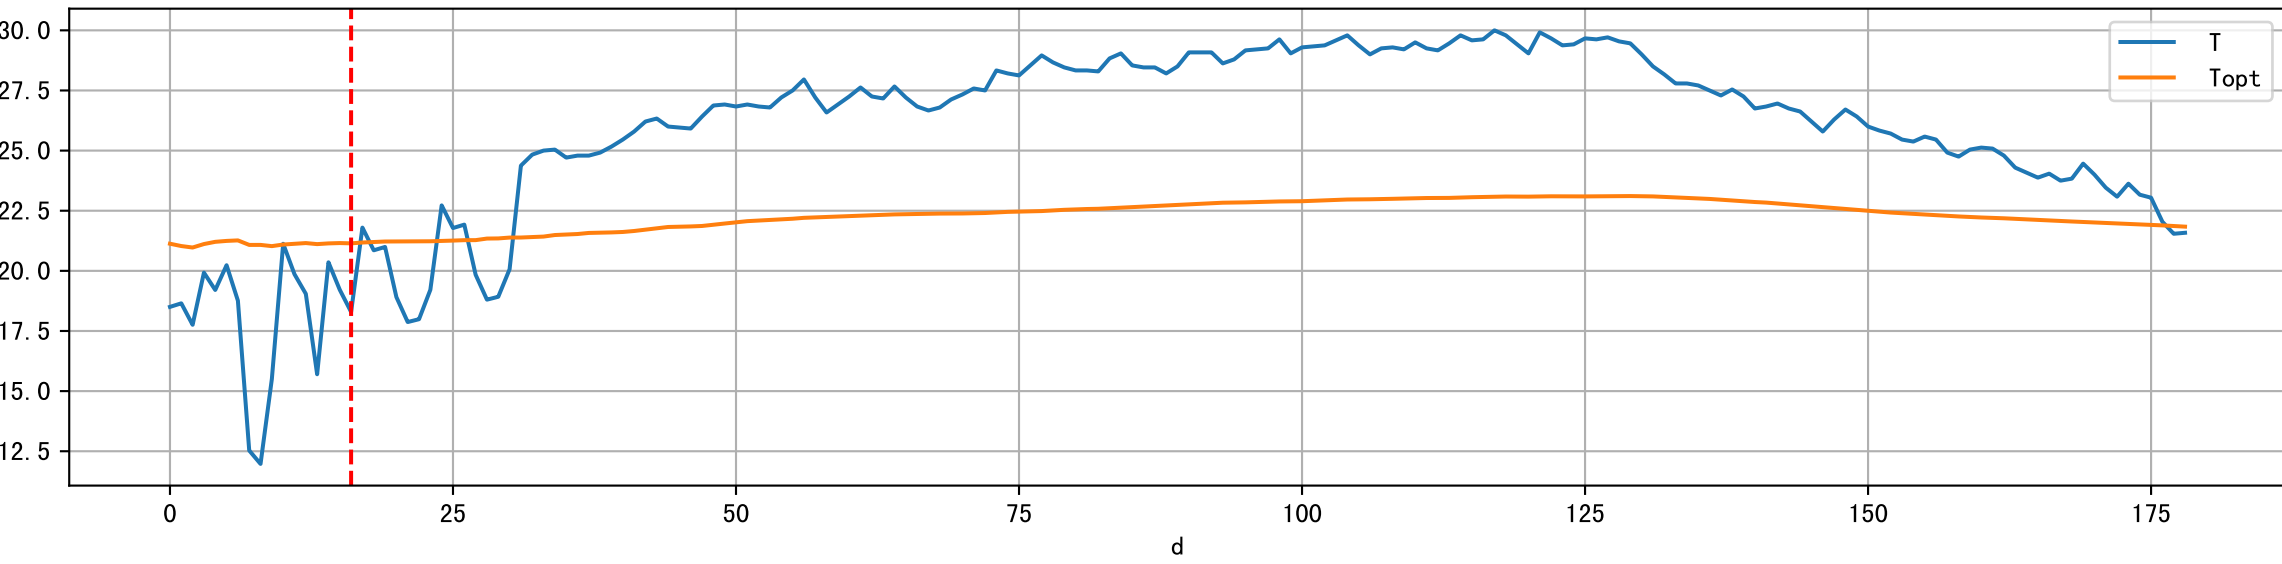
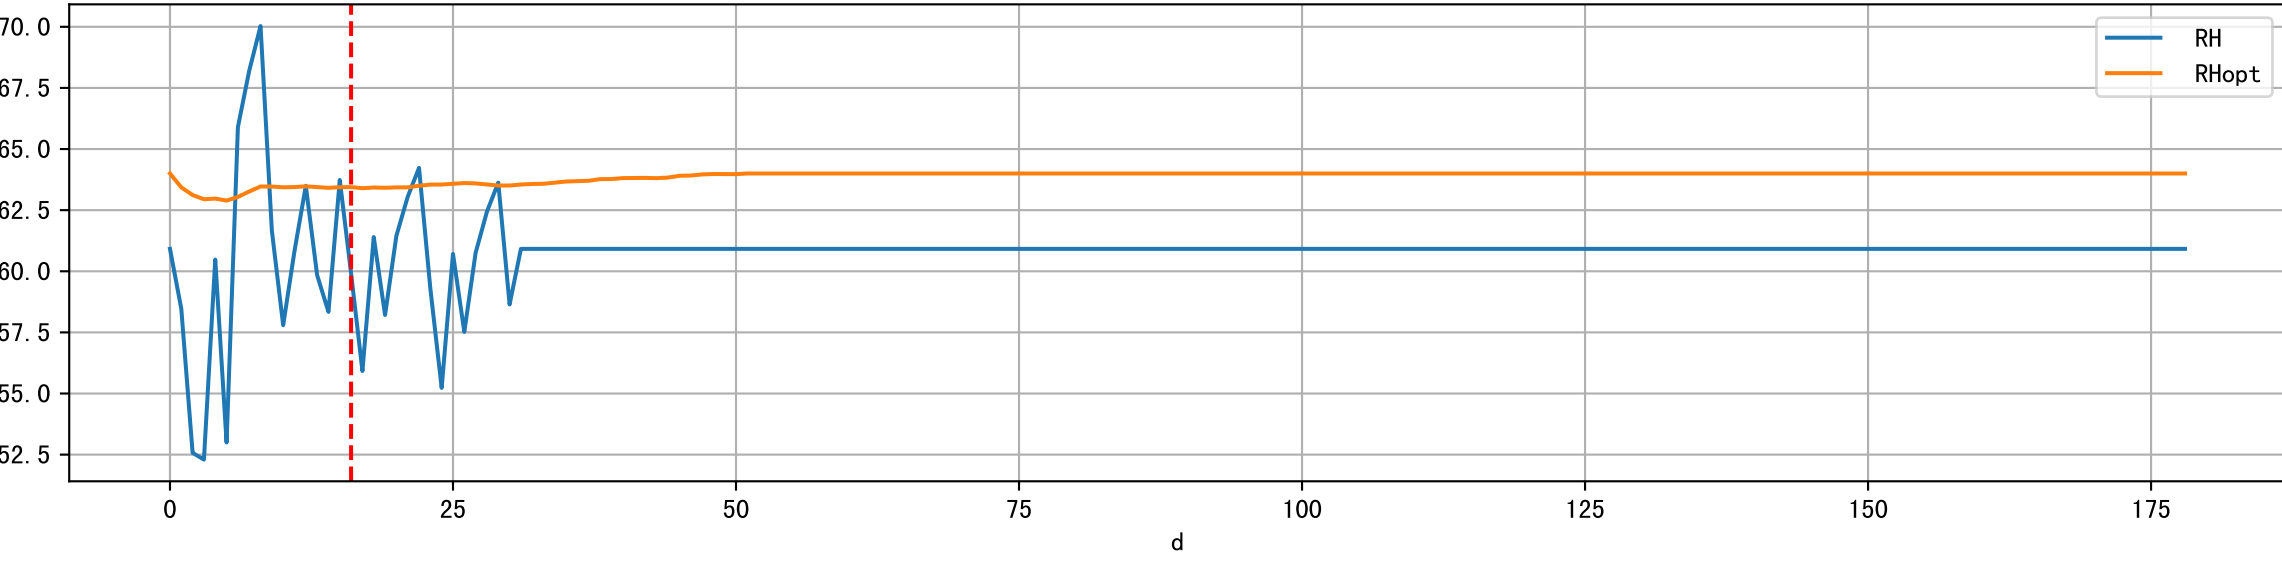
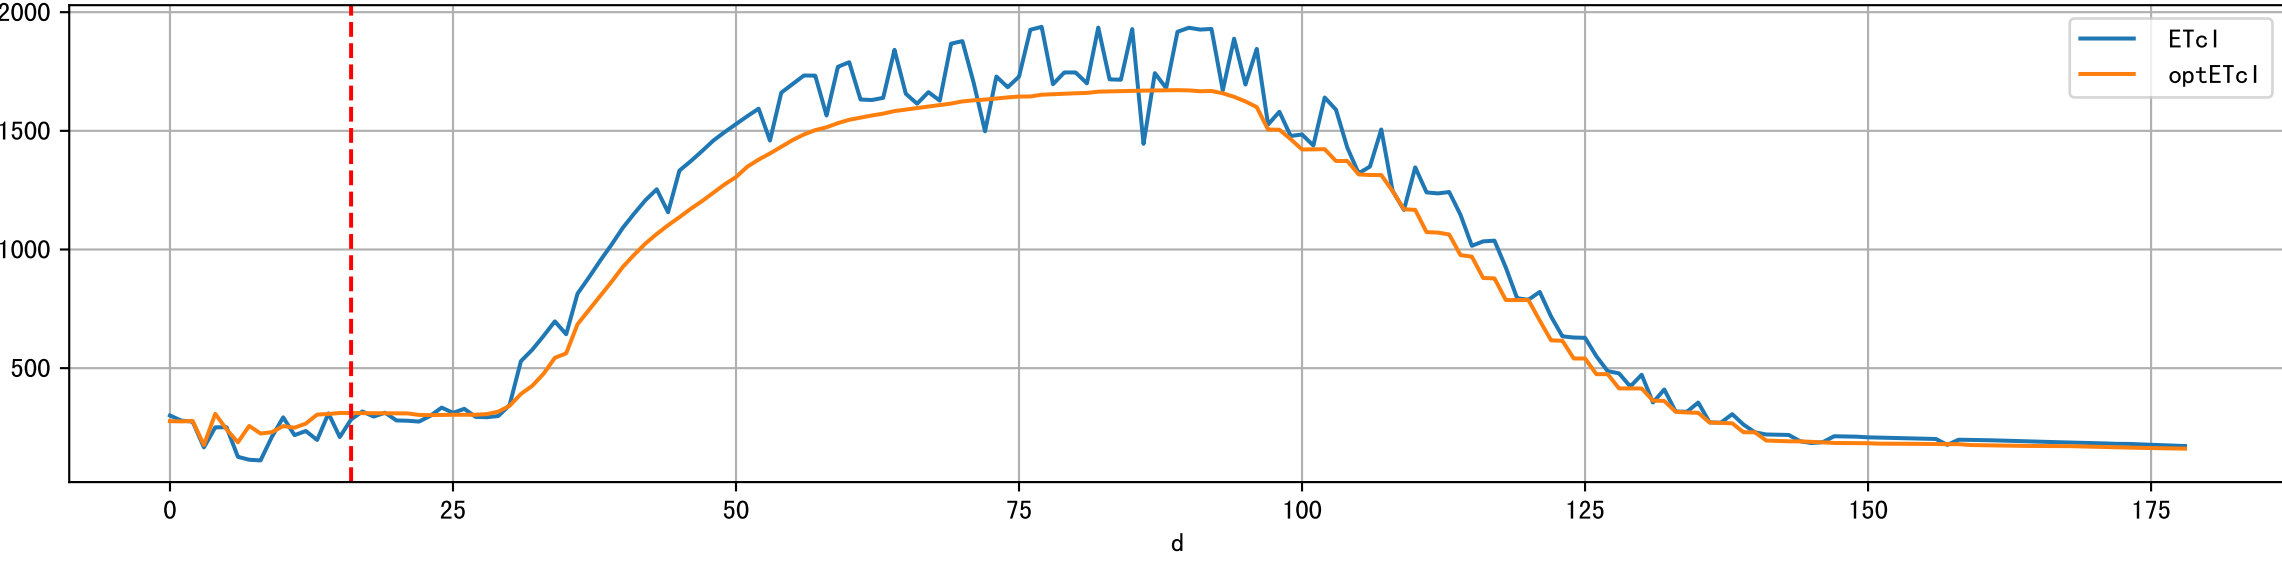
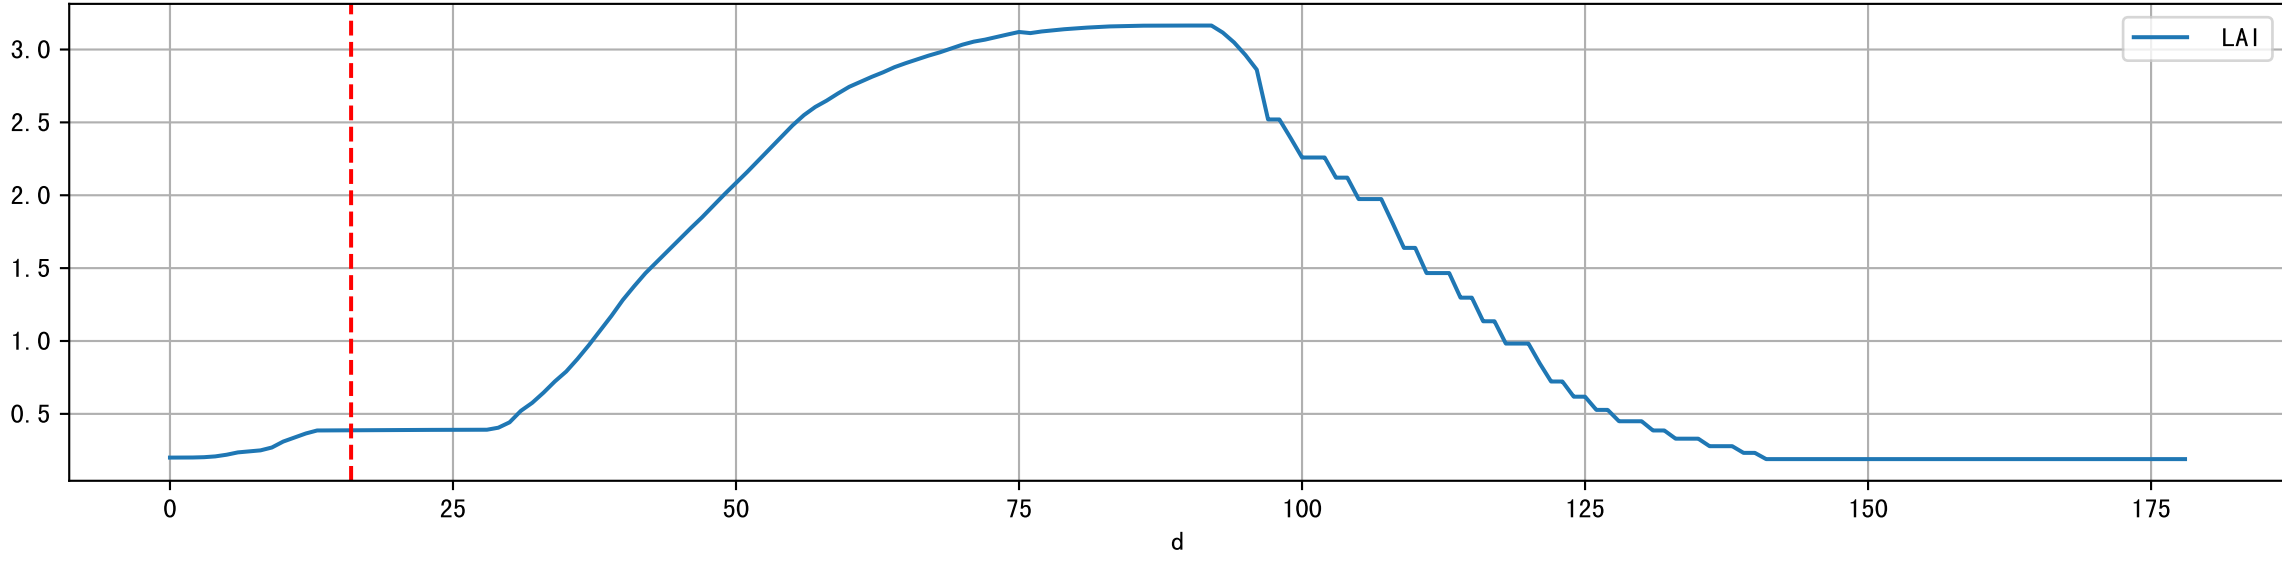
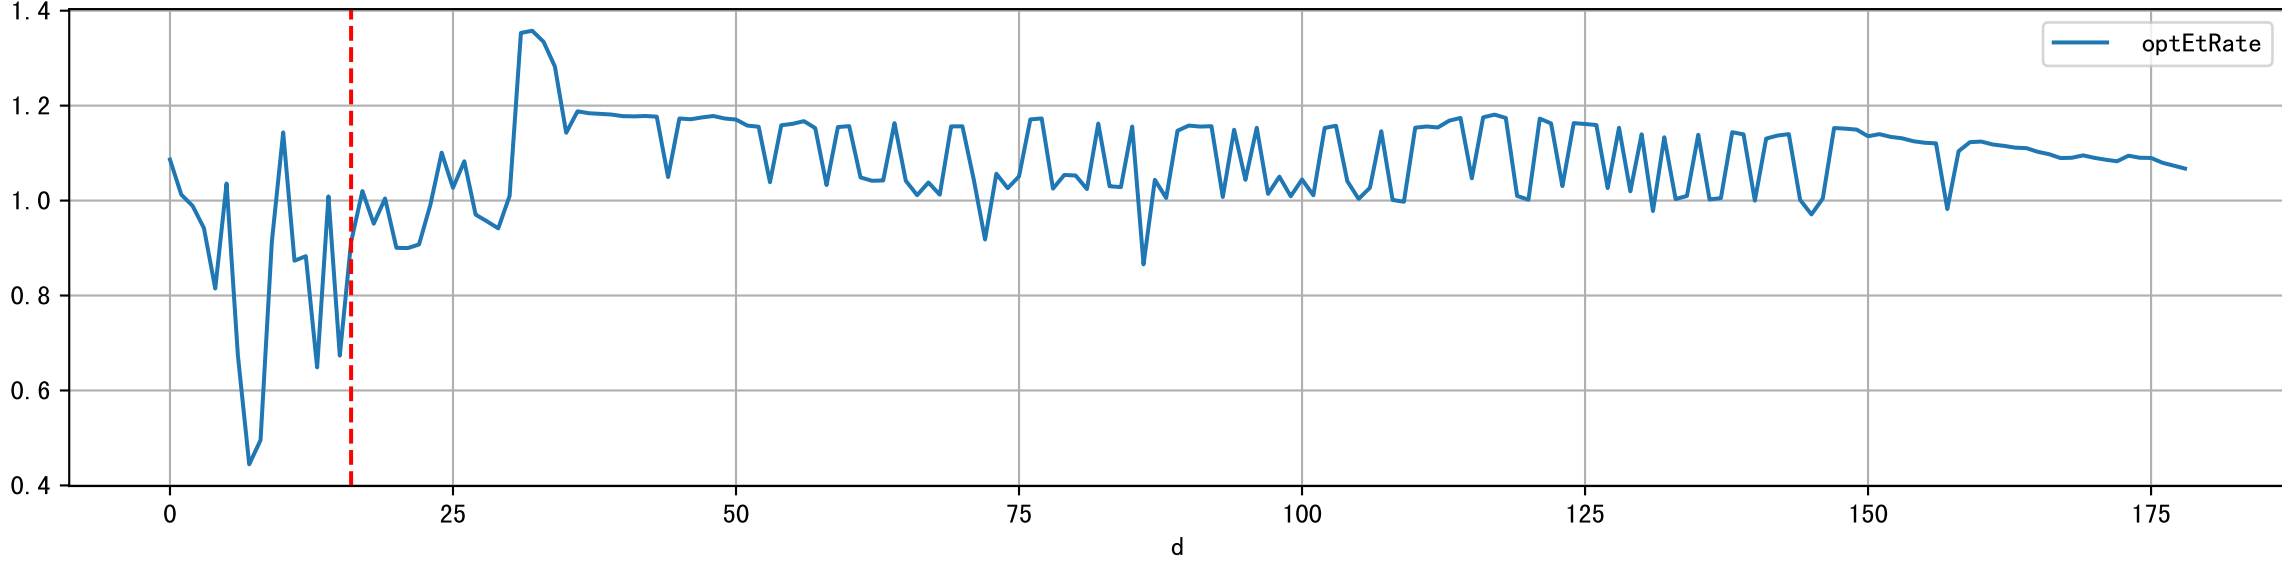
Plot [['I', 'Iopt'], ['T', 'Topt'], ['RH', 'RHopt'], ['ETcl', 'optETcl'], ['LAI', 'optEtRate']]

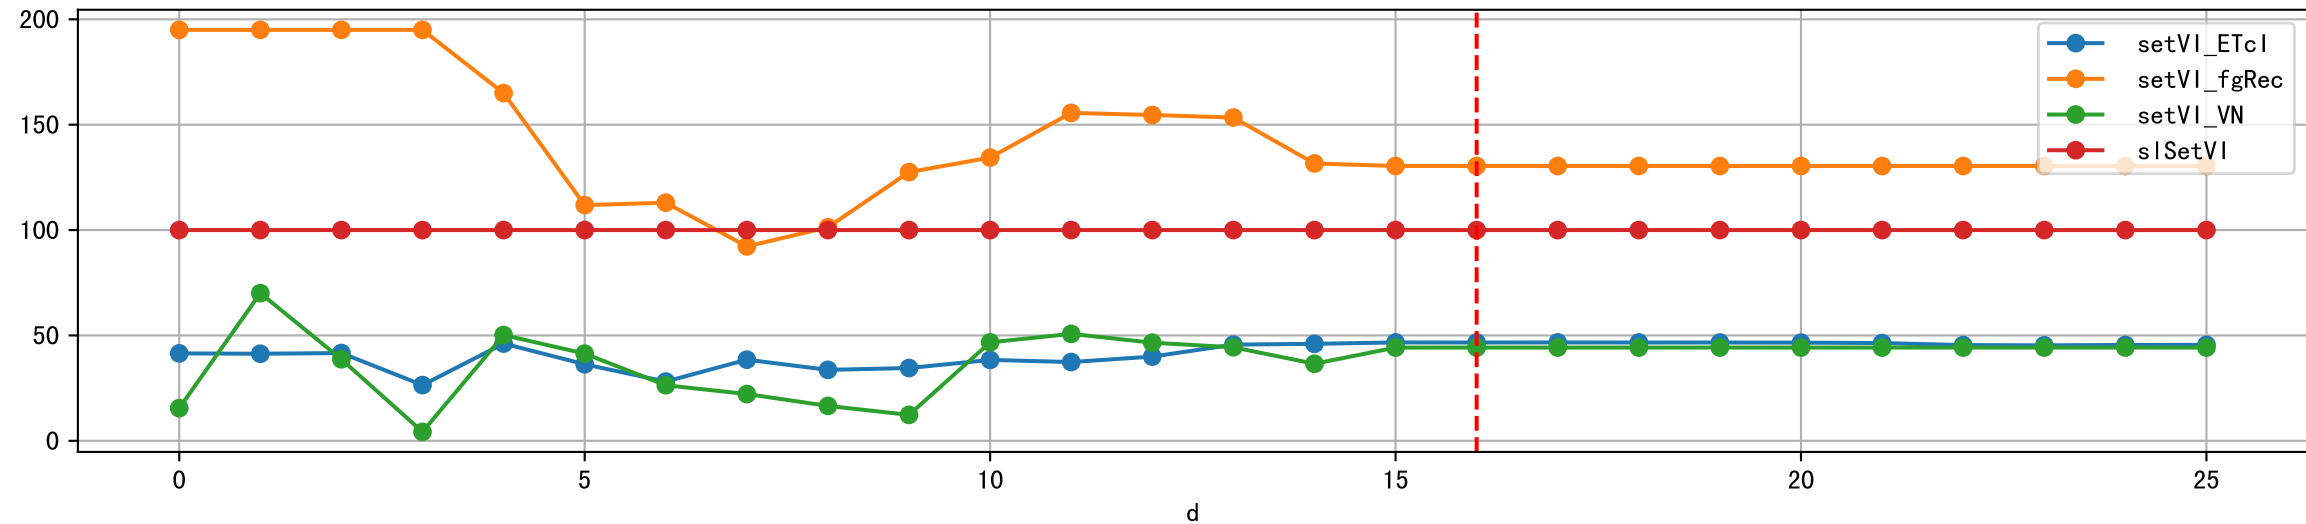
Plot [['setVI\_ETcI', 'setVI\_fgRec', 'setVI\_VN', 'sISetVI']]

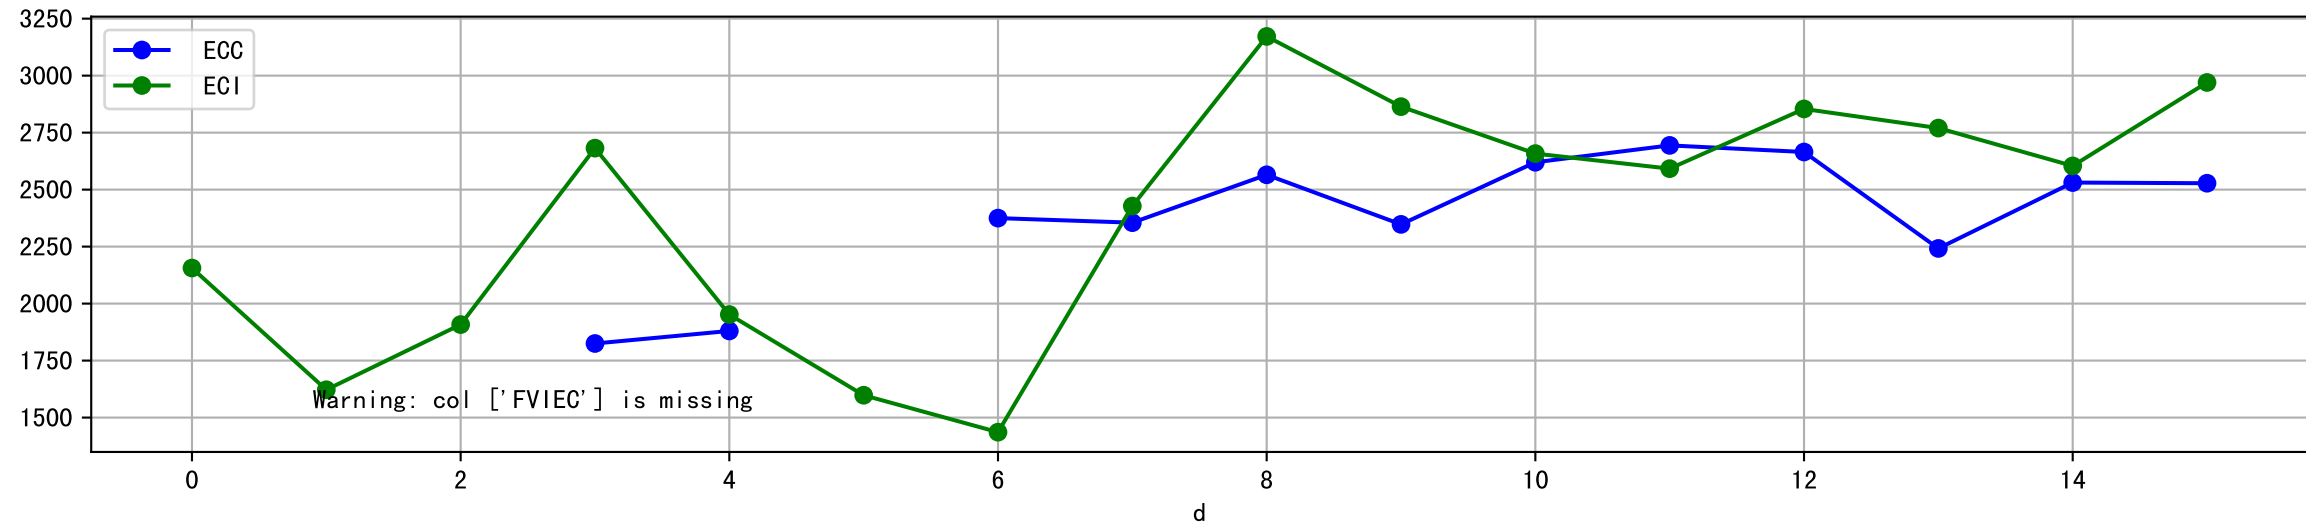
Plot [['ECC:b-o', 'FVIEC:r-o', 'ECI:g-o']]

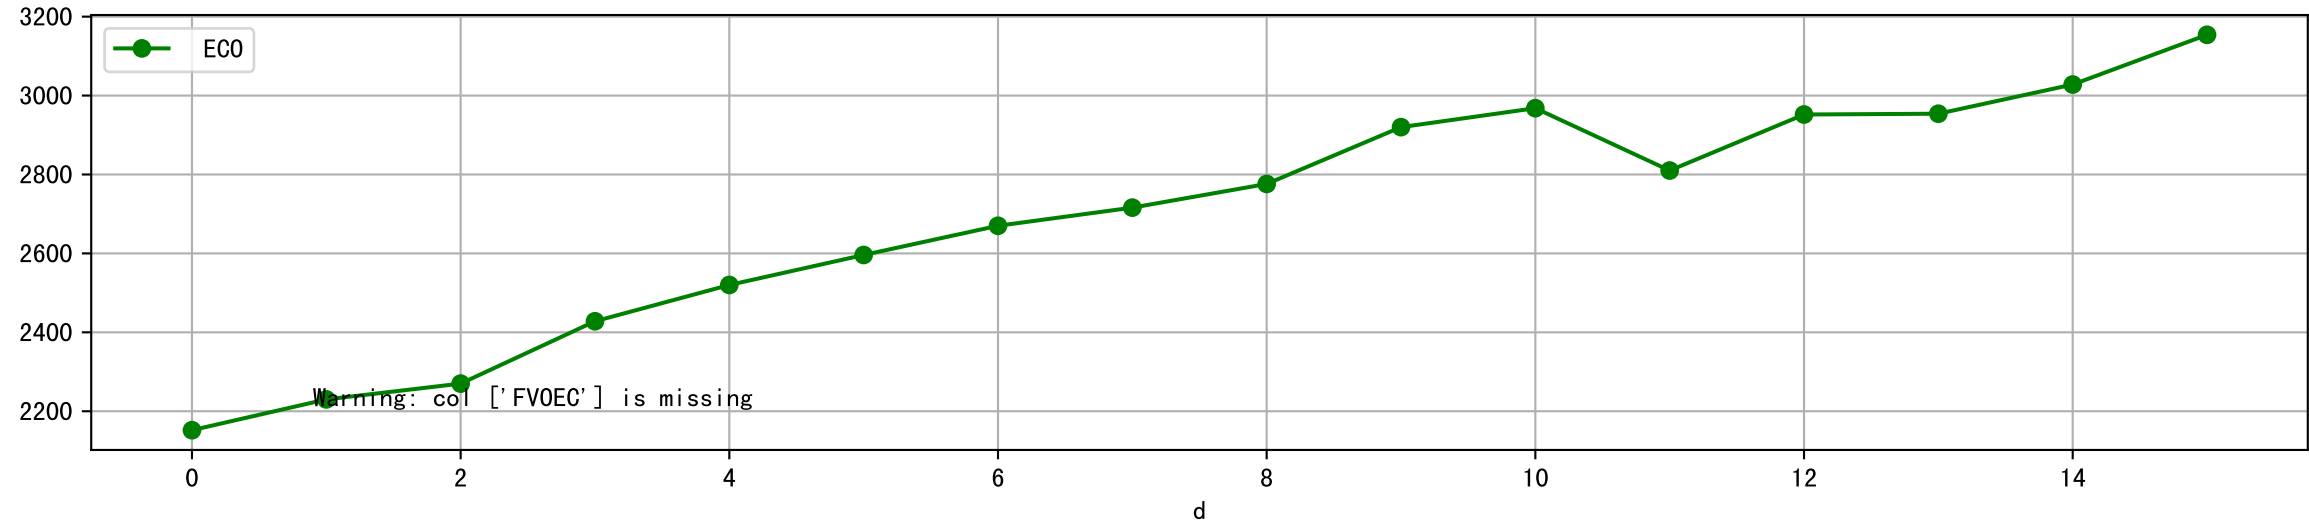
Plot [['FV0EC:r-o', 'ECO:g-o']]

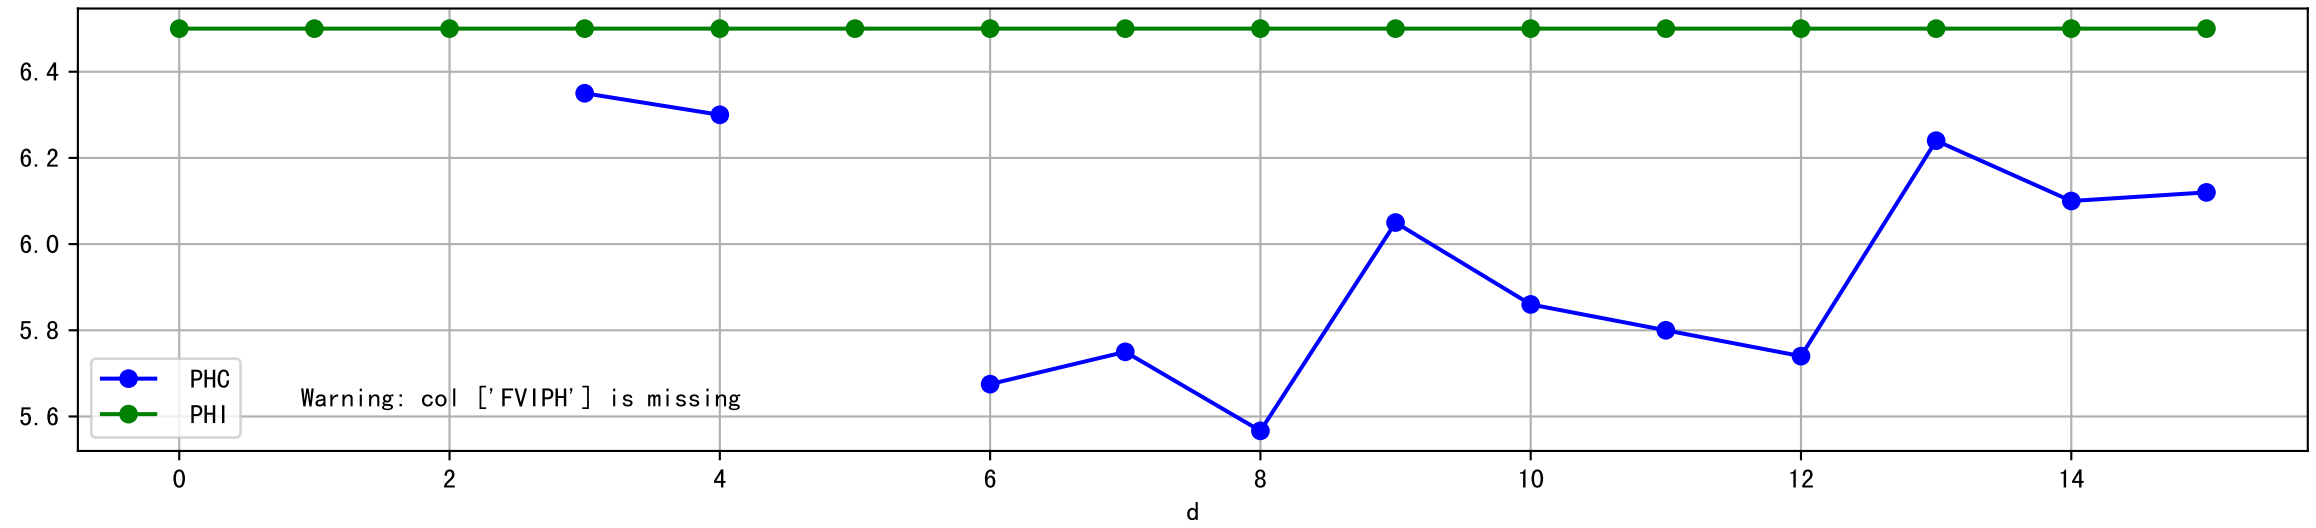
Plot [['PHC:b-o', 'FVIPH:r-o', 'PHI:g-o']]

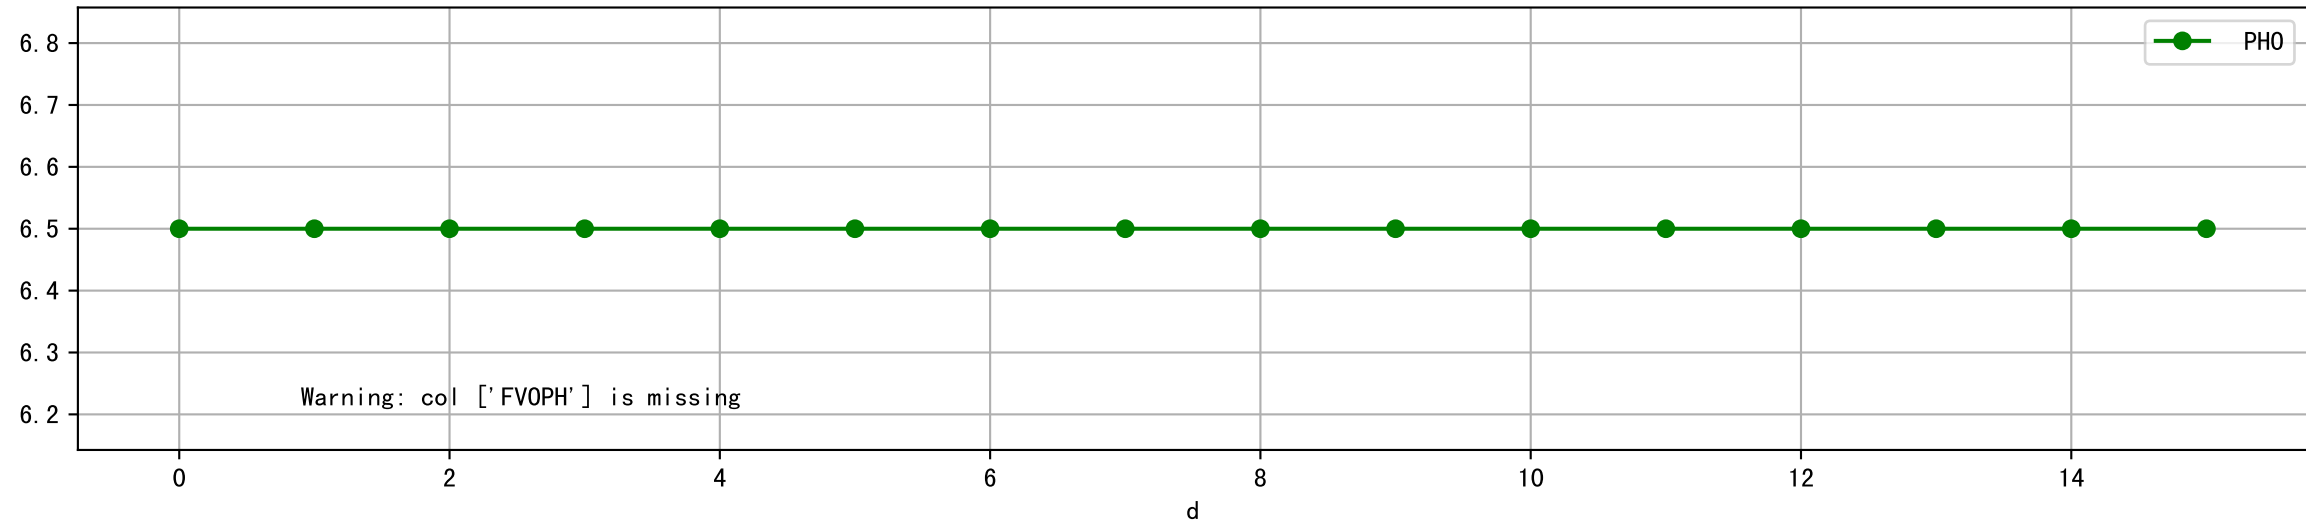
Plot [[' FVOPH:r-o' , ' PH0:g-o' ]]

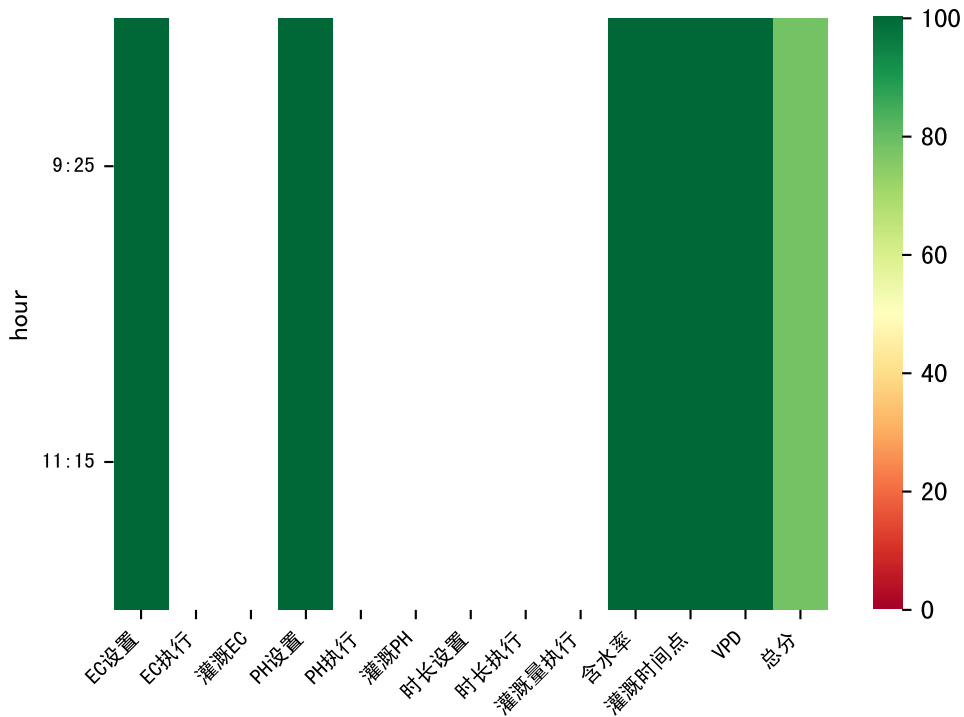
| 时间 | 灌溉时长(秒) | 灌溉量(毫升/株) | 天气 | 注释 |
| 09:25 | 120 | 100.0 | 阴 | 假设@09:25 手动（未用传感器） |
| 11:15 | 120 | 100.0 | 阴 | 假设@11:15 手动（未用传感器） |
| 总计 | 240.0（2次） | 200.0 | | 建议进液EC: 2500.0, PH: 6.5 |

滴头平均流速偏大（1.11），请检查  
施肥机灌溉量与预期值不符（129.0：50.0），可能水表需要校准  
上次灌溉时长未按模型建议（120 vs 238.0）  
默认实际灌溉50.0 ml.  
large discrepancy for begining water status（64:282.0），set to 108.0 ml.

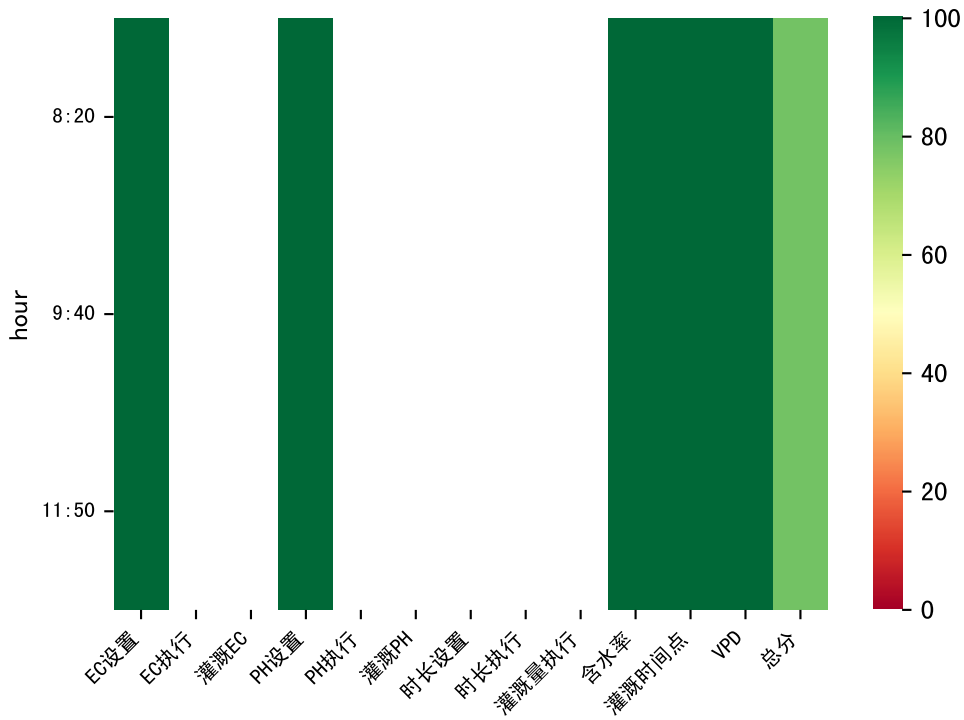
| 时间 | 灌溉时长(秒) | 灌溉量(毫升/株) | 天气 | 注释 |
| 08:20 | 120 | 100.0 | 多云 | 假设@08:20 手动（未用传感器） |
| 09:40 | 120 | 100.0 | 多云 | 假设@09:40 手动（未用传感器） |
| 11:50 | 120 | 100.0 | 晴 | 假设@11:50 手动（未用传感器） |
| 总计 | 360.0 (3次) | 300.0 | | 建议进液EC: 2143.0, PH: 6.5 |

滴头平均流速偏大（1.11），请检查  
施肥机灌溉量与预期值不符（131.0 : 50.0），可能水表需要校准  
上次灌溉时长未按模型建议（120 vs 238.0）  
默认实际灌溉50.0 ml.  
large discrepancy for begining water status (84:261.0), set to 120.0 ml.  
昨天灌溉EC（2242.0）与手测EC（2812.0）偏差较大，请检查  
上次灌溉EC（2550.0）与模型建议（2143.0）偏差较大，请检查。

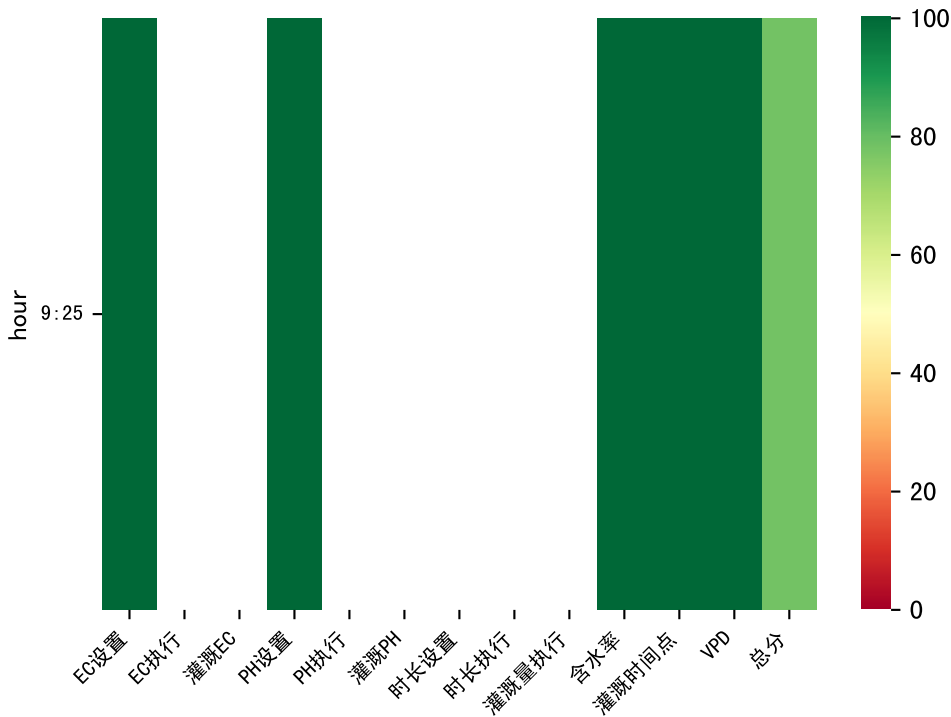
| 时间 | 灌溉时长(秒) | 灌溉量(毫升/株) | 天气 | 注释 |
| 09:25 | 140 | 100.0 | 阴 | 假设@09:25 手动（未用传感器） |
| 总计 | 140.0（1次） | 100.0 | | 建议进液EC：2500.0， PH： 6.5 |

滴头平均流速偏大（1.11）， 请检查  
施肥机灌溉量与预期值不符（152.0 ： 60.0）， 可能水表需要校准  
上次灌溉时长未按模型建议（140 vs 233.0）  
默认实际灌溉60.0 ml.

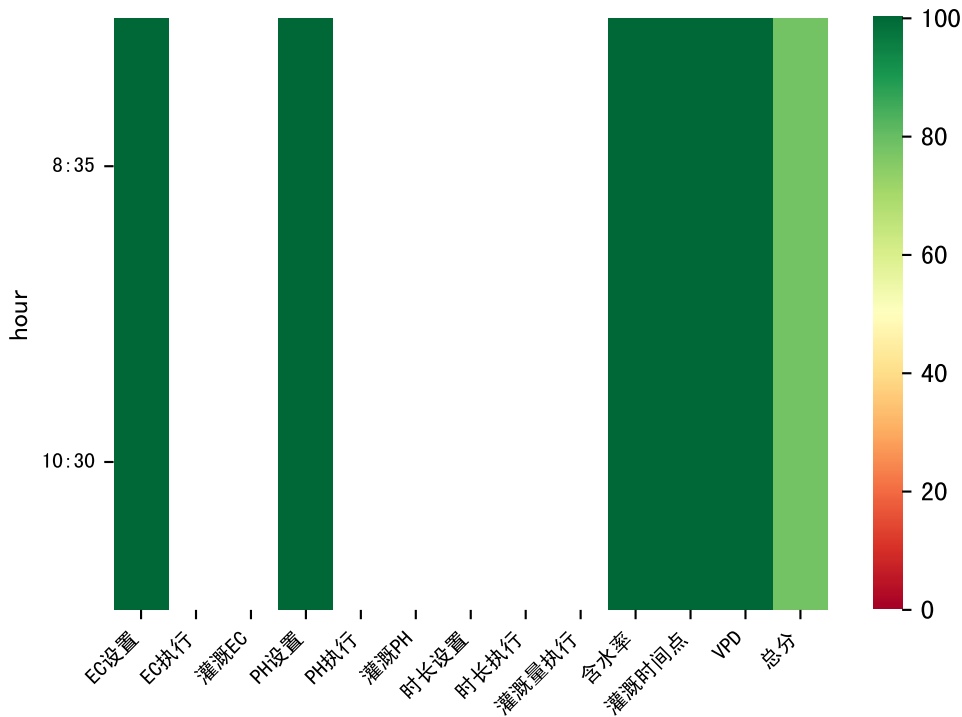
| 时间 | 灌溉时长(秒) | 灌溉量(毫升/株) | 天气 | 注释 |
| 08:35 | 140 | 100.0 | 阴 | 假设@08:35 手动（未用传感器） |
| 10:30 | 140 | 100.0 | 阴 | 假设@10:30 手动（未用传感器） |
| 总计 | 280.0（2次） | 200.0 | | 建议进液EC: 2500.0, PH: 6.5 |

滴头平均流速偏大（1.06），请检查  
施肥机灌溉量与预期值不符（154.0 : 62.0），可能水表需要校准  
上次灌溉时长未按模型建议（140 vs 227.0）  
默认实际灌溉62.0 ml.  
large discrepancy for begining water status (93:276.0), set to 130.0 ml.
