NC11 P4

2025-04-14 (Day 10)

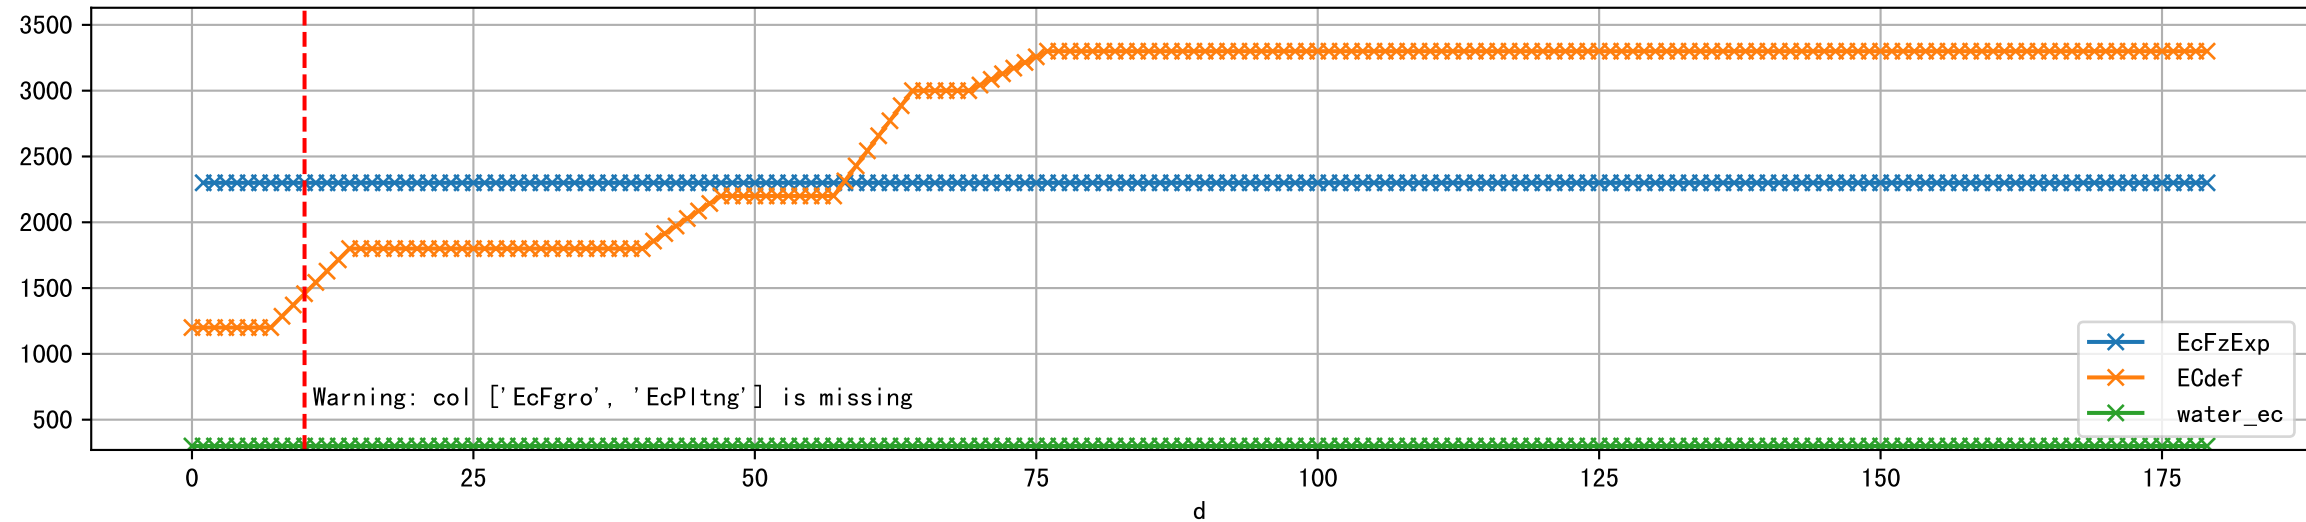
Plot [['EcFgro', 'EcFzExp', 'EcPltng', 'ECdef', 'water\_ec']]

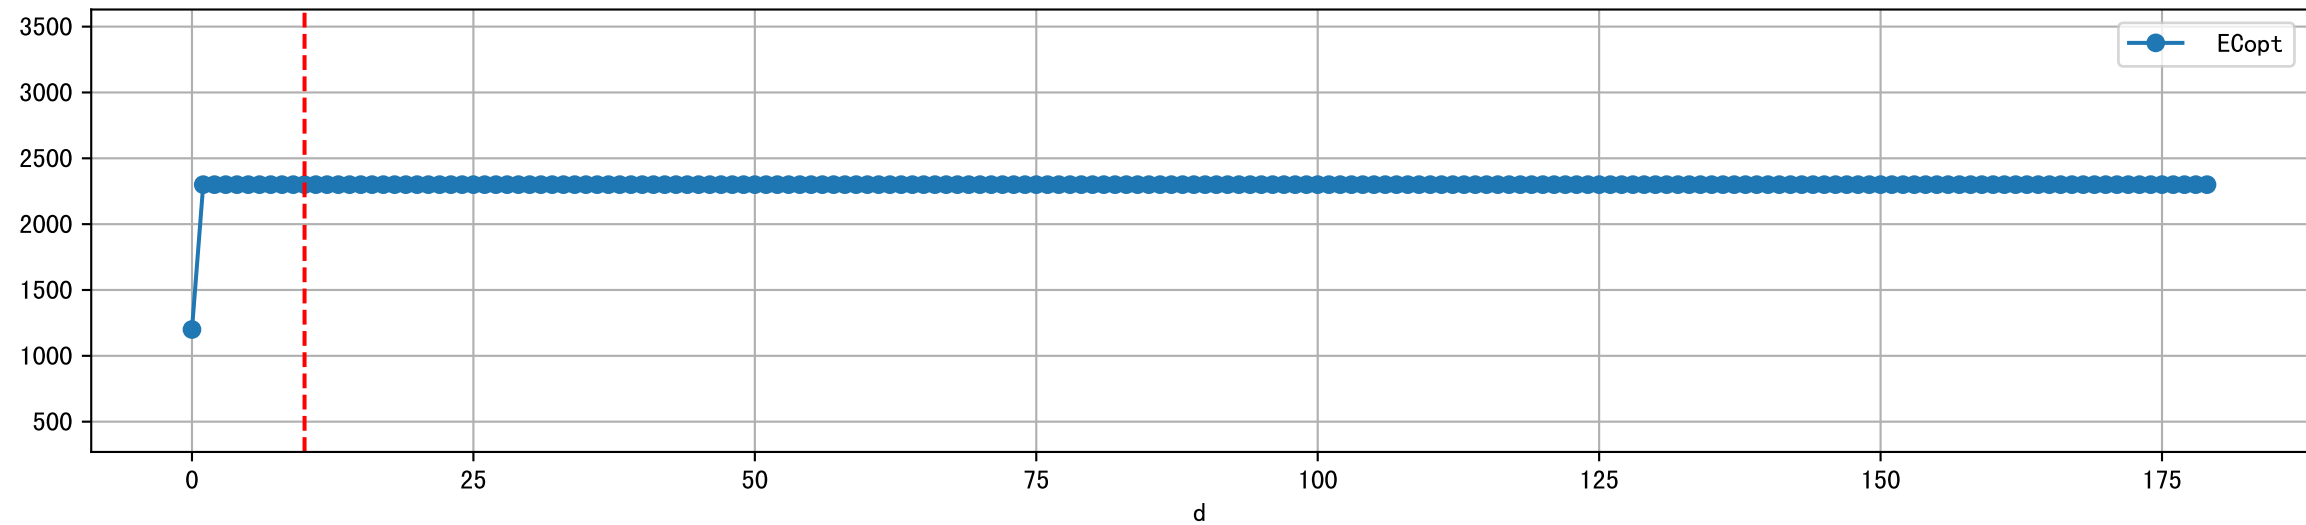
Plot [' ECopt' ]

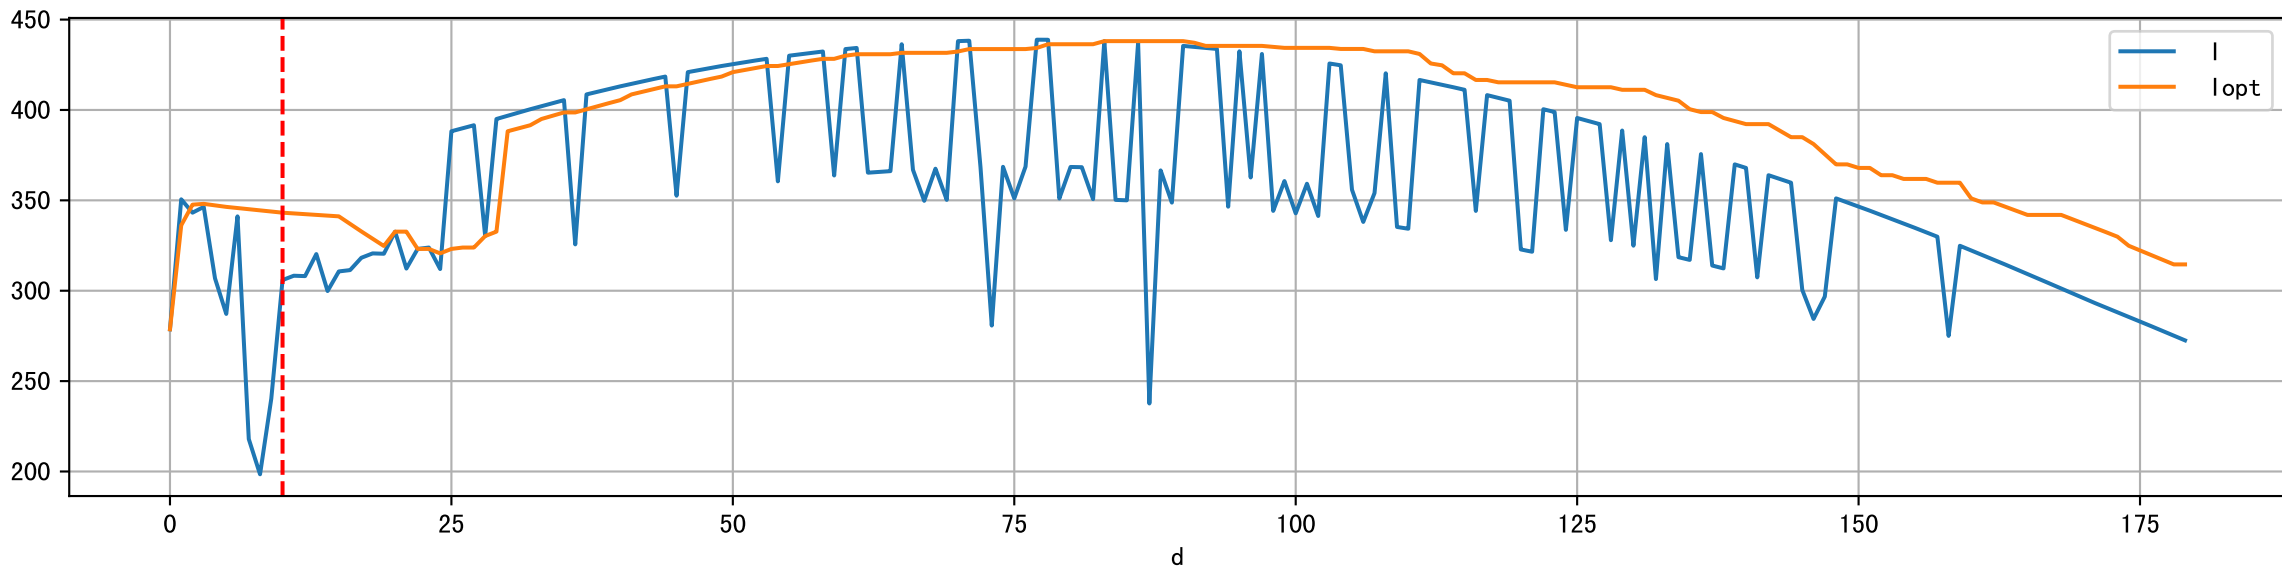
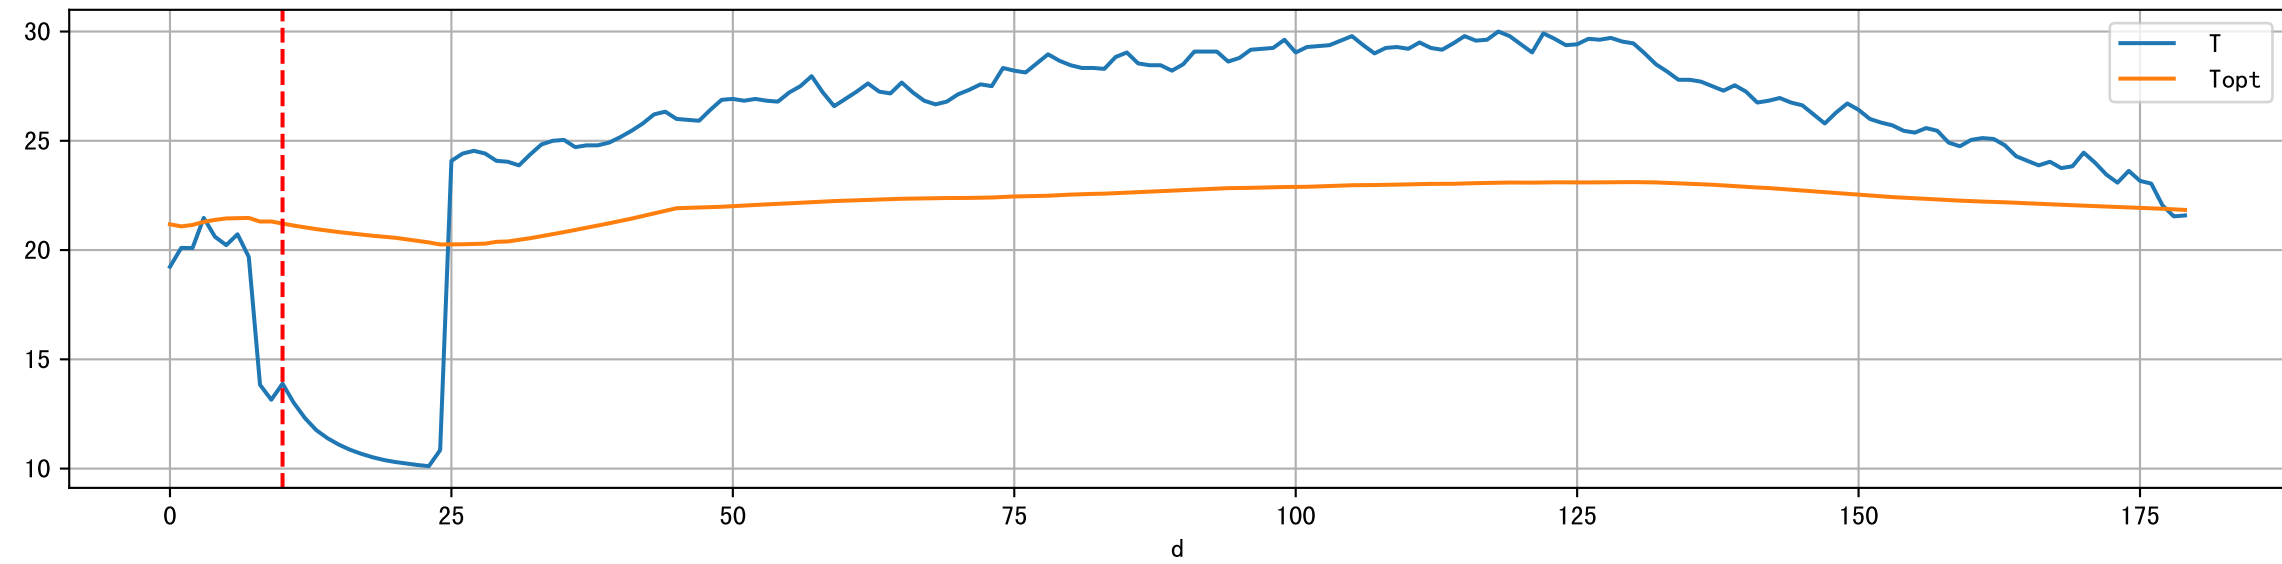
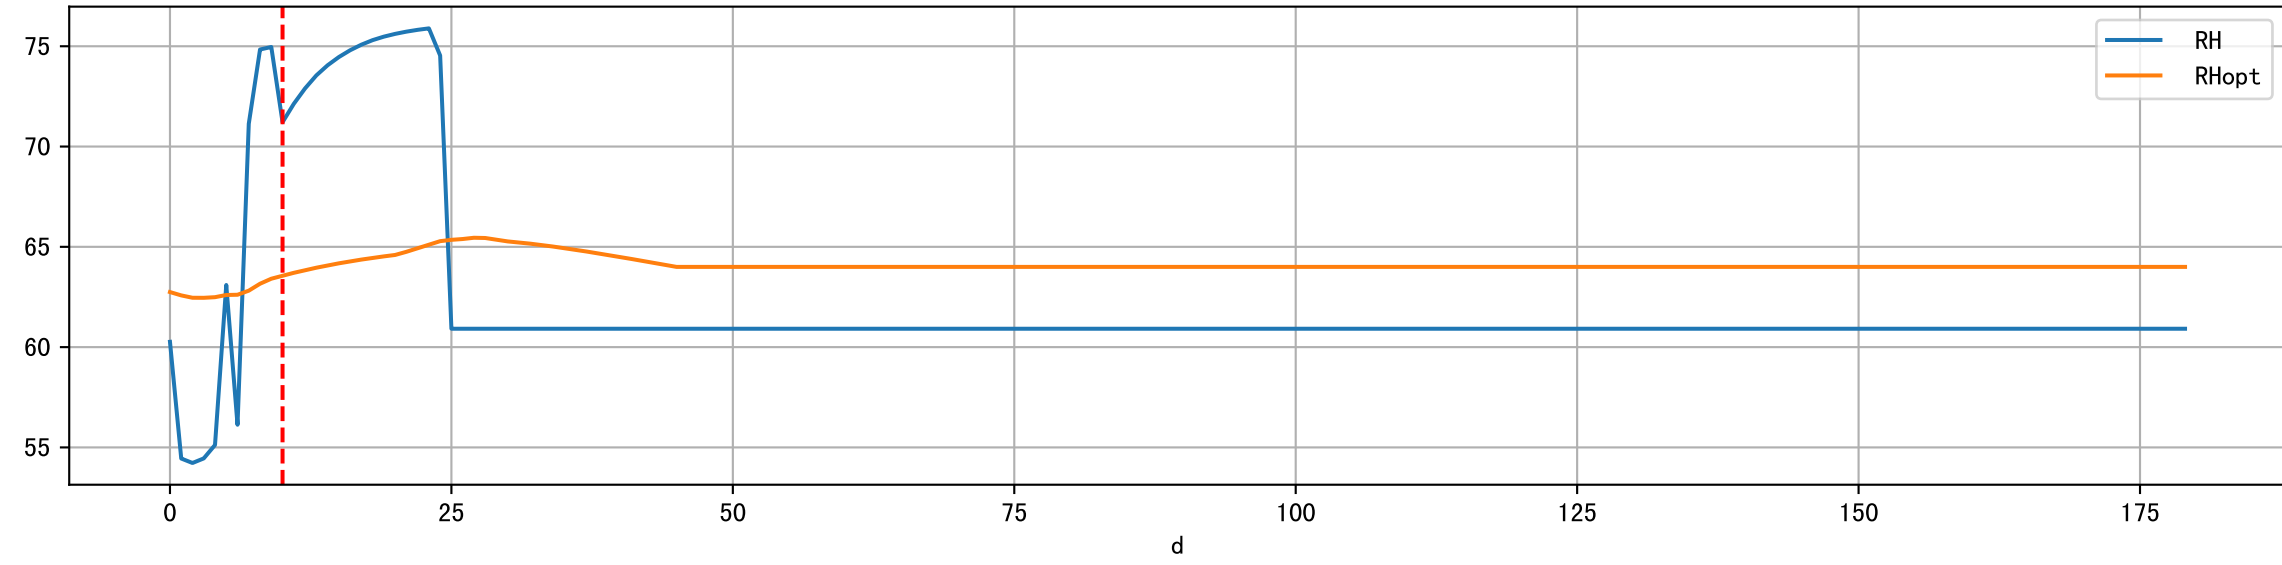
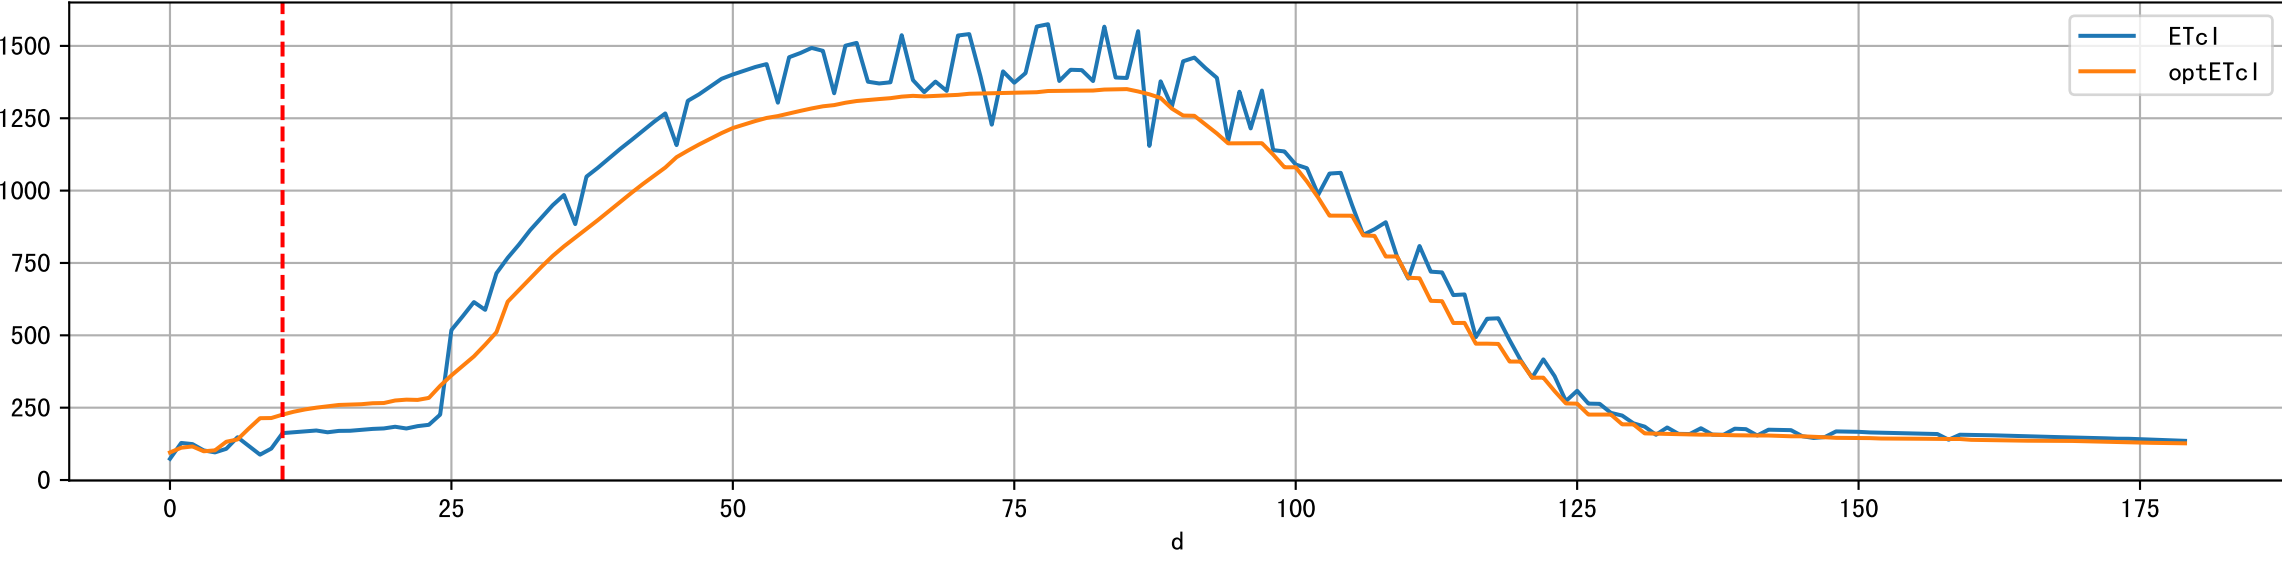
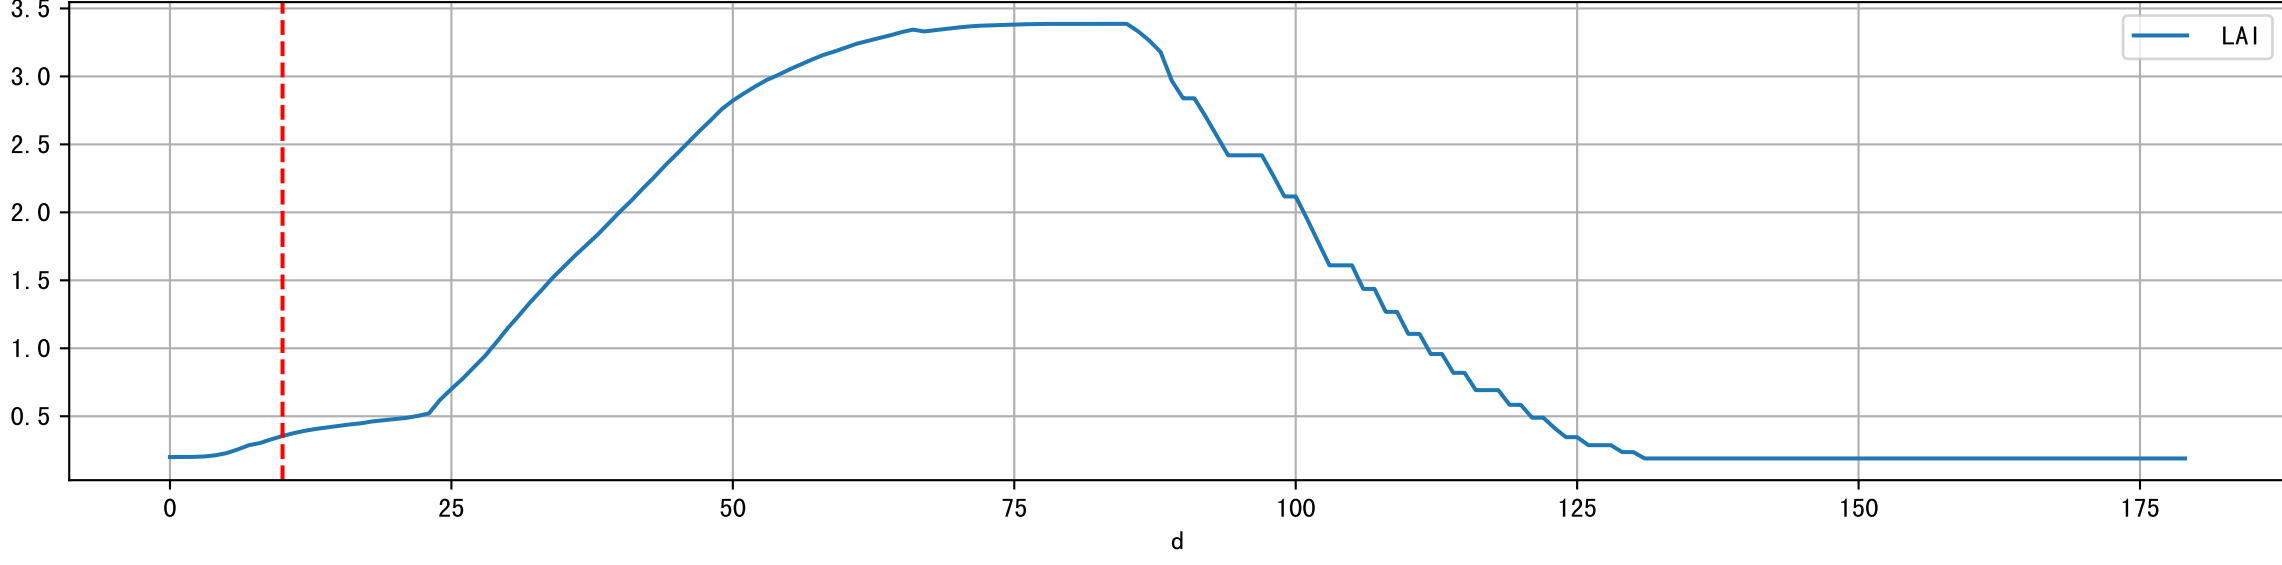
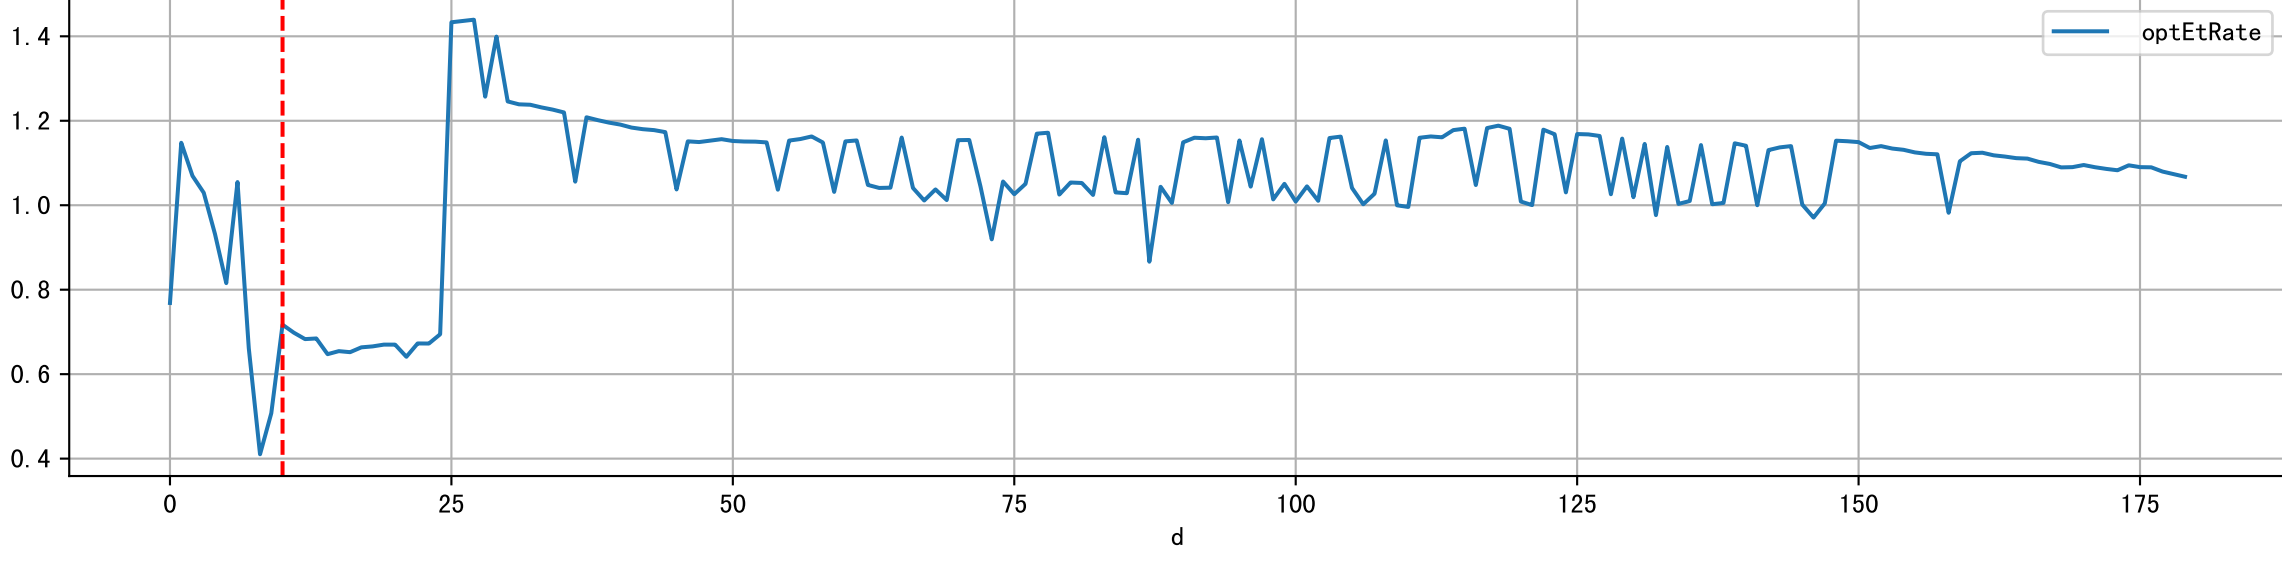
Plot [['I', 'Iopt'], ['T', 'Topt'], ['RH', 'RHopt'], ['ETcl', 'optETcl'], 'LAI', 'optEtRate']

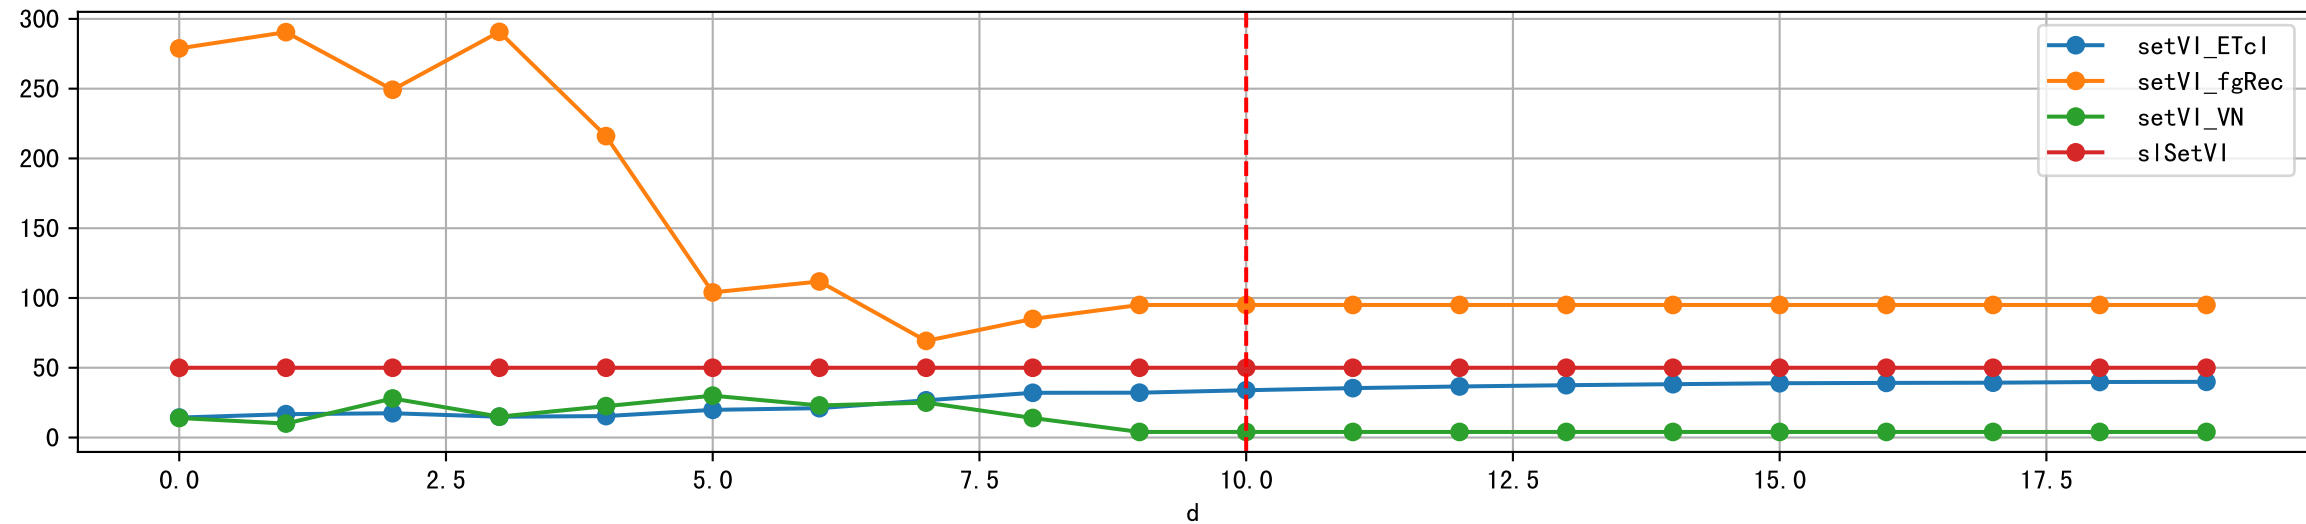
Plot [['setVI\_ETcI', 'setVI\_fgRec', 'setVI\_VN', 'sISetVI']]

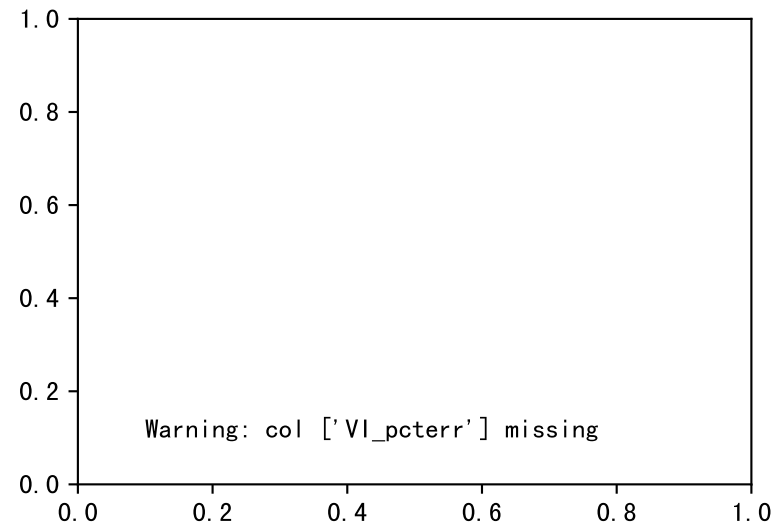
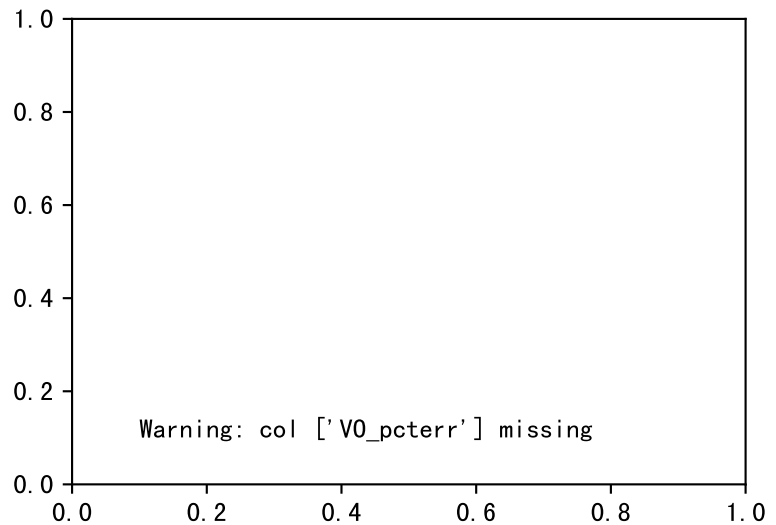
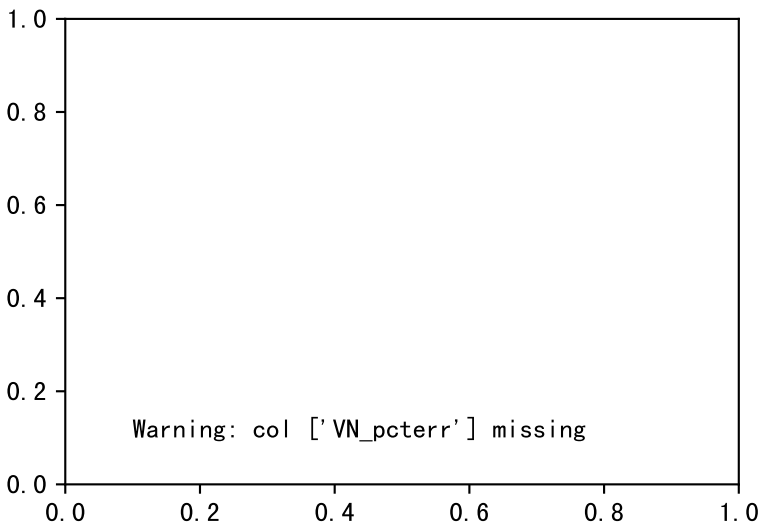
Plot ['VI\_pcterr', 'VO\_pcterr', 'VN\_pcterr']

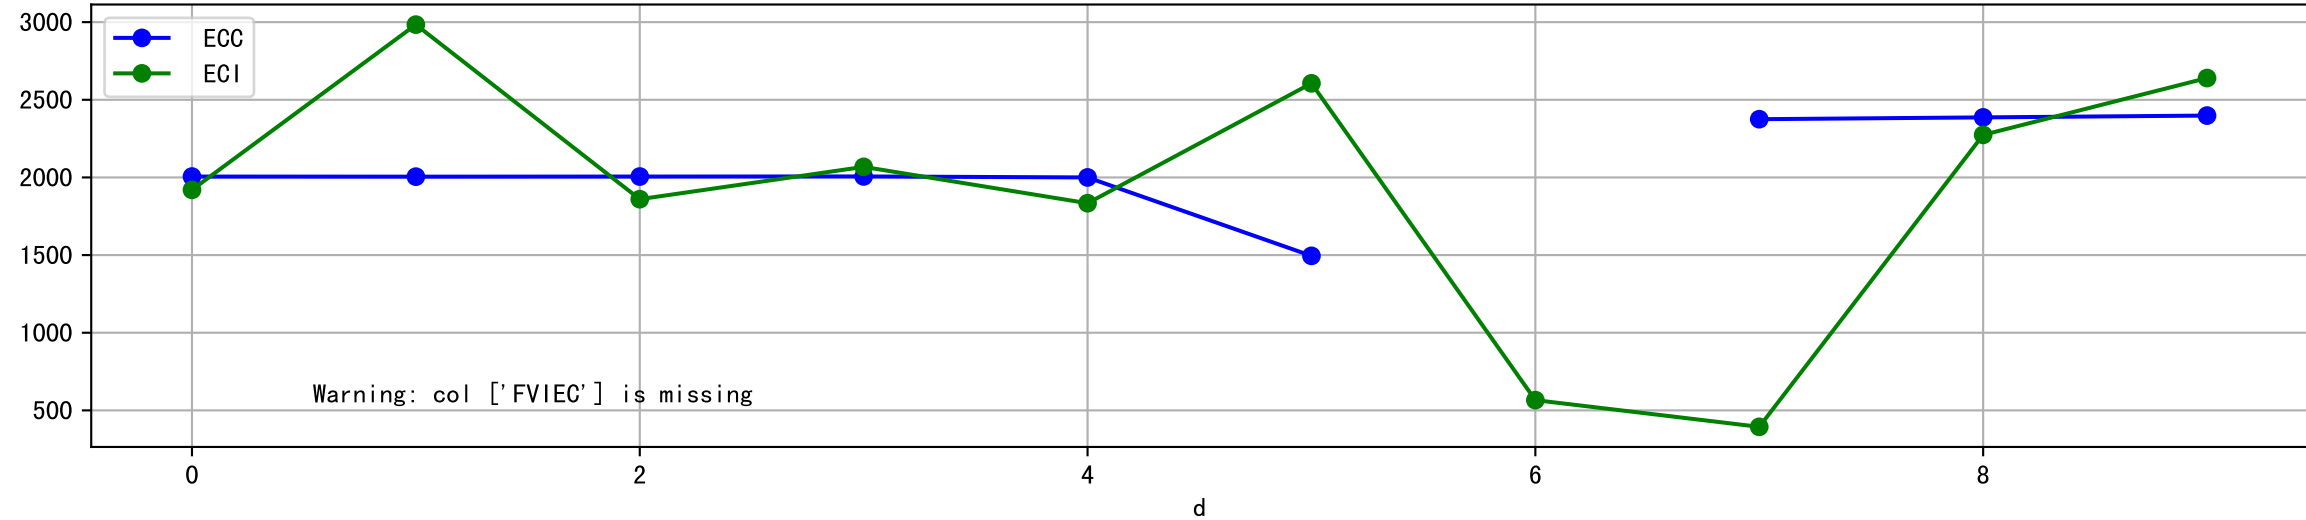
Plot [['ECC:b-o', 'FVIEC:r-o', 'ECI:g-o']]

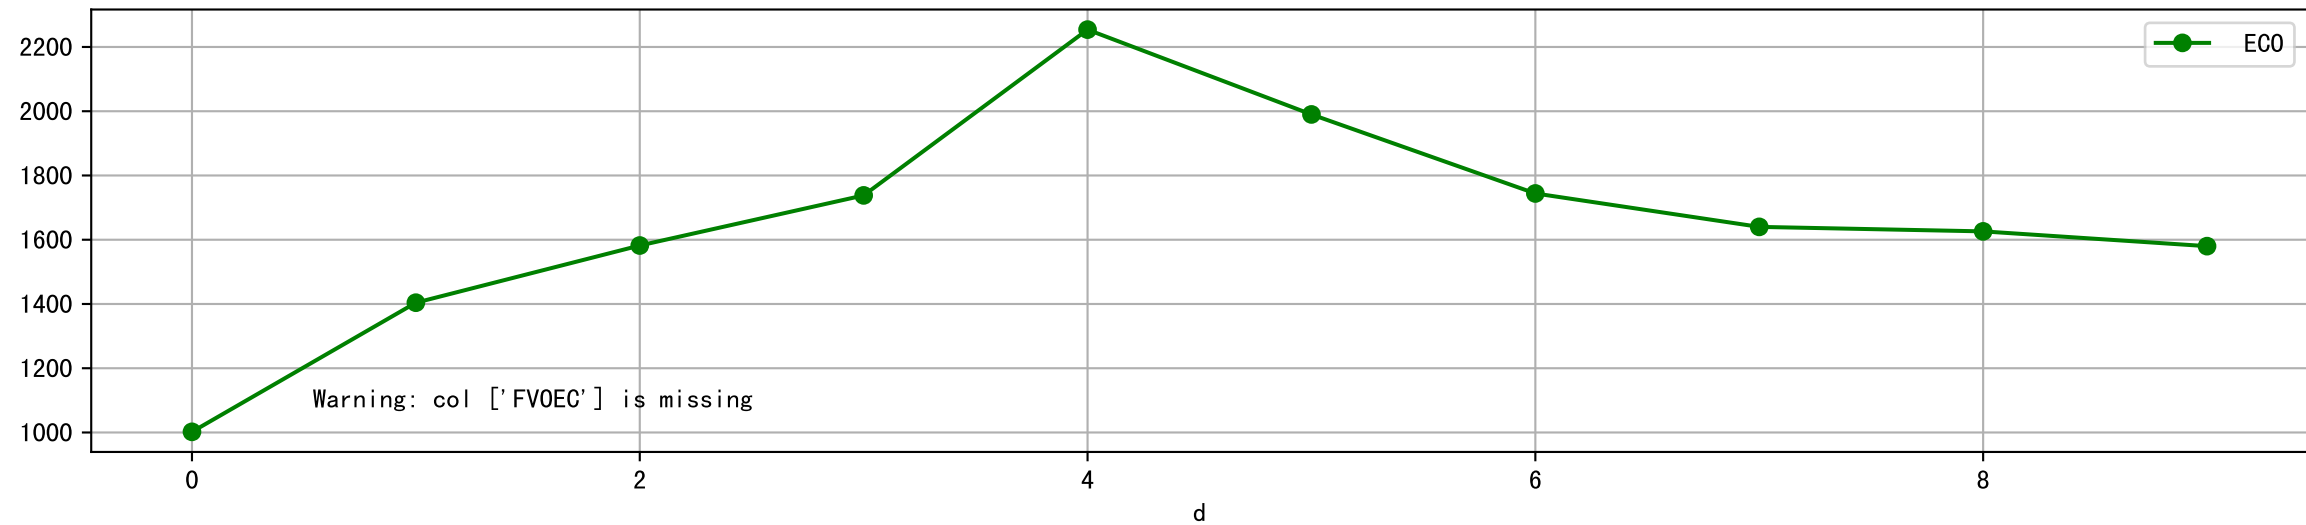
Plot [['FV0EC:r-o', 'EC0:g-o']]

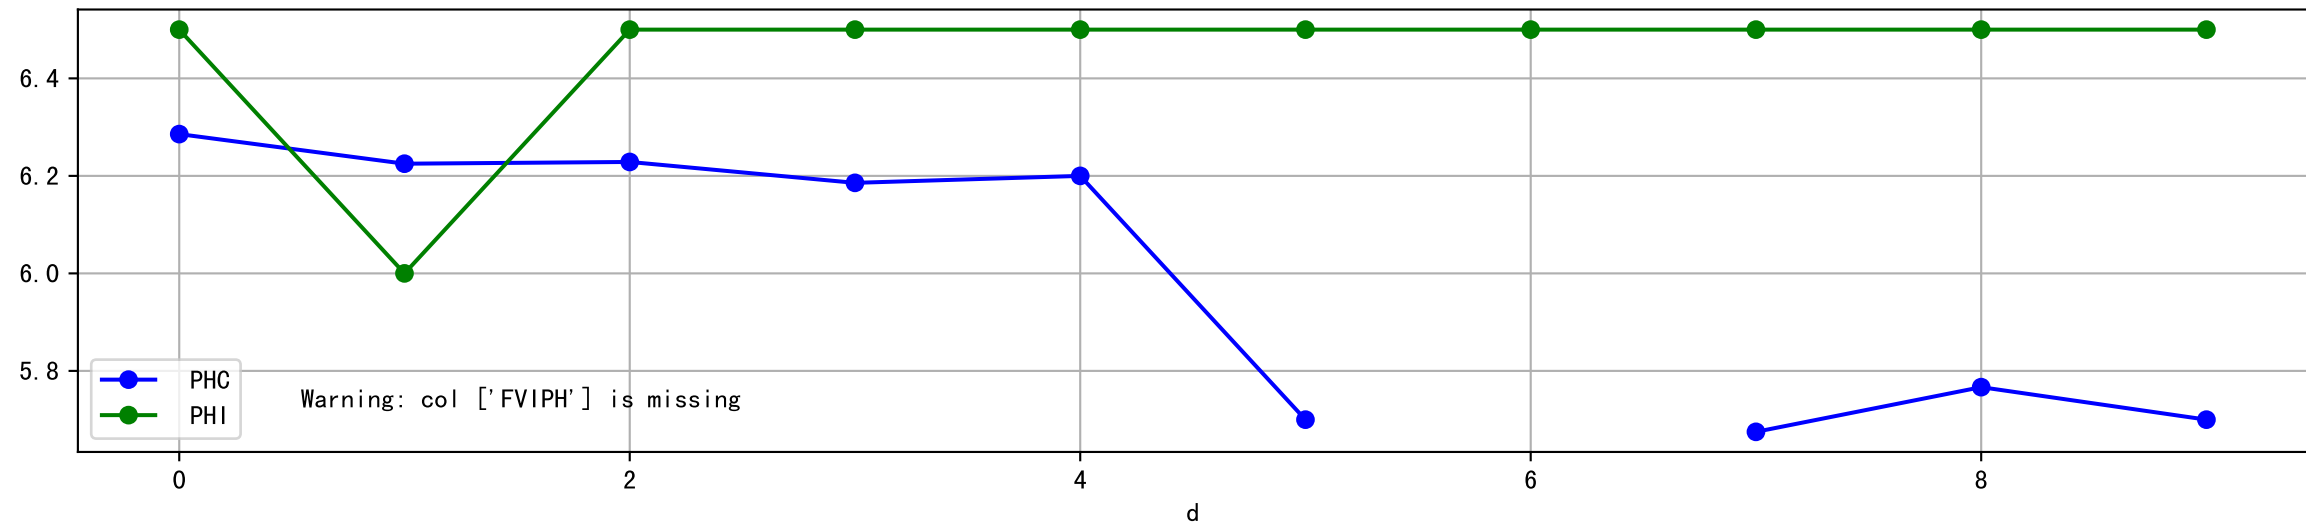
Plot [['PHC:b-o', 'FVIPH:r-o', 'PHI:g-o']]

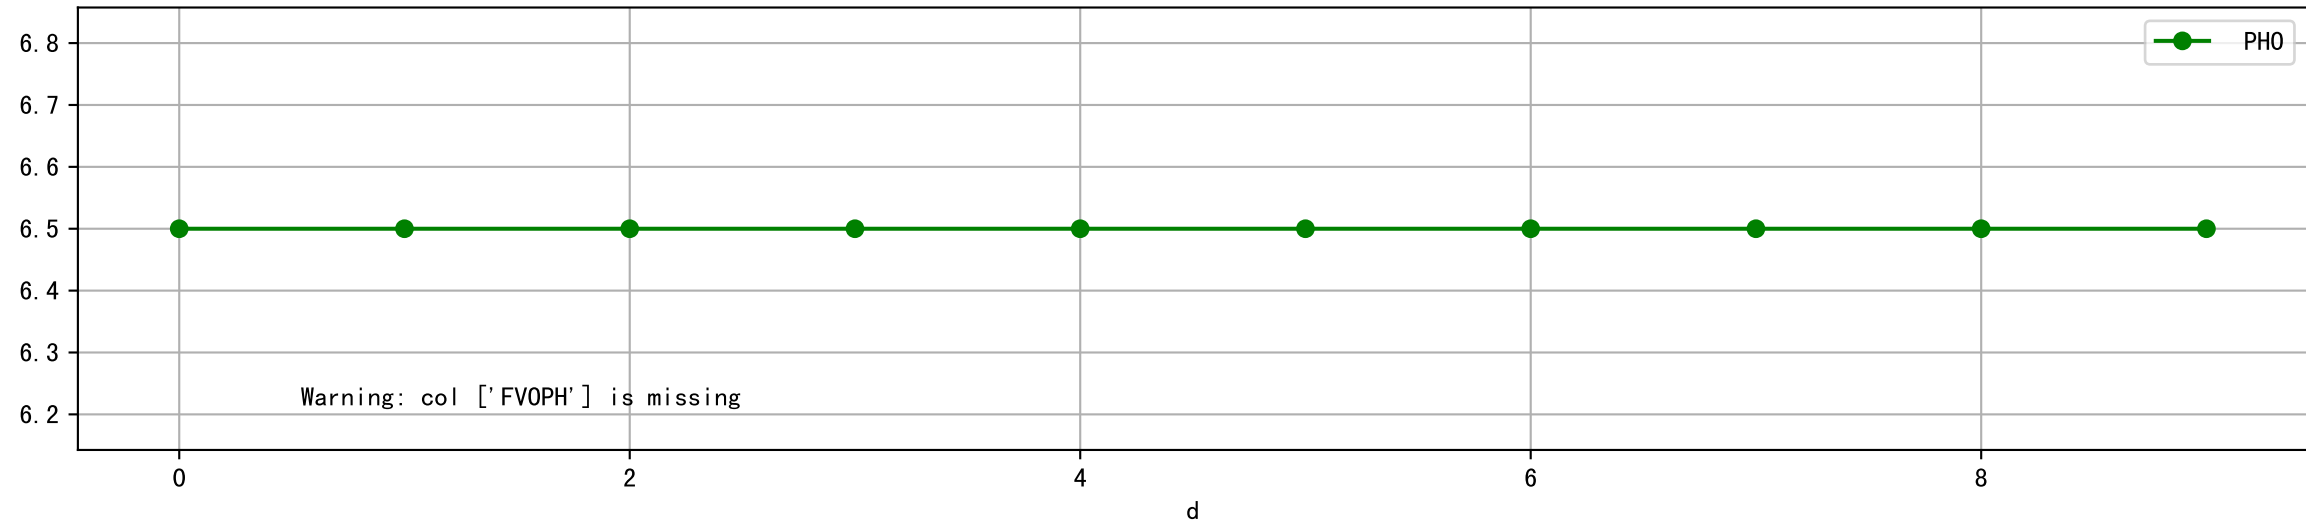
Plot [[' FVOPH:r-o' , ' PH0:g-o' ]]

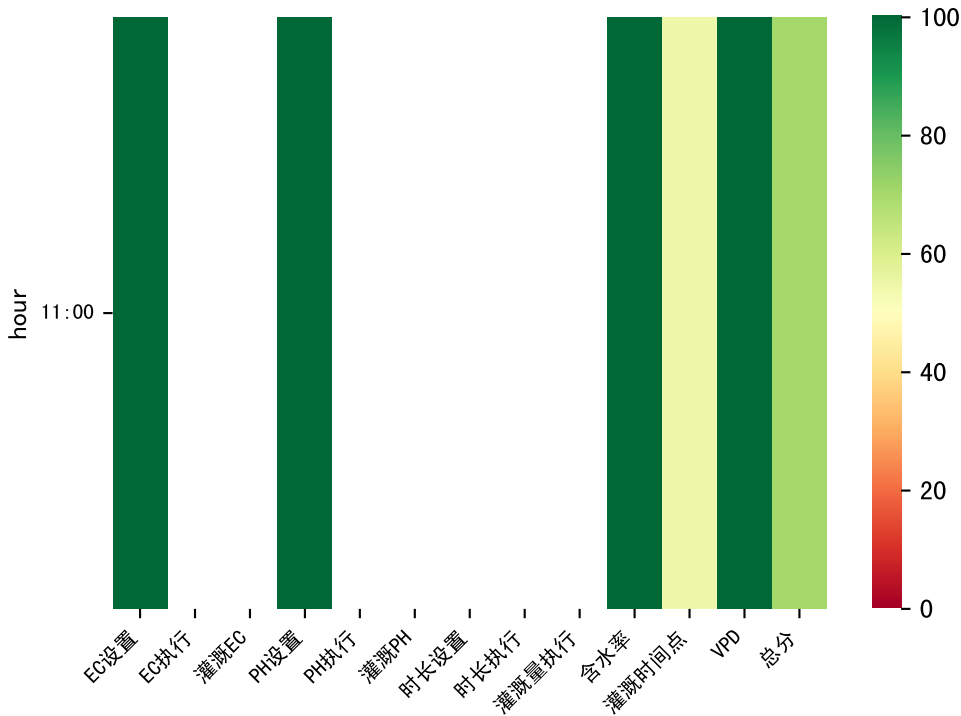
| 时间 | 灌溉时长(秒) | 灌溉量(毫升/株) | 天气 | 注释 |
| 11:00 | 120 | 50.0 | 阴 | 假设@11:00（未用传感器） |
| 总计 | 120.0（1次） | 50.0 | | 建议进液EC: 2750.0, PH: 6.5 |

滴头平均流速偏大（0.94），请检查  
上次灌溉流速比平时大（1.2 vs 0.94)), 可能有多阀同灌或管道漏水  
施肥机灌溉量与预期值不符（87.0 : 34.0），可能水表需要校准  
上次灌溉时长未按模型建议(72.0 vs 106.0))  
默认实际灌溉34.0 ml.  
昨天灌溉EC（2387.0）与手测EC（1334.0）偏差较大，请检查  
回液EC（1633.0 vs 2185）偏低

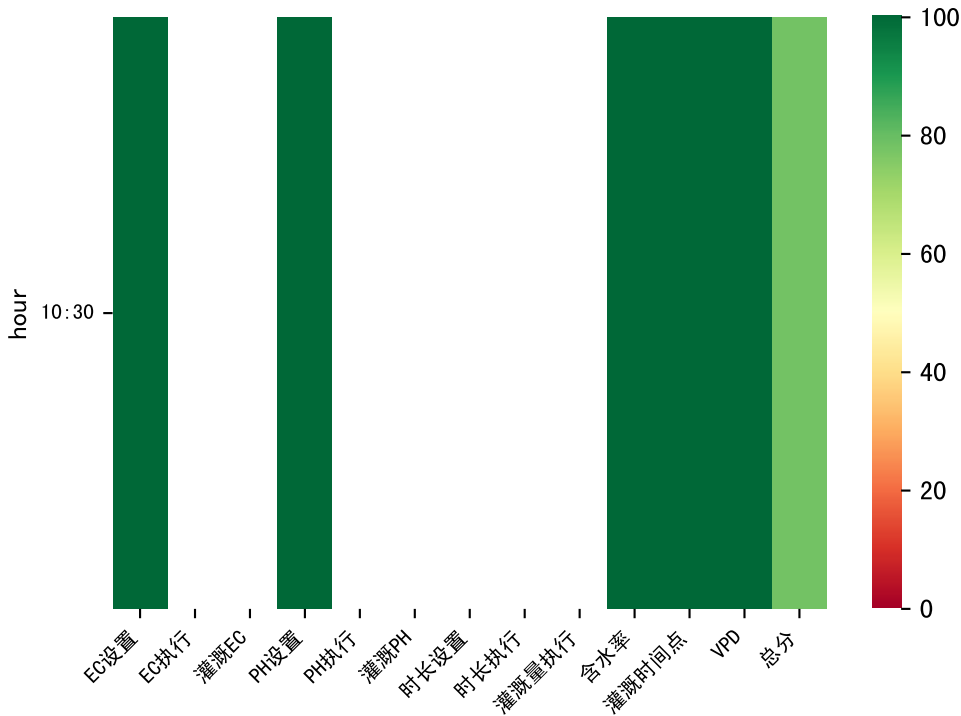
| 时间 | 灌溉时长(秒) | 灌溉量(毫升/株) | 天气 | 注释 |
| 10:30 | 90 | 50.0 | 阴 | 假设@10:30（未用传感器） |
| 总计 | 90.0（1次） | 50.0 | | 建议进液EC: 2612.5， PH: 6.5 |

滴头平均流速偏大（1.08）， 请检查  
上次灌溉流速比平时小（0.93 vs 1.08），可能有多阀同灌或管道堵塞或水压不足  
施肥机灌溉量与预期值不符（83.0 ： 42.0），可能水表需要校准  
上次灌溉时长未按模型建议（90.0 vs 106.0）  
默认实际灌溉42.0 ml.  
昨天灌溉EC（2375.0）与手测EC（480.0）偏差较大，请检查  
回液EC（1692.0 vs 2185）偏低  
上次灌溉PH（5.6）与设定值（6.5）偏差较大，请检查。  
上次灌溉PH（5.6）与模型建议（6.5）偏差较大，请检查。

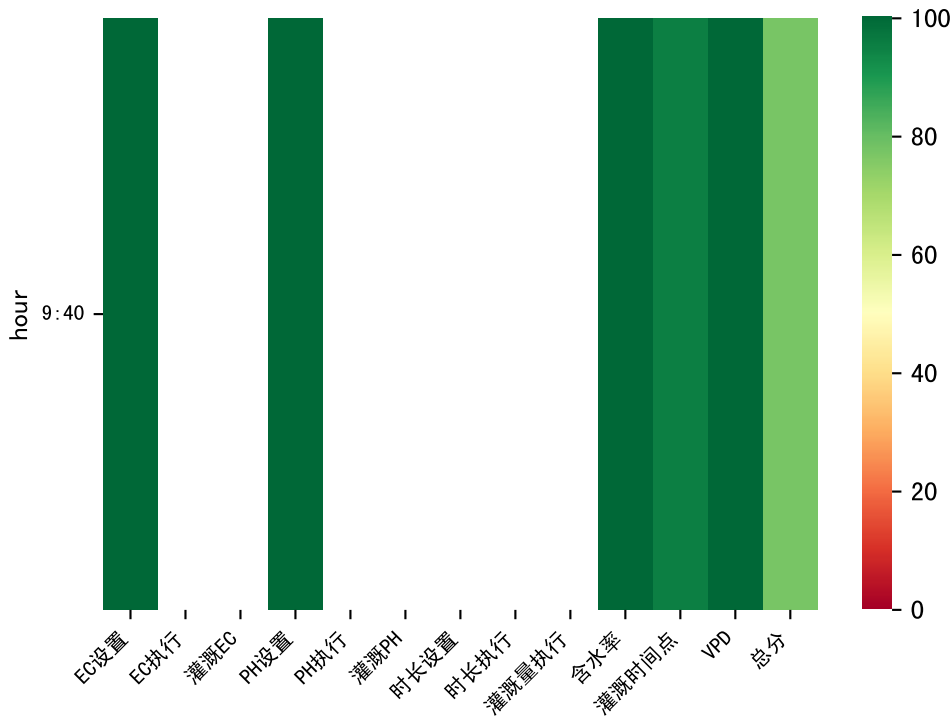
| 时间 | 灌溉时长(秒) | 灌溉量(毫升/株) | 天气 | 注释 |
| 09:40 | 90 | 50.0 | 多云 | 假设@09:40（未用传感器） |
| 总计 | 90.0（1次） | 50.0 | | 建议进液EC：2475.0， PH： 6.5 |

滴头平均流速偏大（1.23），请检查  
上次灌溉流速比平时小（0.92 vs 1.23），可能有多阀同灌或管道堵塞或水压不足  
施肥机灌溉量与预期值不符（21.0：11.0），可能水表需要校准  
上次灌溉时长未按模型建议（23.0 vs 106.0）  
默认实际灌溉11.0 ml.  
昨天灌溉EC（2283.0）与手测EC（1586.0）偏差较大，请检查  
回液EC（1867.0 vs 2185）偏低

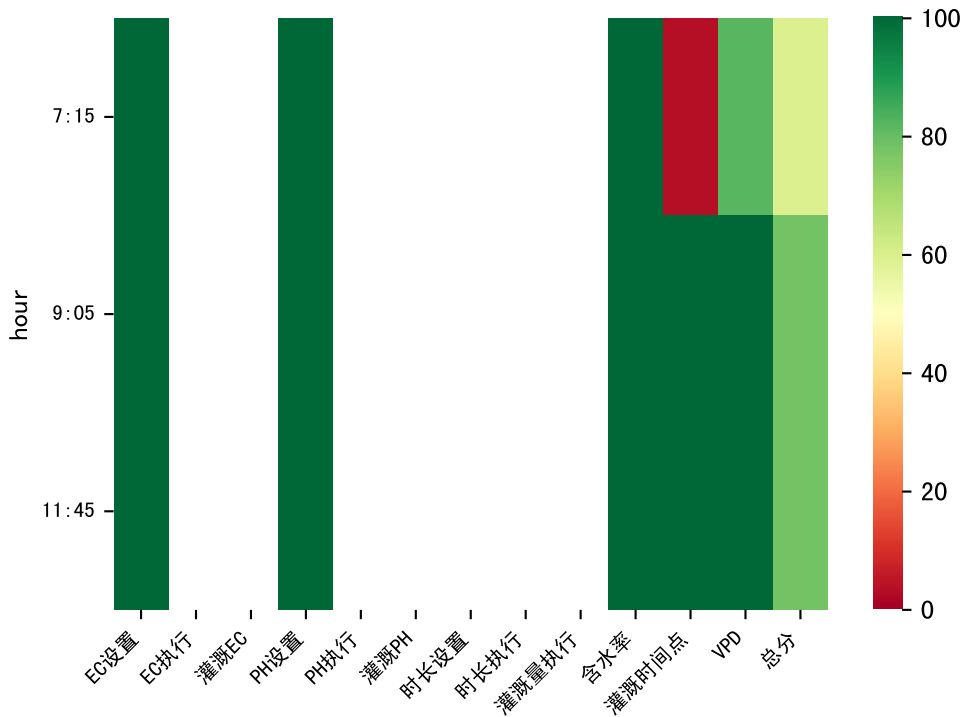
| 时间 | 灌溉时长(秒) | 灌溉量(毫升/株) | 天气 | 注释 |
| 07:15 | 120 | 50.0 | 雾 | 假设@07:15（未用传感器） |
| 09:05 | 120 | 50.0 | 多云 | 假设@09:05（未用传感器） |
| 11:45 | 120 | 50.0 | 多云 | 假设@11:45（未用传感器） |
| 总计 | 360.0（3次） | 150.0 | | 建议进液EC：2079.0， PH： 6.5 |

滴头平均流速偏大（1.27），请检查  
上次灌溉流速比平时小（0.92 vs 1.27），可能有多阀同灌或管道堵塞或水压不足  
施肥机灌溉量与预期值不符（110.0 ： 56.0），可能水表需要校准  
上次灌溉时长未按模型建议（120.0 vs 106.0）  
默认实际灌溉56.0 ml.  
回液EC（2122.0 vs 2185）偏低
