NC11 P4

2025-04-10 (Day 6)

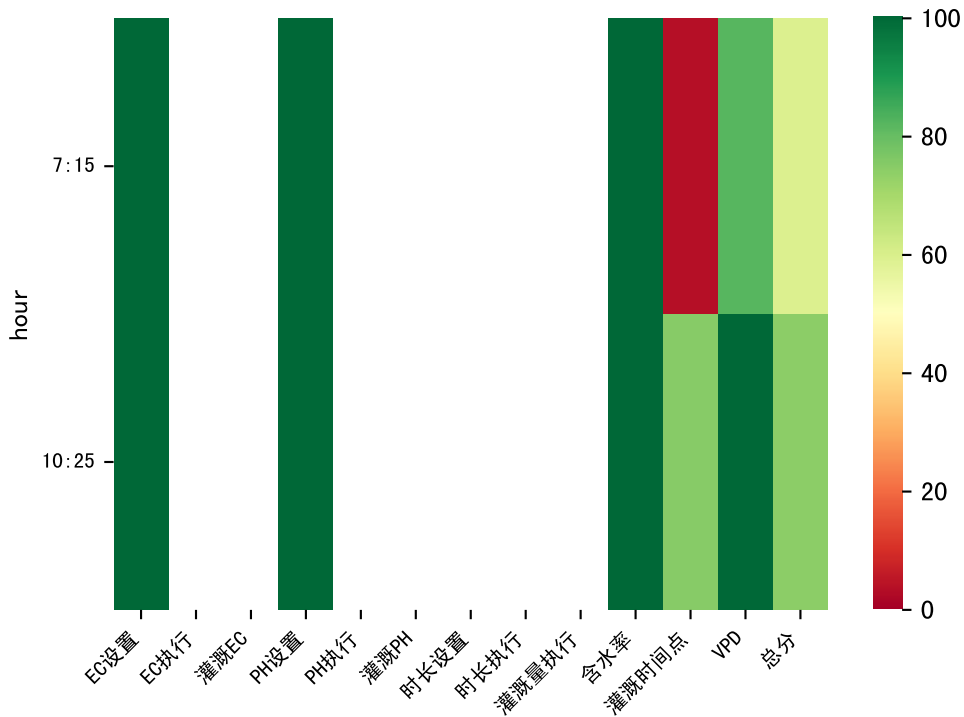
滴头平均流速偏大（1.33），请检查  
施肥机灌溉量与预期值不符（292.0 ： 94.0），可能水表需要校准  
上次灌溉时长未按模型建议(210.0 vs 111.0))  
默认实际灌溉94.0 ml.  
昨天灌溉EC（2006.0）与手测EC（2422.0）偏差较大，请检查  
回液EC（1493.0 vs 2185）偏低  
进回液EC差(2422.0 vs 1493.0)偏低

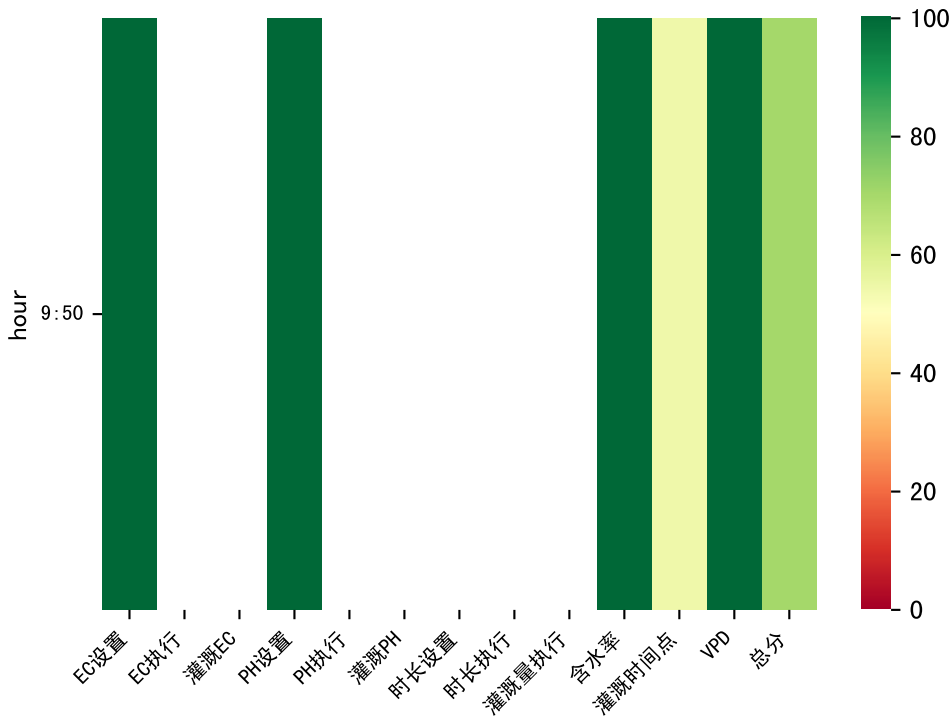
滴头平均流速偏大（1.36），请检查  
施肥机灌溉量与预期值不符（289.0：88.0），可能水表需要校准  
上次灌溉时长未按模型建议(210.0 vs 119.0))  
默认实际灌溉88.0 ml.  
昨天灌溉EC（2005.0）与手测EC（2452.0）偏差较大，请检查  
回液EC（1203.0 vs 2185）偏低  
进回液EC差(2452.0 vs 1203.0)偏低
