NC11 P4

2025-04-11 (Day 7)

P4\_0

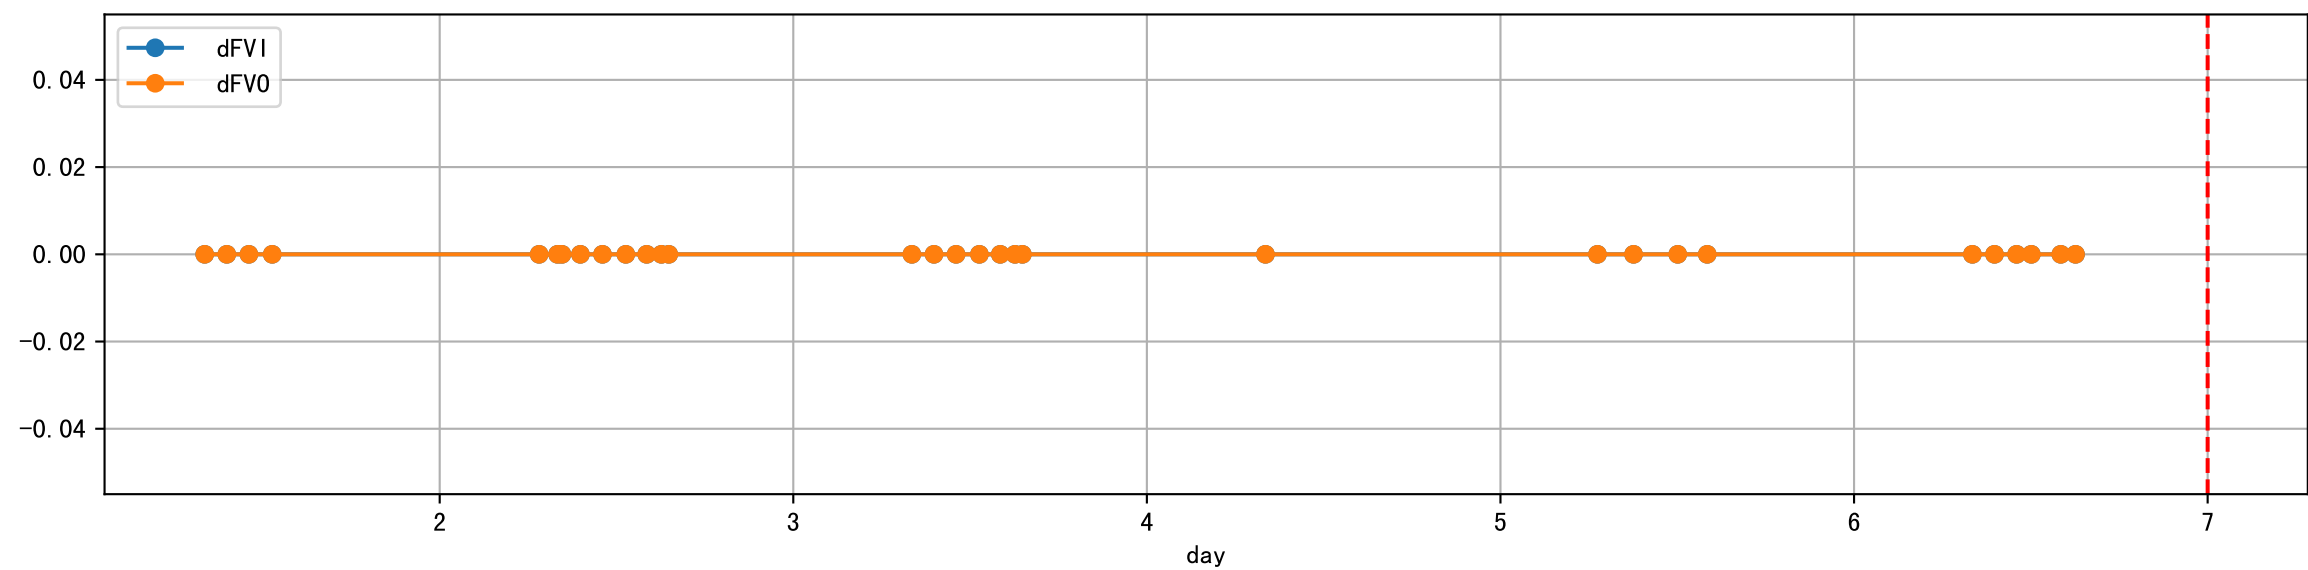
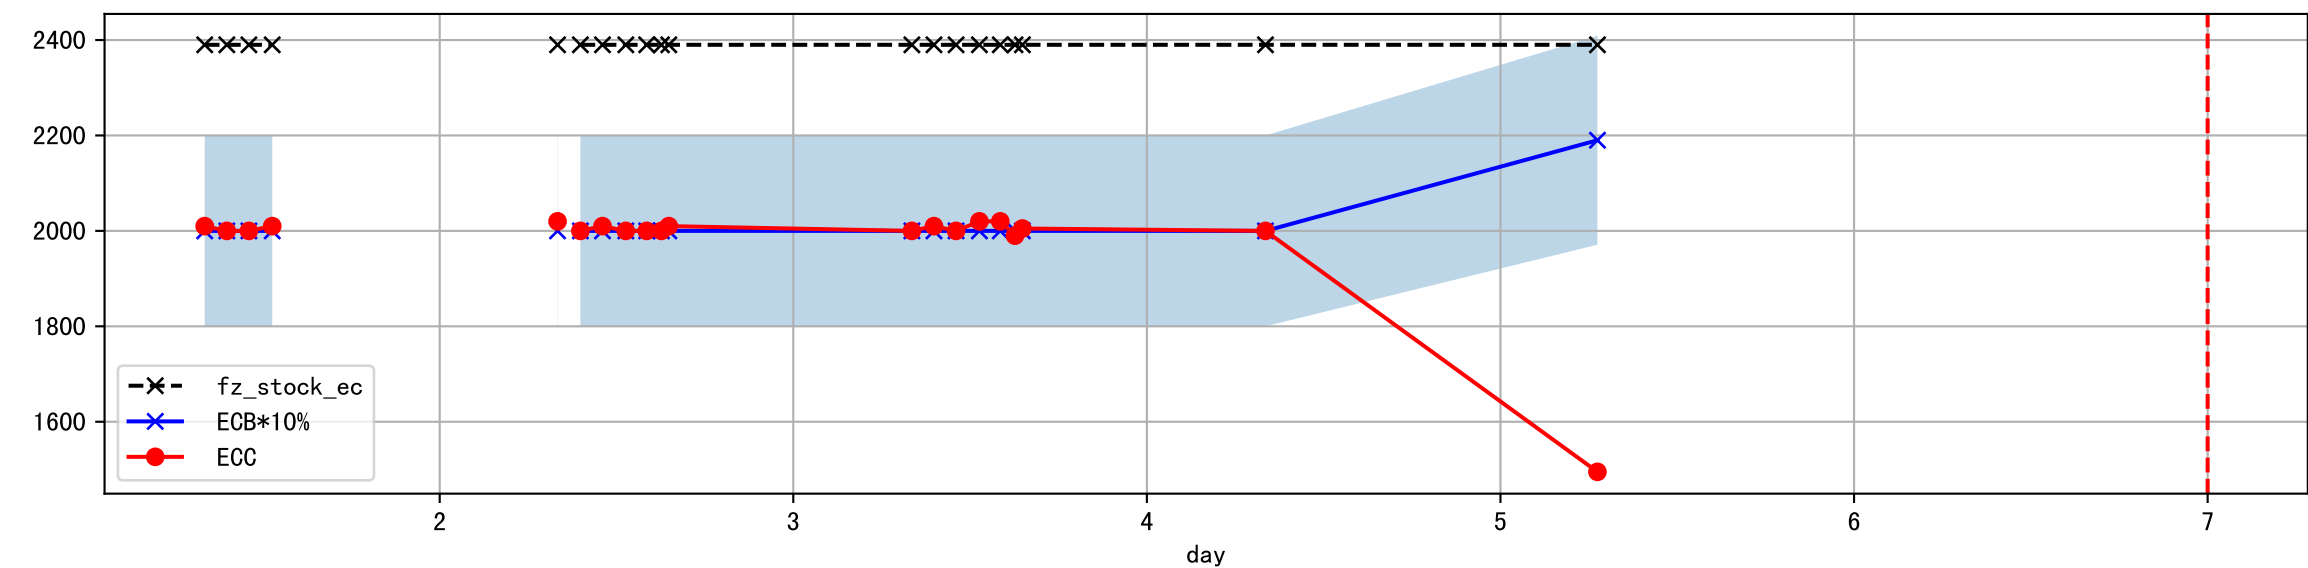
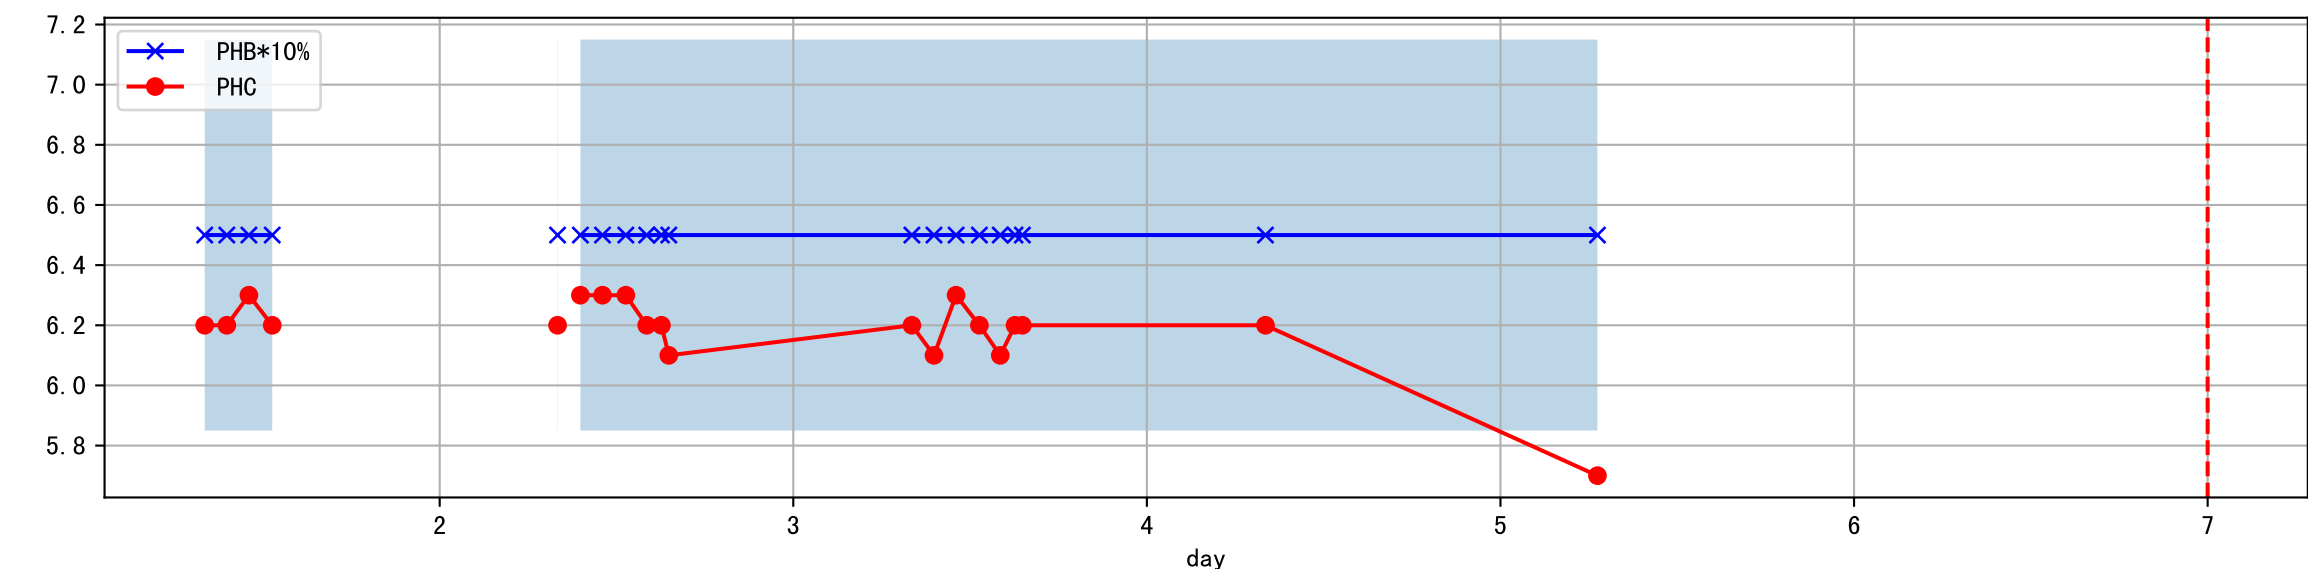
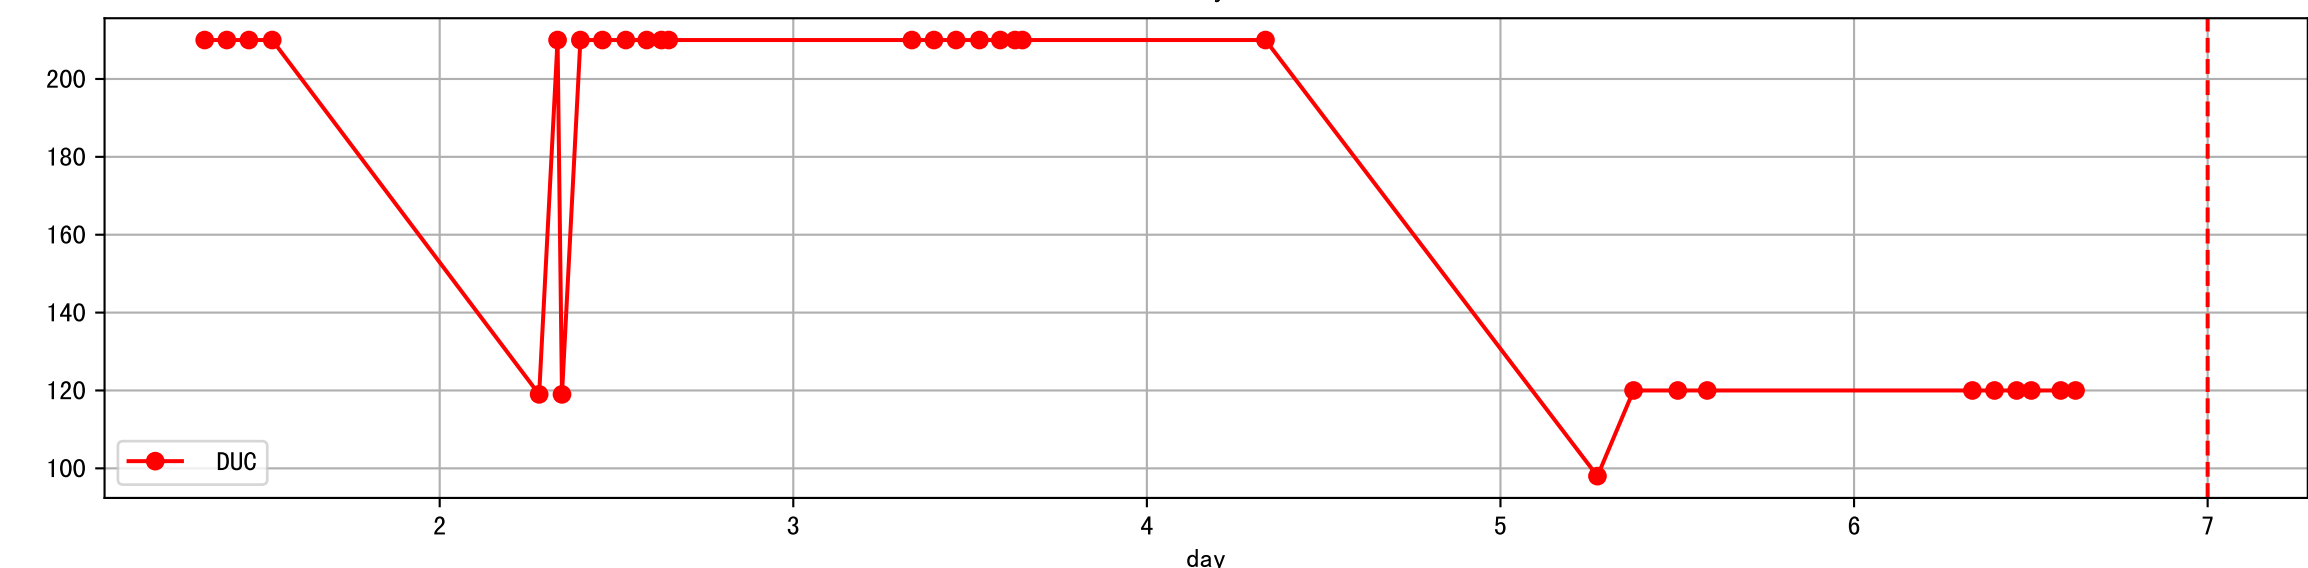
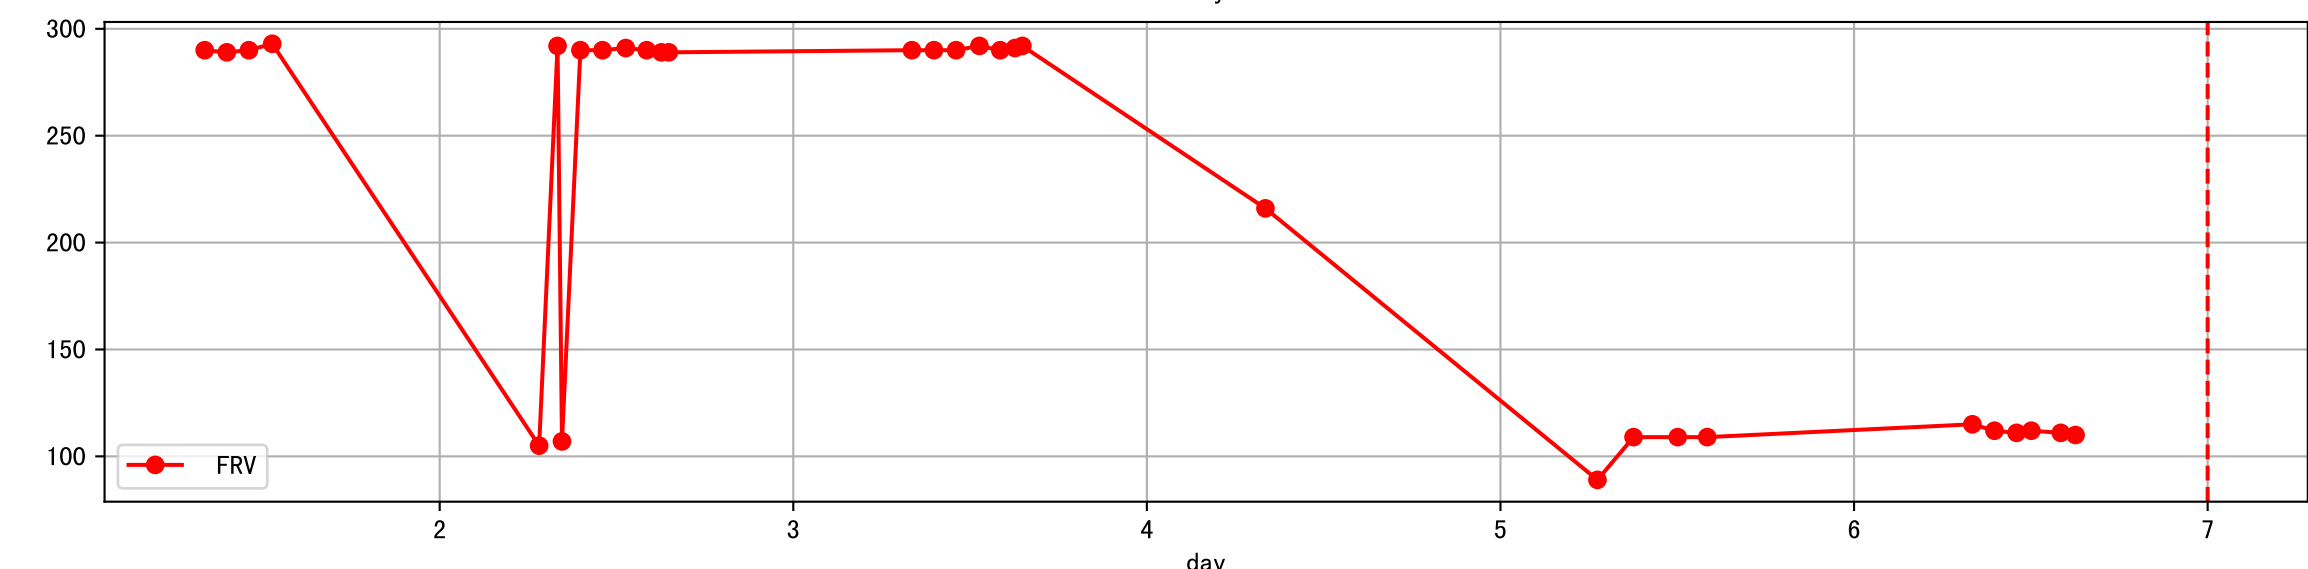
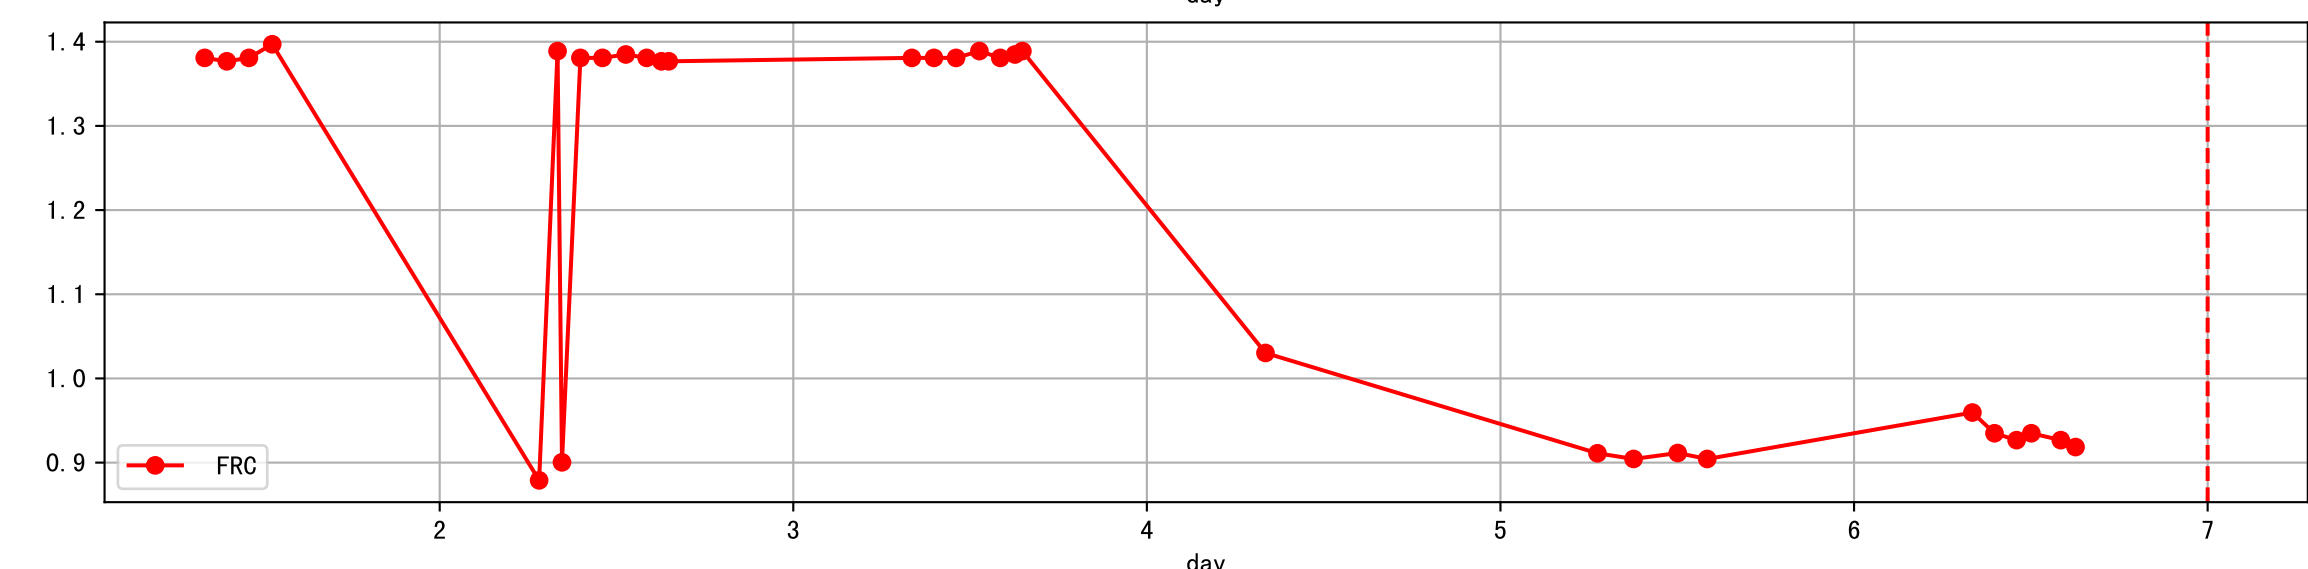
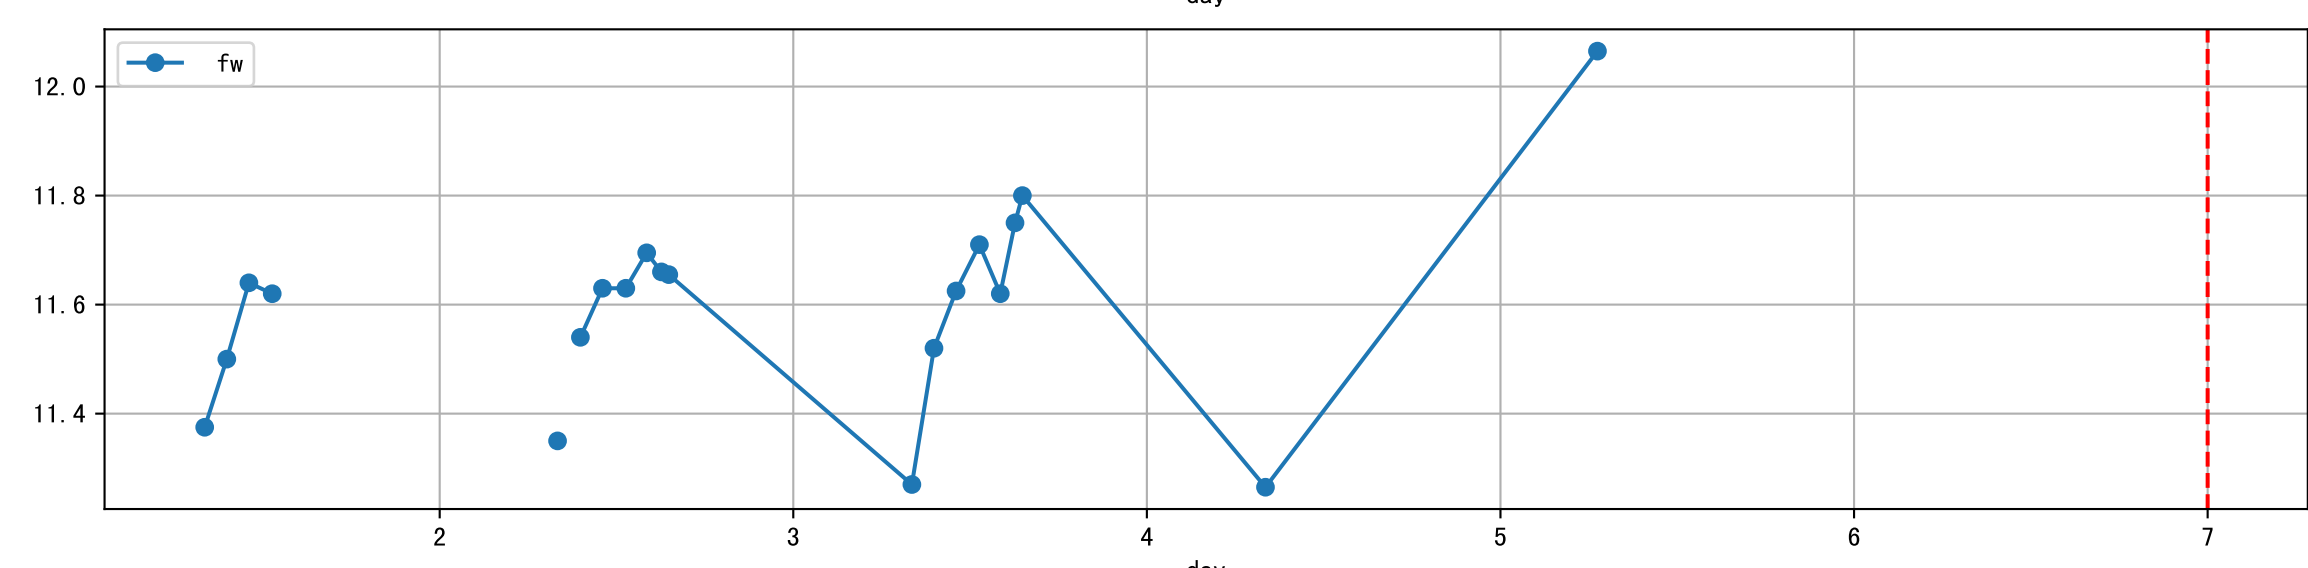
Plot Sensor and FgRec Data

Plot [['I', 'Iopt'], ['T', 'Topt'], ['RH', 'RHopt'], ['ETcl', 'optETcl'], ['LAI', 'optEtRate']]

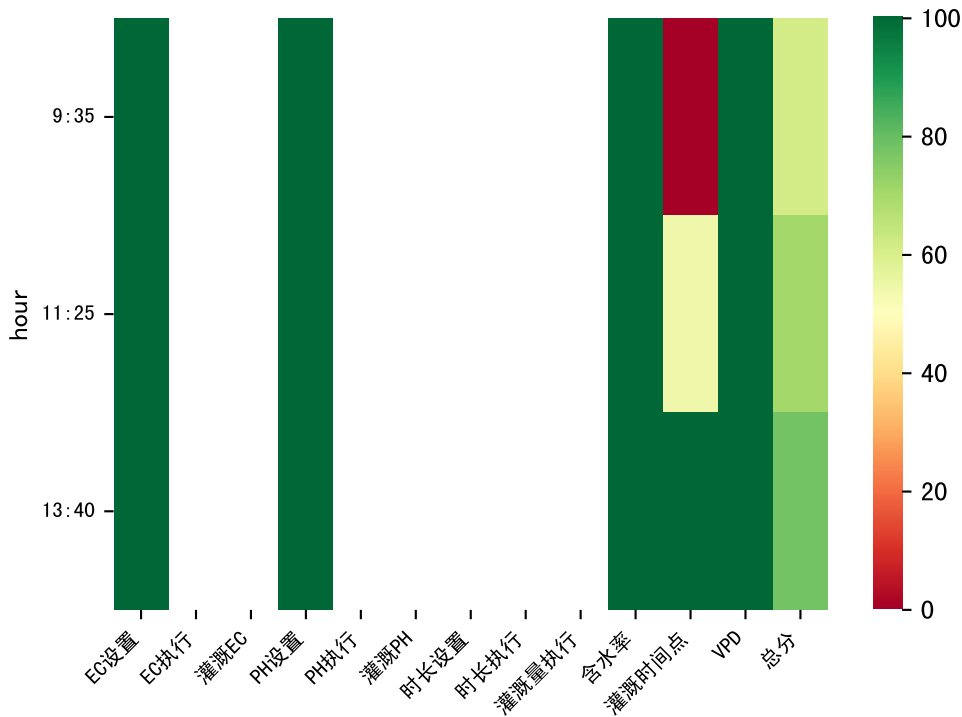
| 时间 | 灌溉时长(秒) | 灌溉量(毫升/株) | 天气 | 注释 |
| 09:35 | 109 | 50.0 | 晴 | 预期@09:35 (未用传感器) |
| 11:25 | 109 | 50.0 | 晴 | 预期@11:25 (未用传感器) |
| 13:40 | 109 | 50.0 | 晴 | 预期@13:40 (未用传感器) |
| 总计 | 327.0 (3次) | 150.0 | | 建议进液EC: 2200.0, PH: 6.5 |

昨天灌溉EC (2006.0) 与手测EC (1586.0) 偏差较大, 请检查  
回液EC (1867.0 vs 2185) 偏低

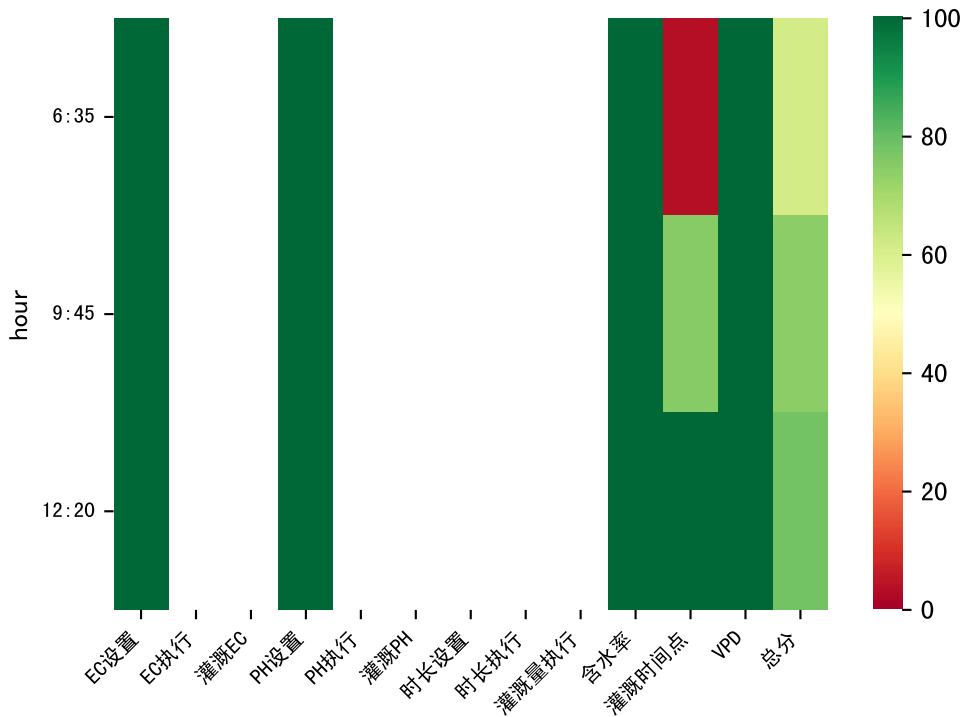
| 时间 | 灌溉时长(秒) | 灌溉量(毫升/株) | 天气 | 注释 |
| 06:35 | 120 | 50.0 | 多云 | 假设@06:35（未用传感器） |
| 09:45 | 120 | 50.0 | 多云 | 假设@09:45（未用传感器） |
| 12:20 | 120 | 50.0 | 多云 | 假设@12:20（未用传感器） |
| 总计 | 360.0（3次） | 150.0 | | 建议进液EC：1960.0， PH： 6.5 |

滴头平均流速偏大（1.27），请检查  
上次灌溉流速比平时小（0.92 vs 1.27），可能有多阀同灌或管道堵塞或水压不足  
施肥机灌溉量与预期值不符（110.0 ： 56.0），可能水表需要校准  
上次灌溉时长未按模型建议（120.0 vs 106.0）  
默认实际灌溉56.0 ml.  
回液EC（2122.0 vs 2185）偏低

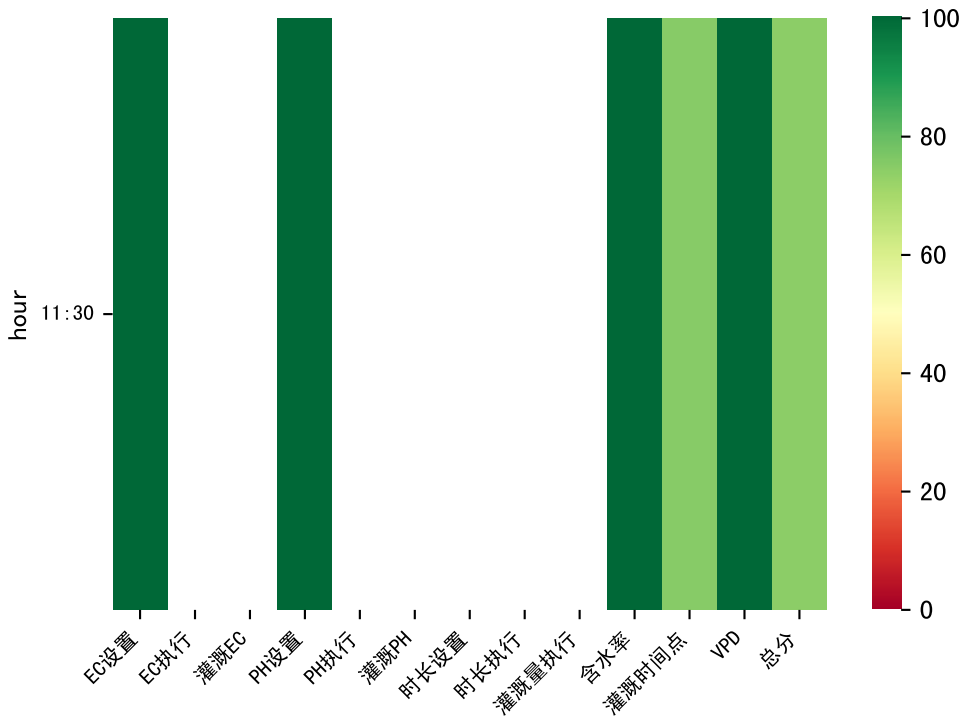
| 时间 | 灌溉时长(秒) | 灌溉量(毫升/株) | 天气 | 注释 |
| 11:30 | 98 | 50.0 | 多云 | 假设@11:30（未用传感器） |
| 总计 | 98.0（1次） | 50.0 | | 建议进液EC：2189.0， PH： 6.5 |

滴头平均流速偏大（1.33）， 请检查  
上次灌溉流速比平时小（0.9 vs 1.33），可能有多阀同灌或管道堵塞或水压不足  
施肥机灌溉量与预期值不符（109.0 ： 56.0），可能水表需要校准  
上次灌溉时长未按模型建议(120.0 vs 106.0))  
默认实际灌溉56.0 ml.  
回液EC（1996.0 vs 2185）偏低

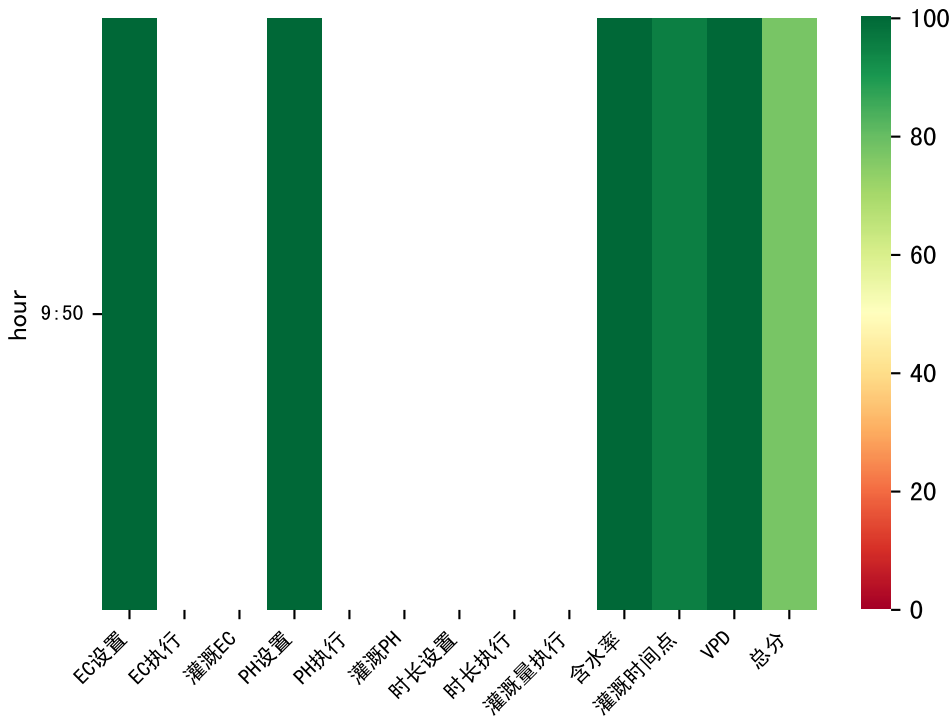
| 时间 | 灌溉时长(秒) | 灌溉量(毫升/株) | 天气 | 注释 |
| 09:50 | 210 | 50.0 | 晴 | 假设@09:50（未用传感器） |
| 总计 | 210.0（1次） | 50.0 | | 建议进液EC: 2200.0, PH: 6.5 |

滴头平均流速偏大（1.36），请检查  
上次灌溉流速比平时小（1.03 vs 1.36），可能有多阀同灌或管道堵塞或水压不足  
施肥机灌溉量与预期值不符（216.0 : 101.0），可能水表需要校准  
上次灌溉时长未按模型建议(210.0 vs 104.0))  
默认实际灌溉101.0 ml.  
回液EC（1660.0 vs 2185）偏低
