NC11 P5

2025-04-16 (Day 12)

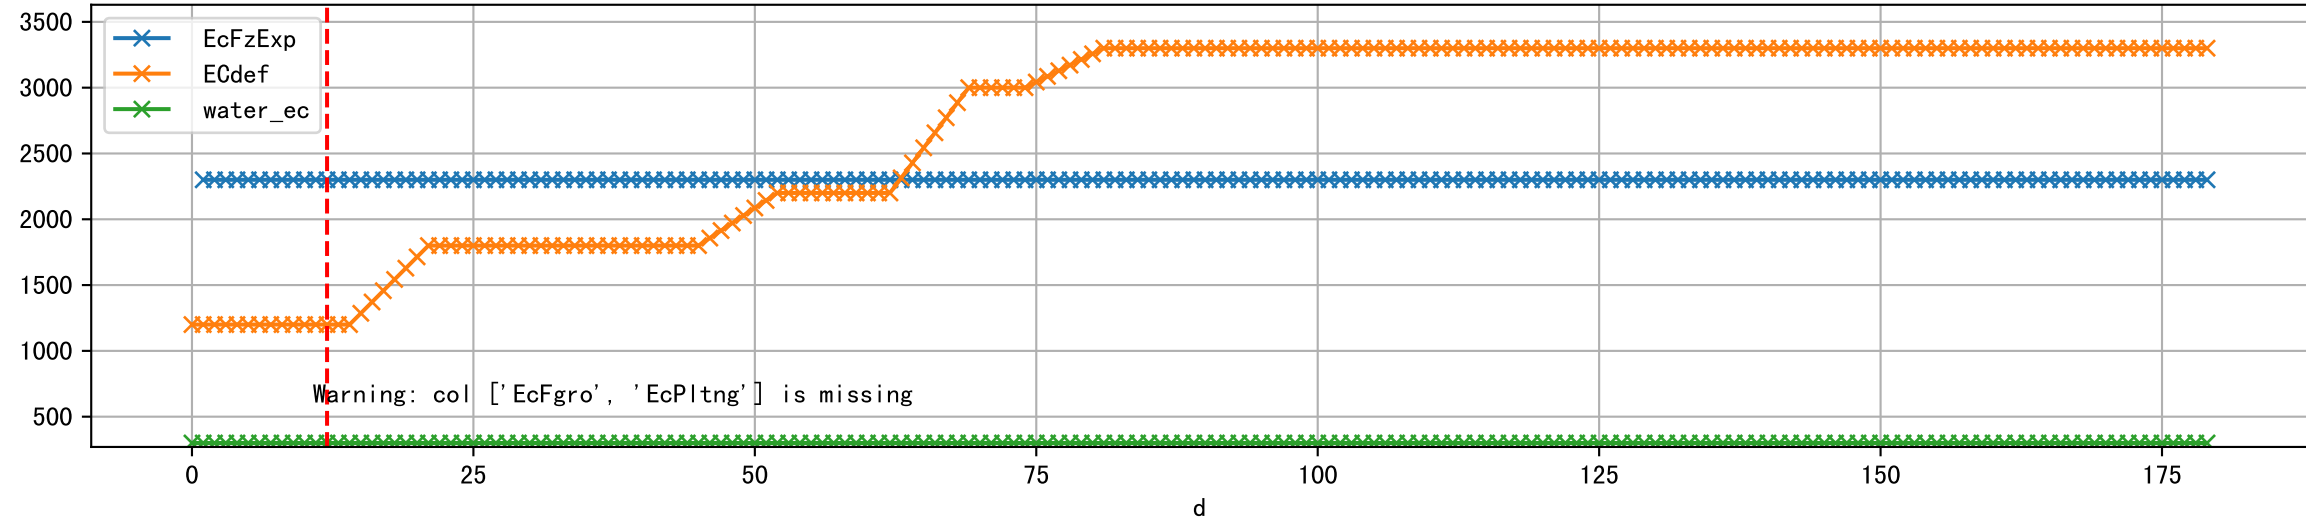
Plot [['EcFgro', 'EcFzExp', 'EcPltng', 'ECdef', 'water\_ec']]

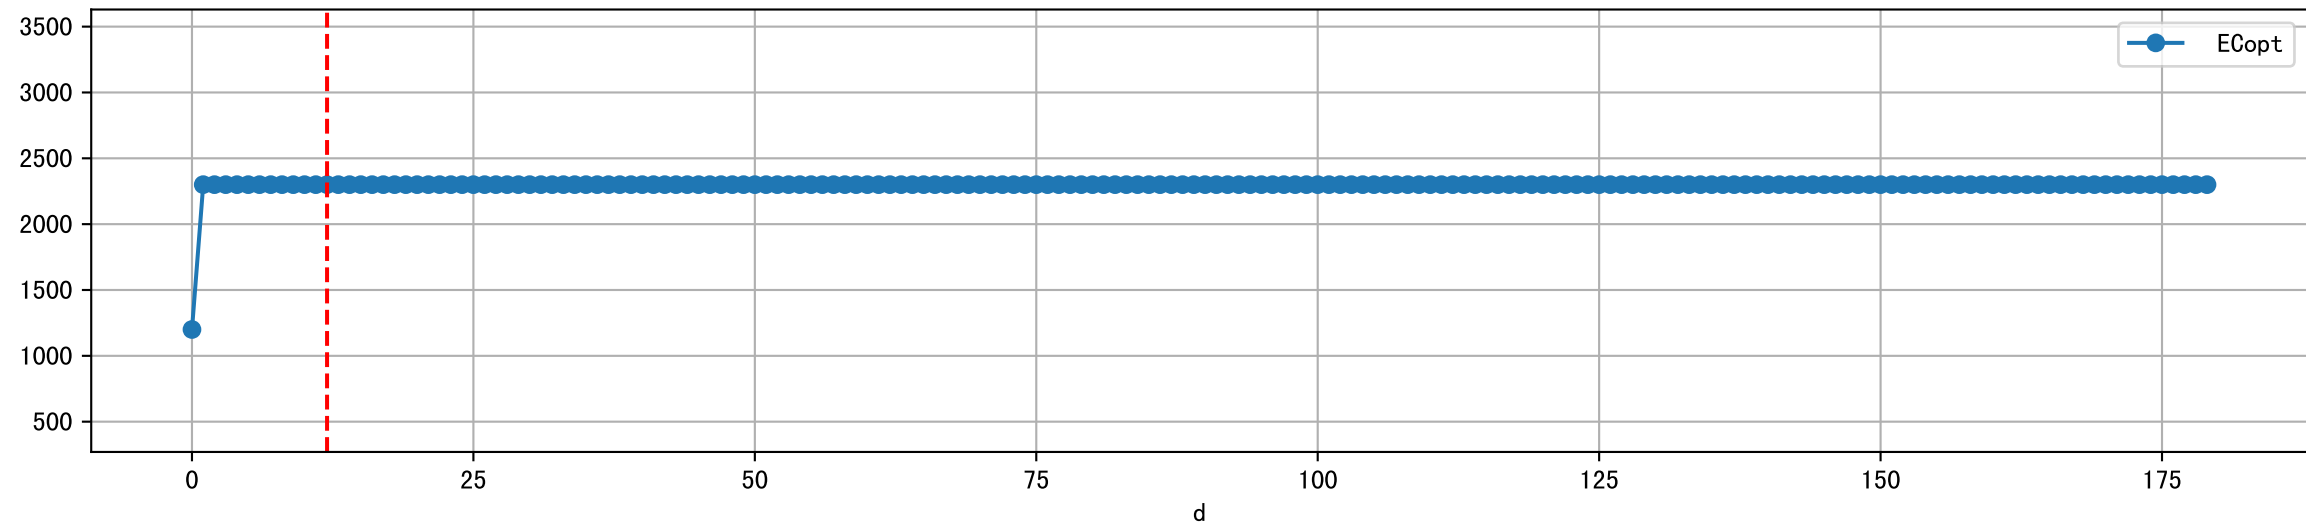
Plot [' ECopt' ]

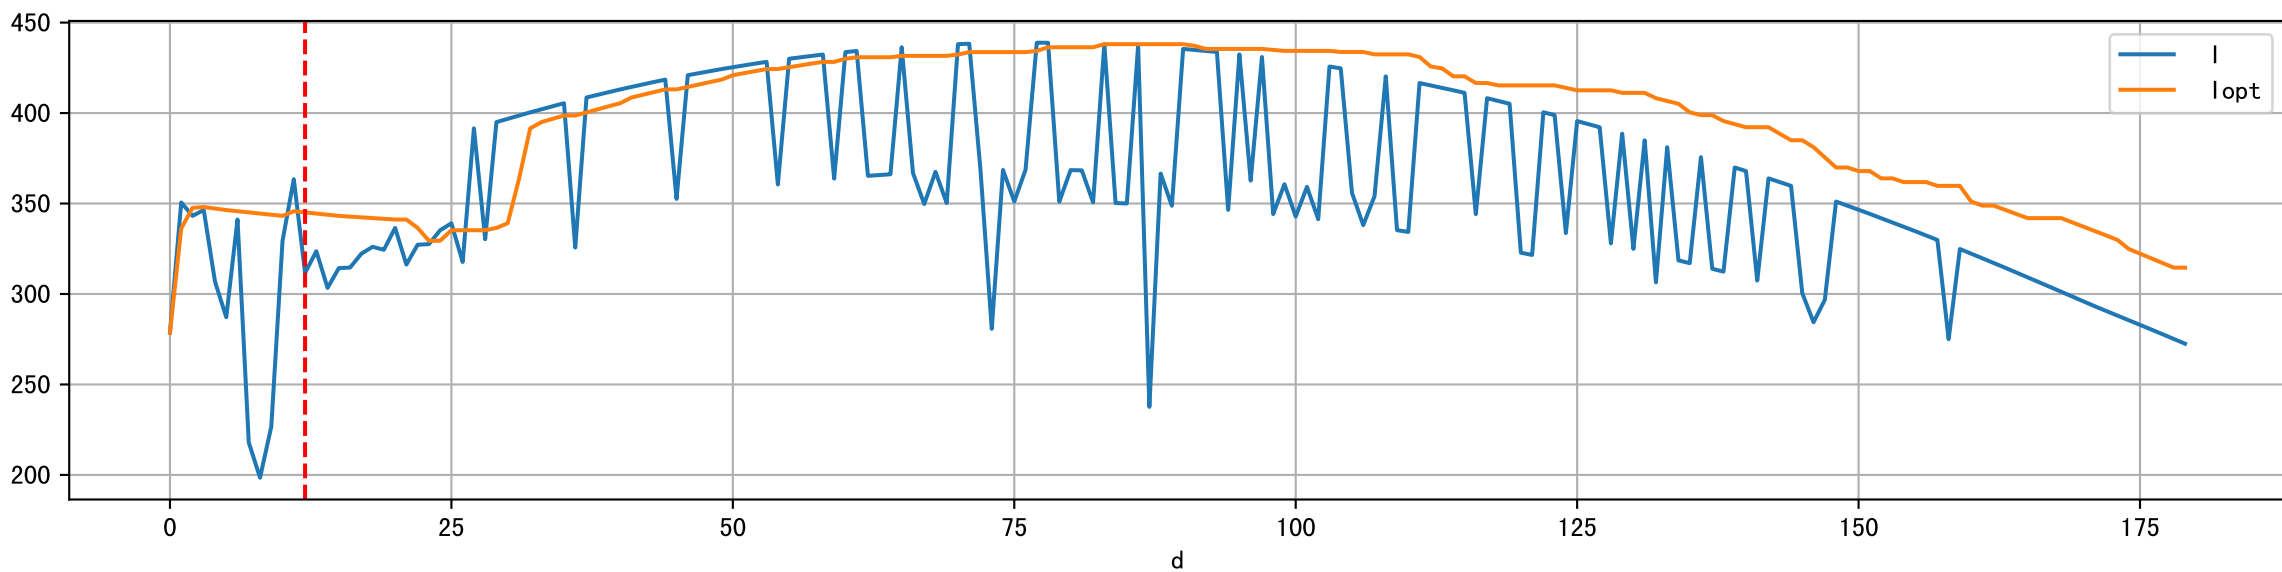
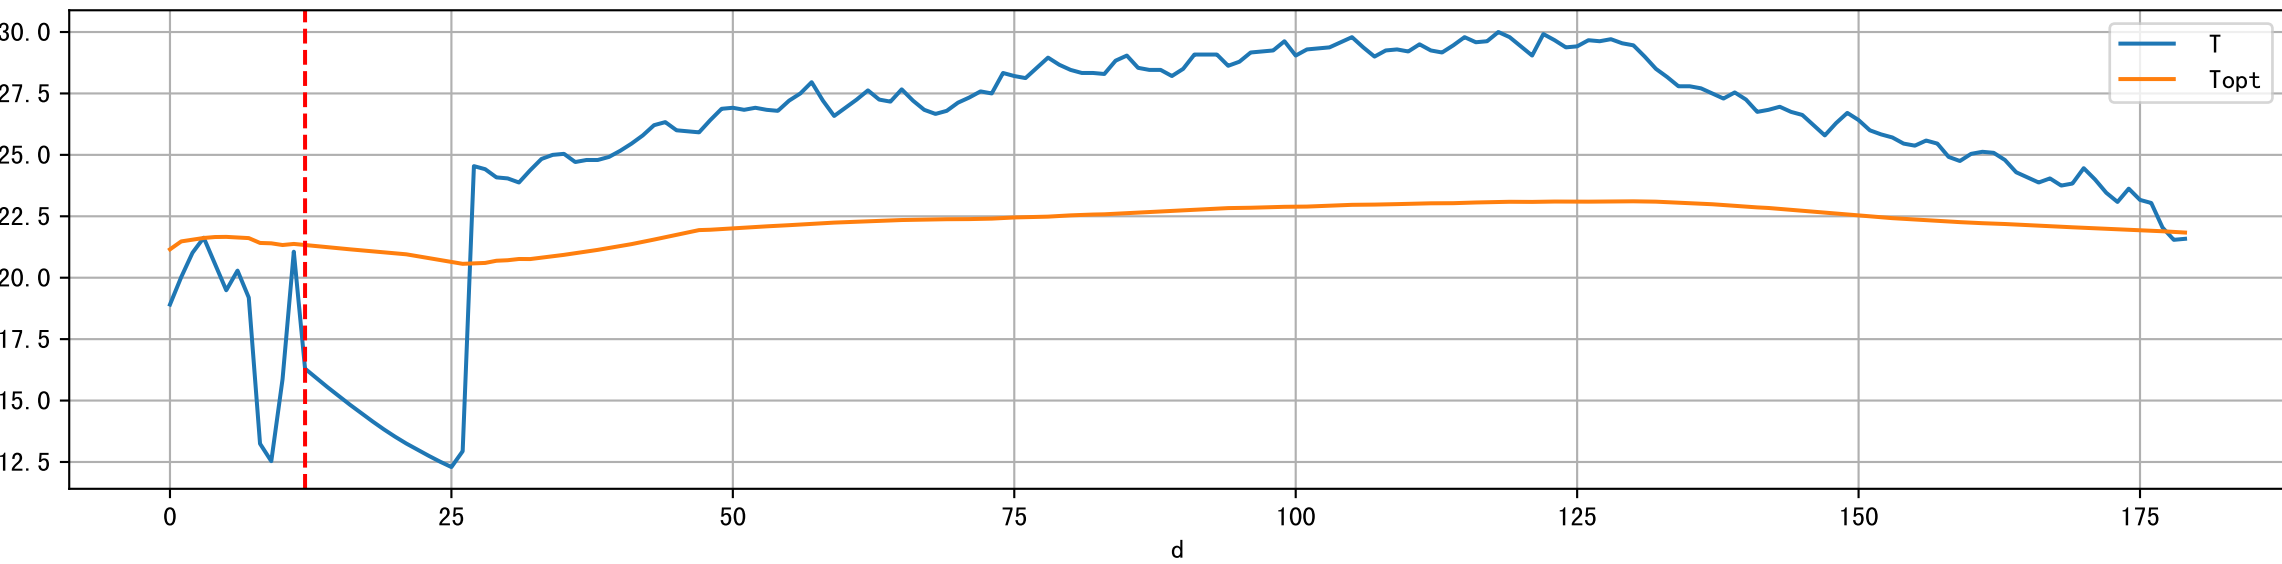
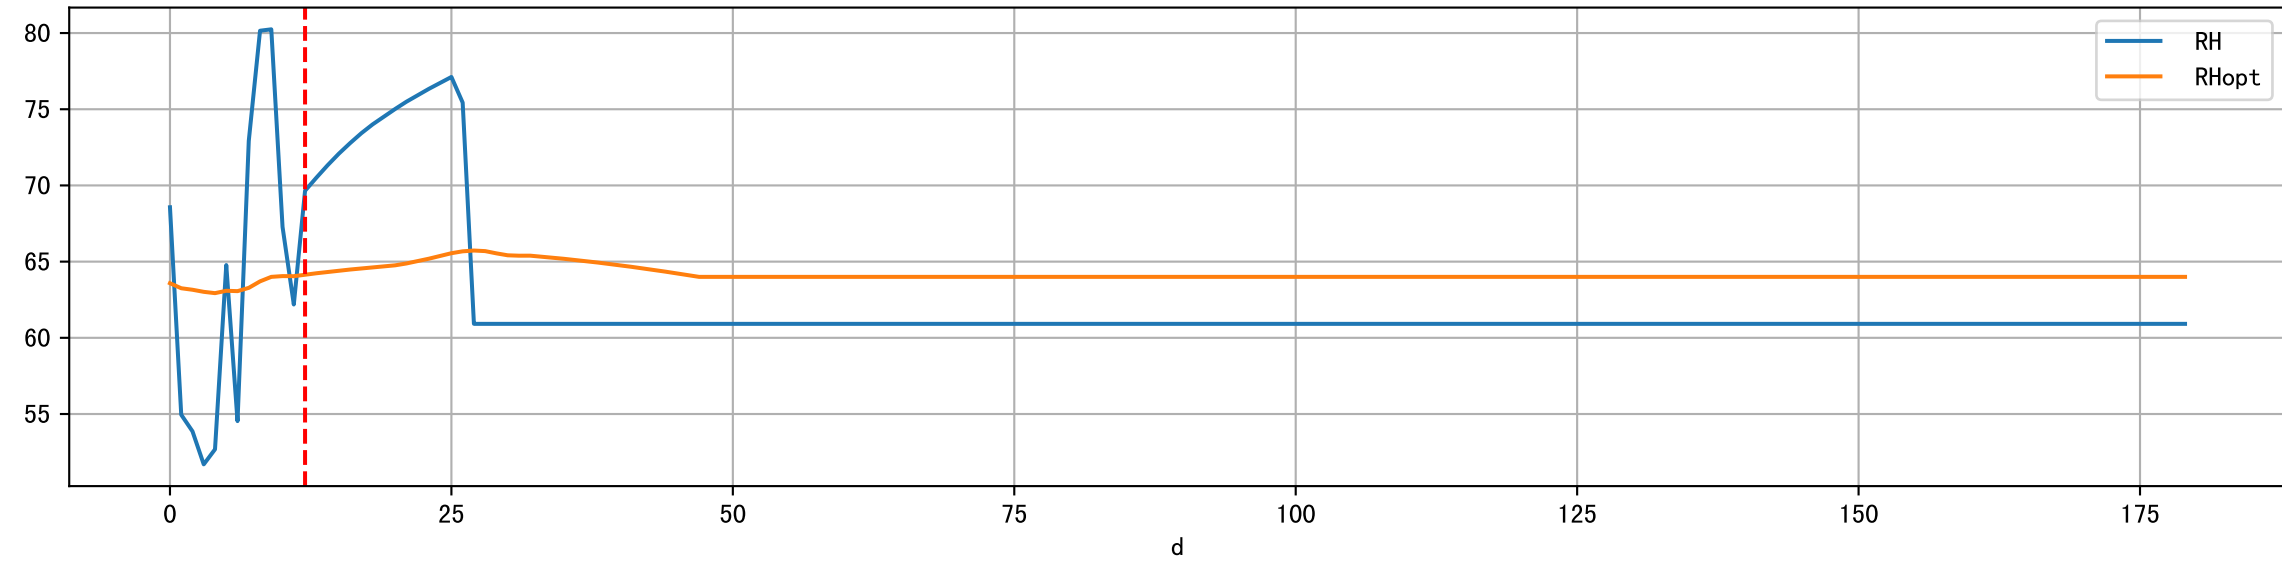
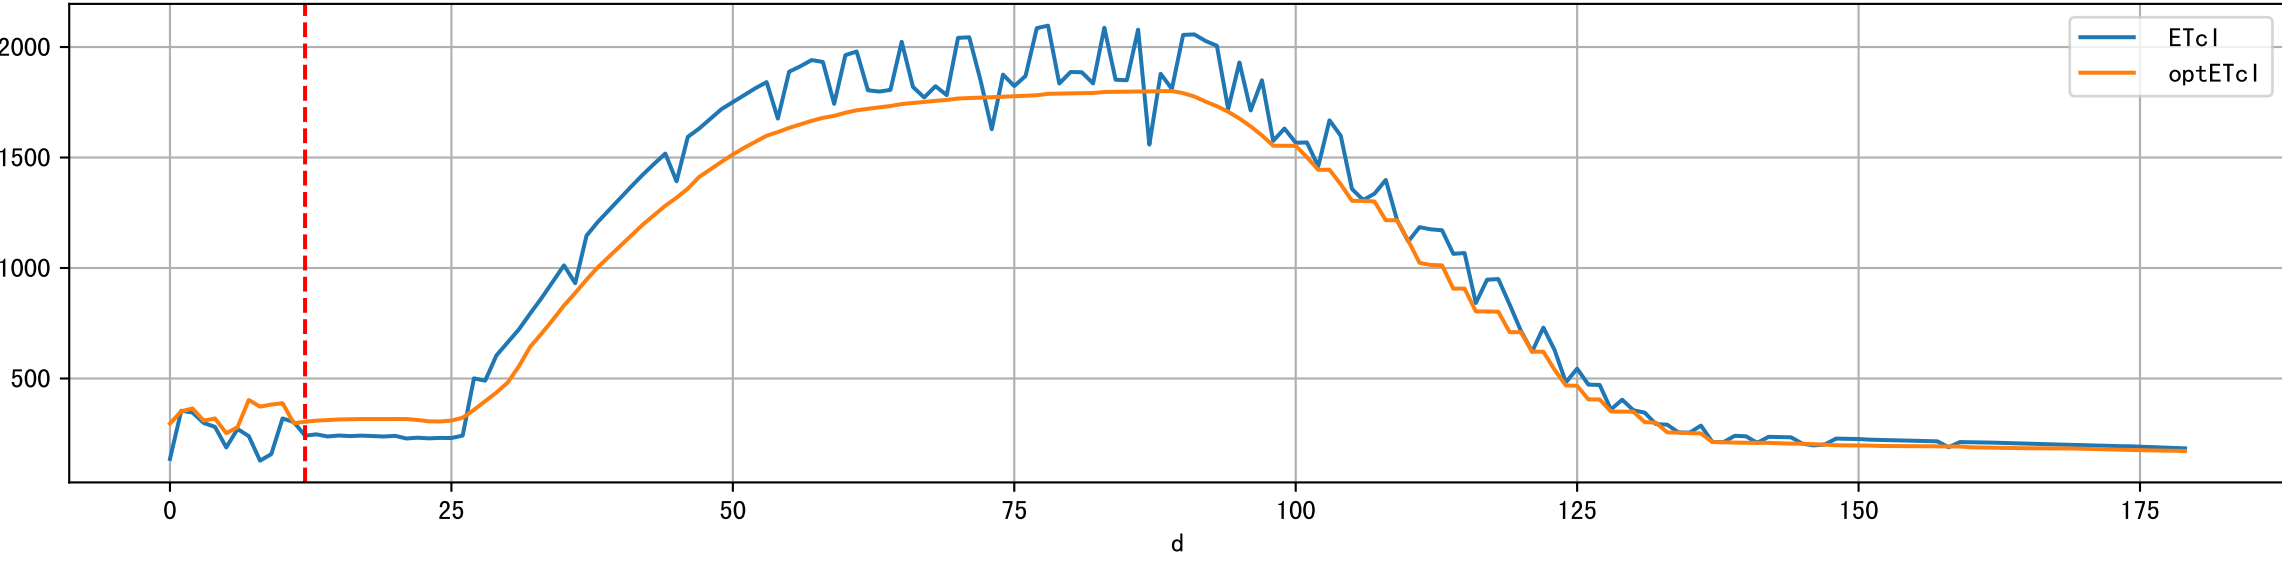
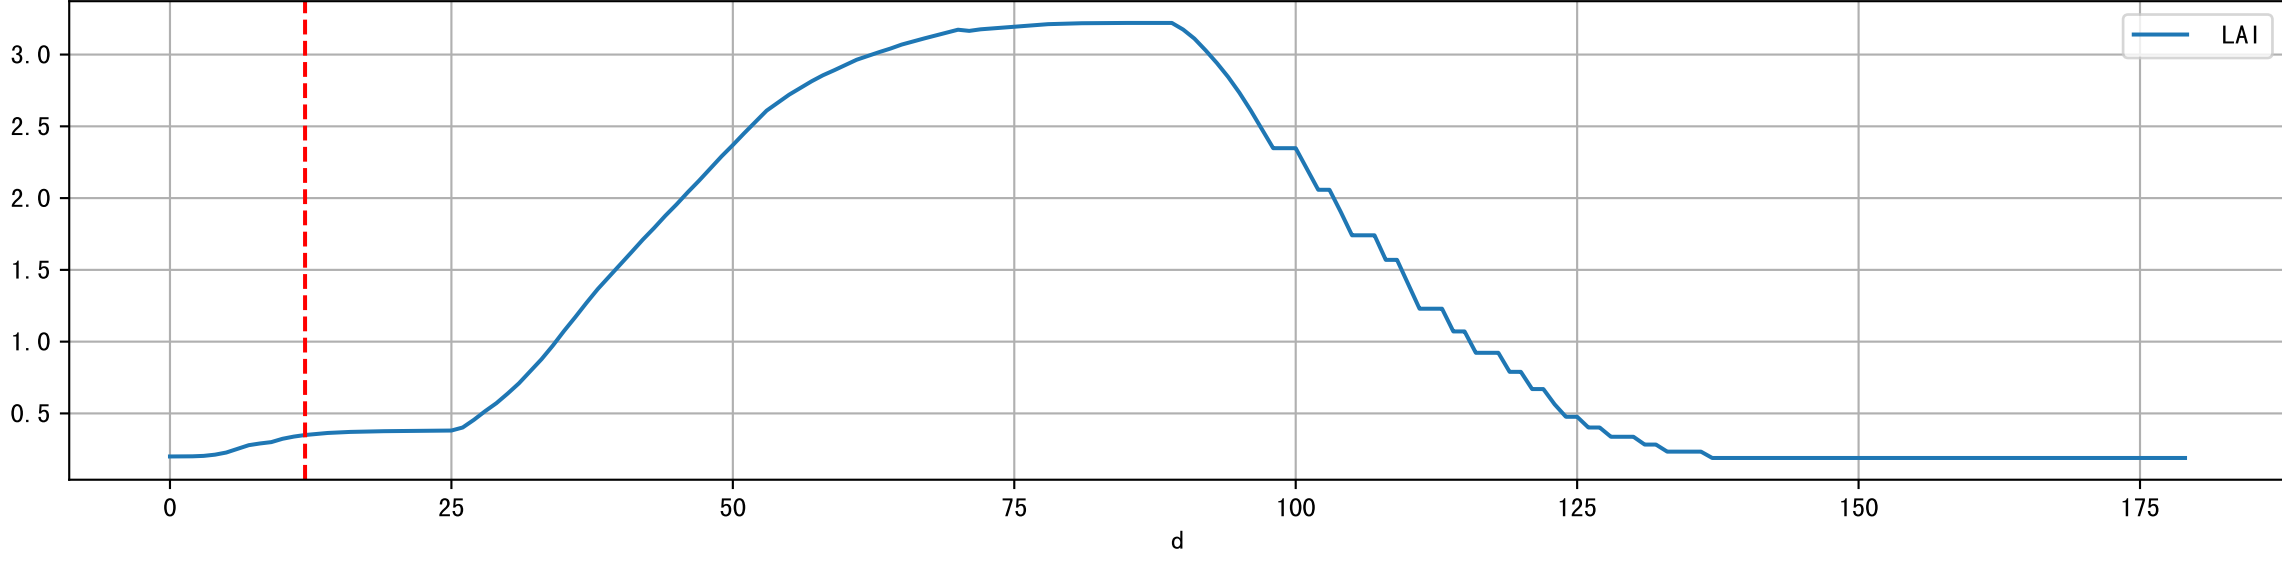
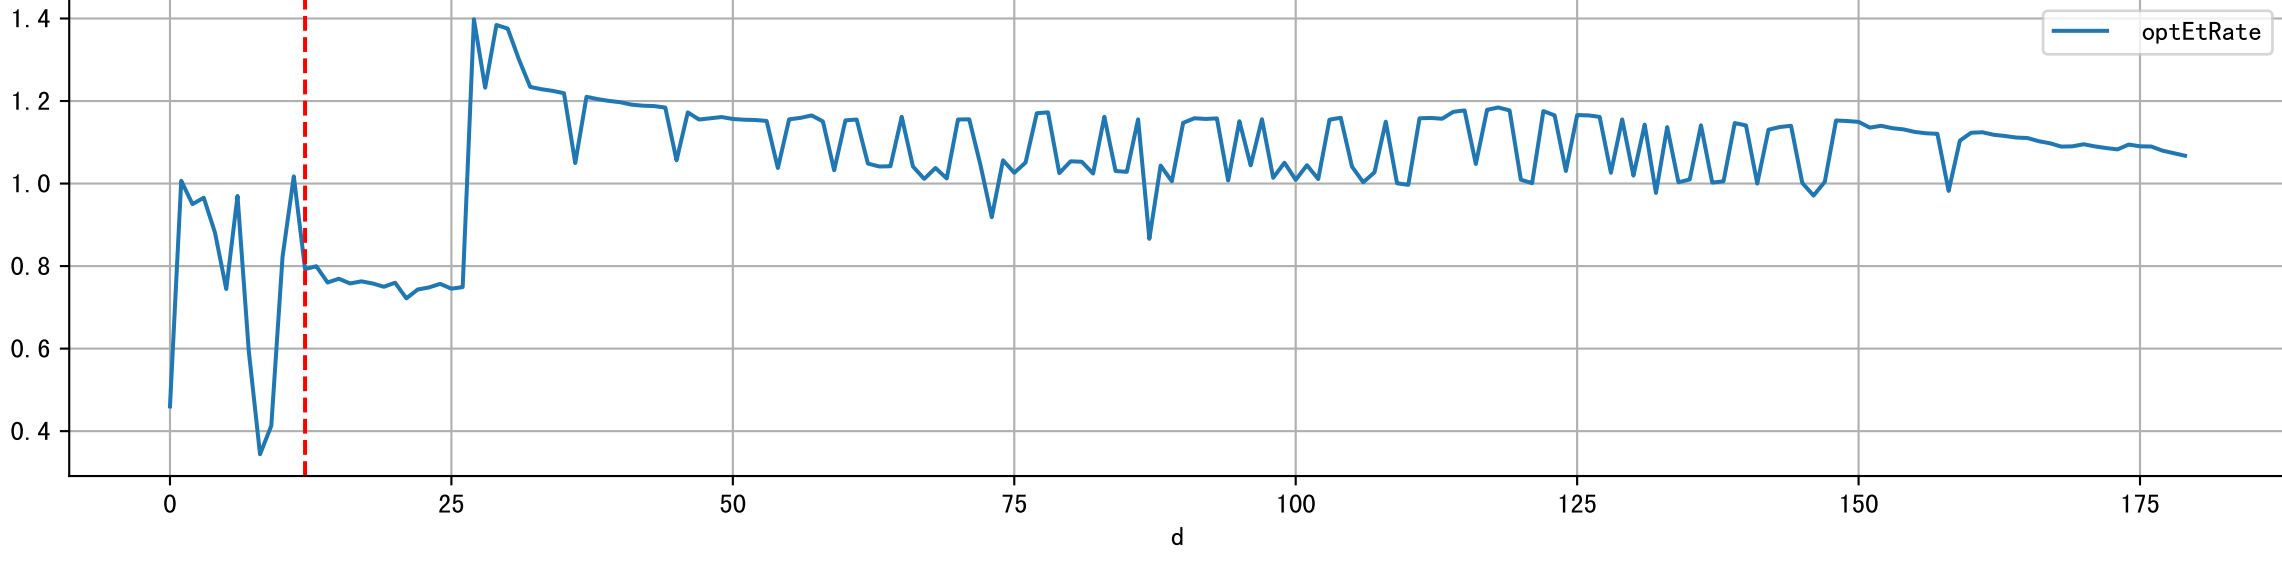
Plot [['I', 'Iopt'], ['T', 'Topt'], ['RH', 'RHopt'], ['ETcl', 'optETcl'], 'LAI', 'optEtRate']

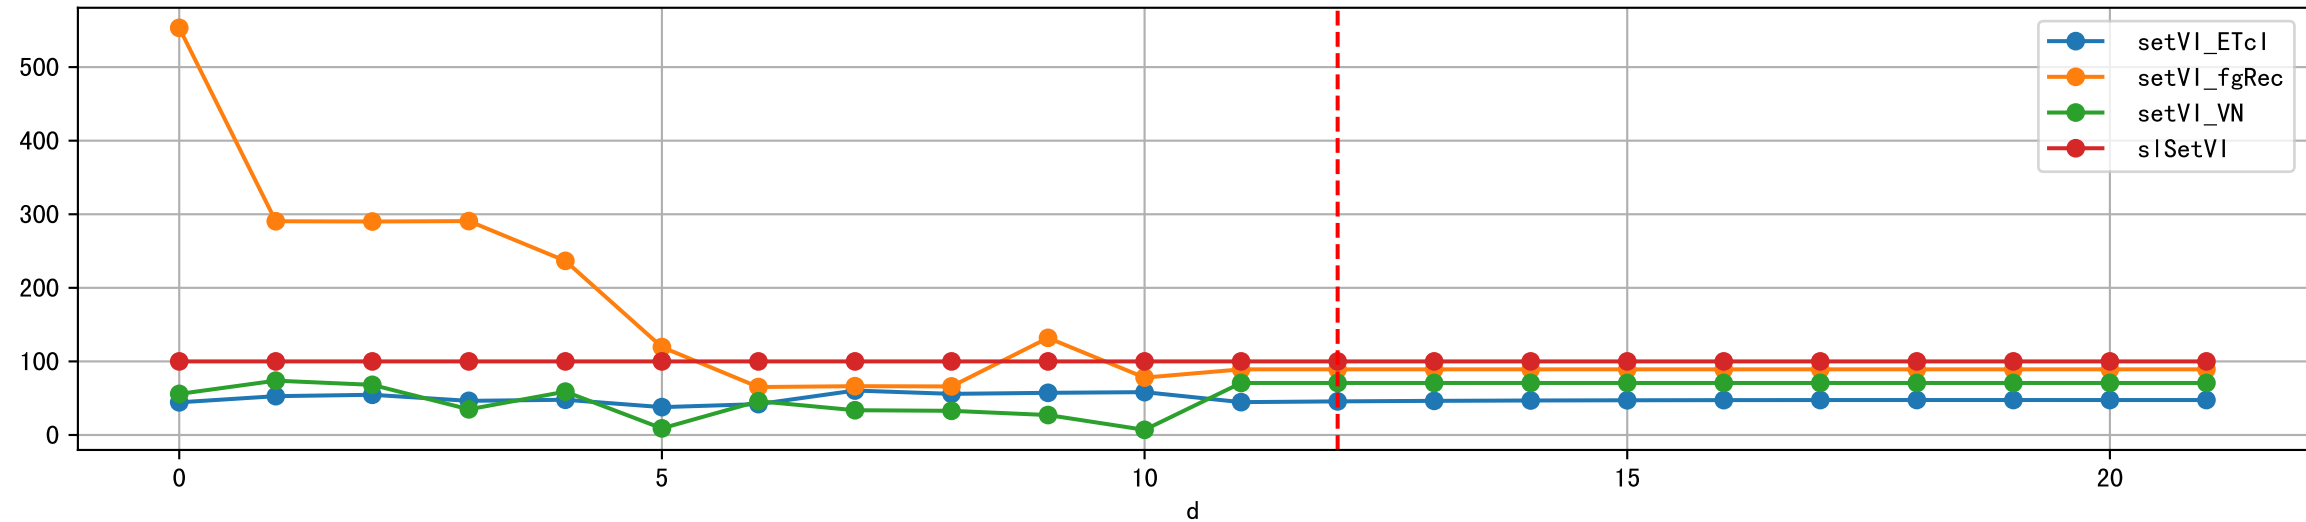
Plot [['setVI\_ETcI', 'setVI\_fgRec', 'setVI\_VN', 'sISetVI']]

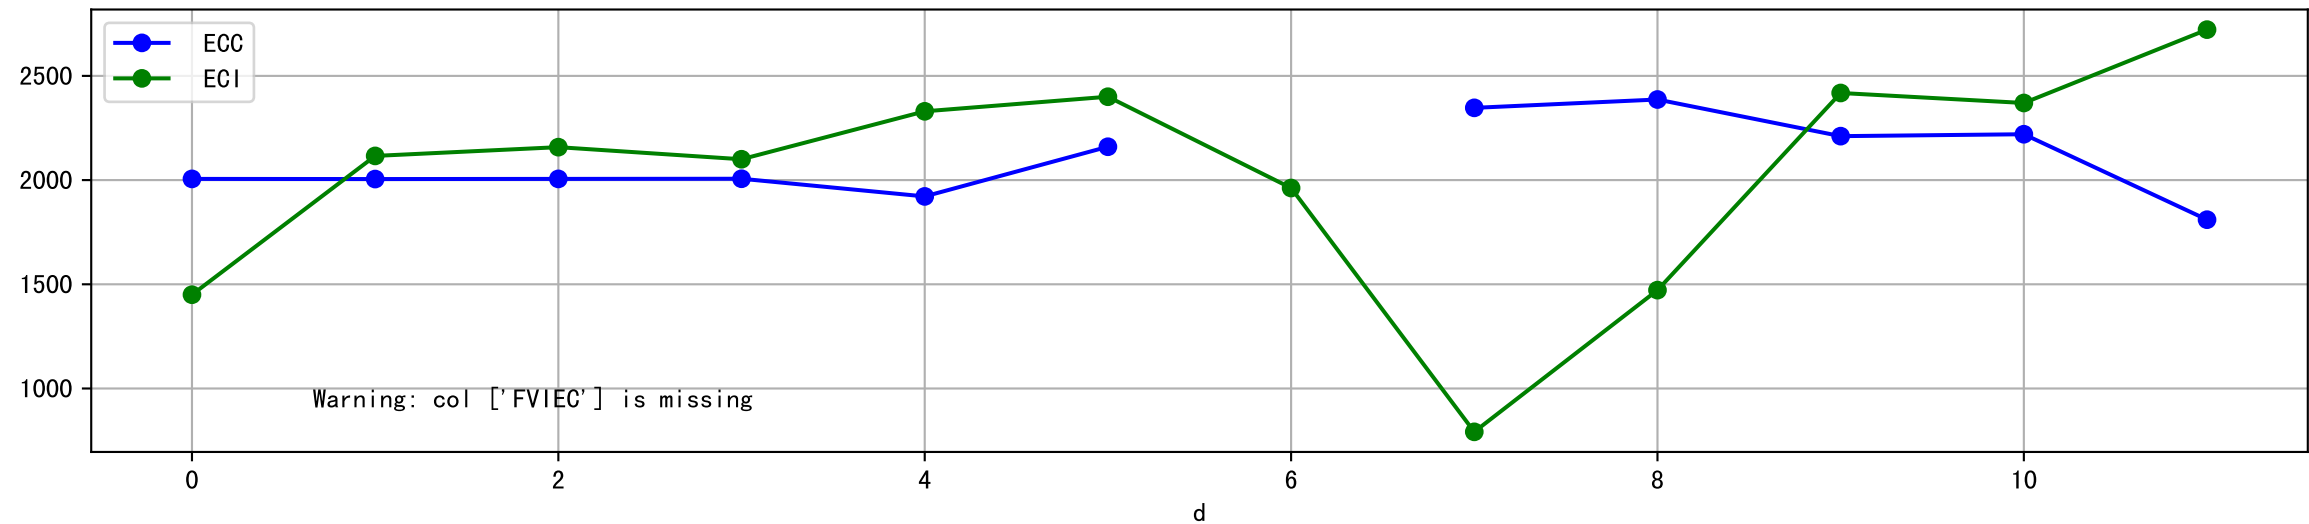
Plot [['ECC:b-o', 'FVIEC:r-o', 'ECI:g-o']]

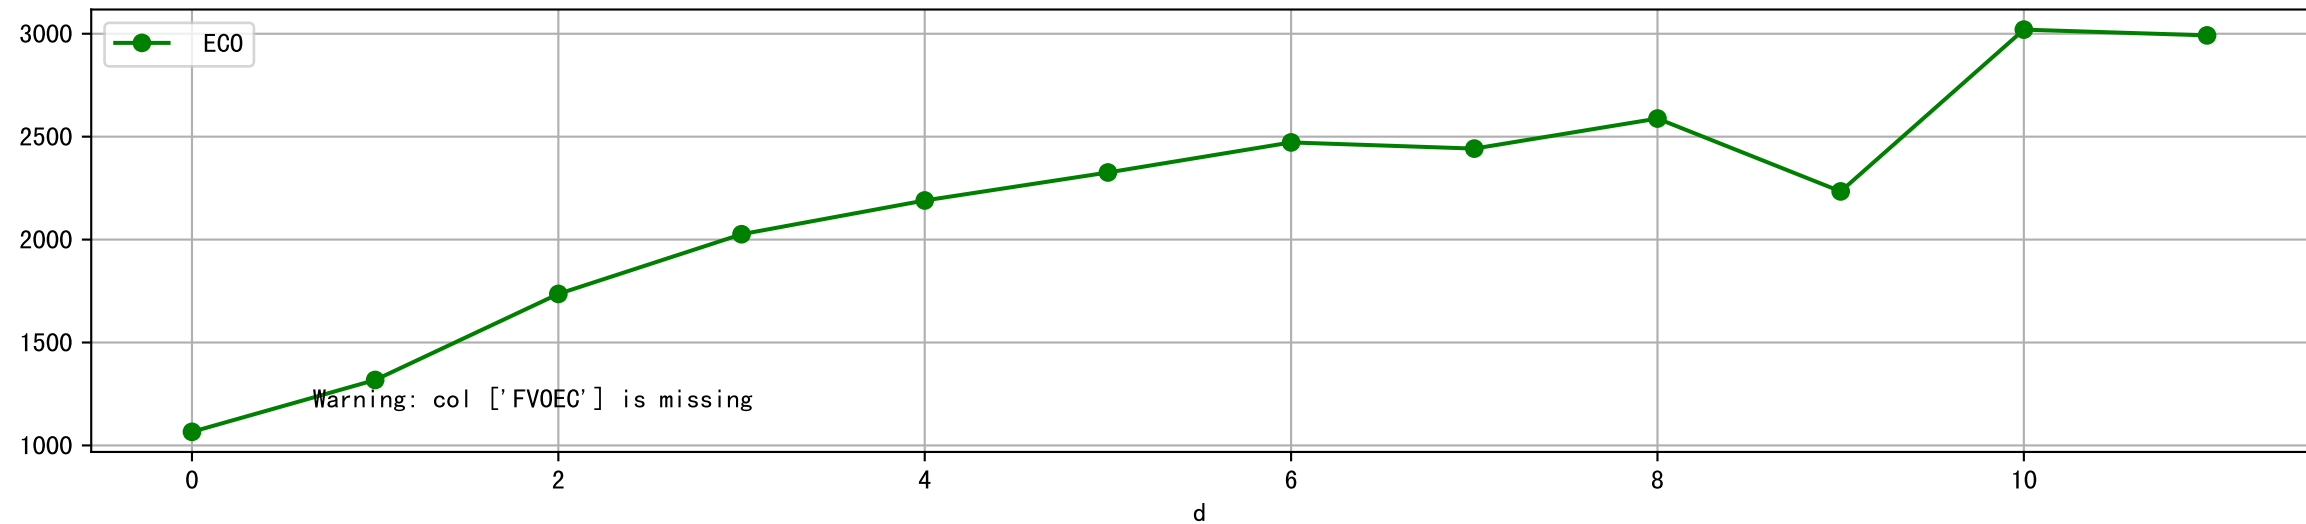
Plot [[' FV0EC:r-o', ' ECO:g-o' ]]

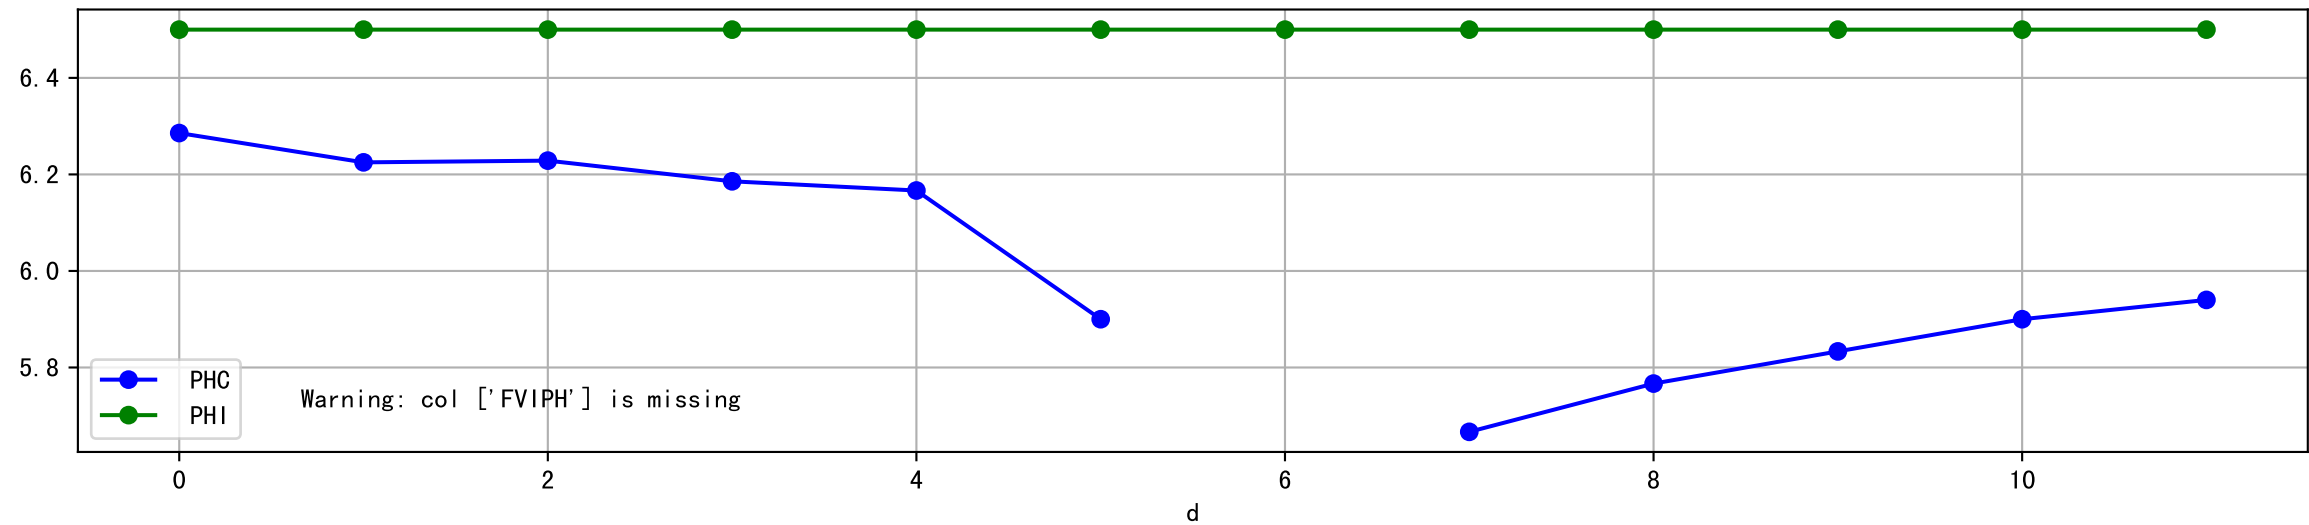
Plot [['PHC:b-o', 'FVIPH:r-o', 'PHI:g-o']]

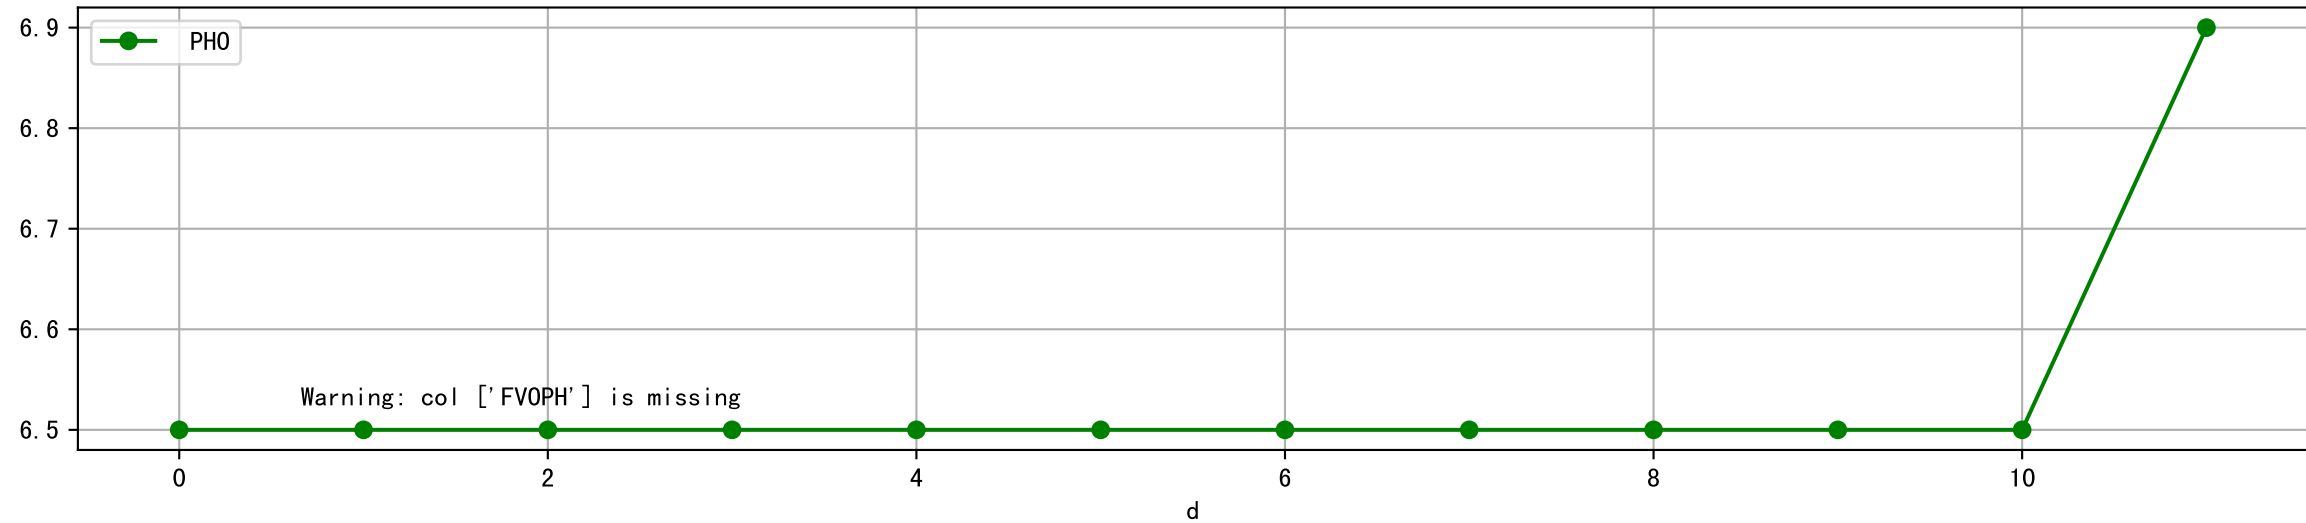
Plot [[' FVOPH:r-o' , ' PH0:g-o' ]]
