NC11 P5

2025-04-12 (Day 8)

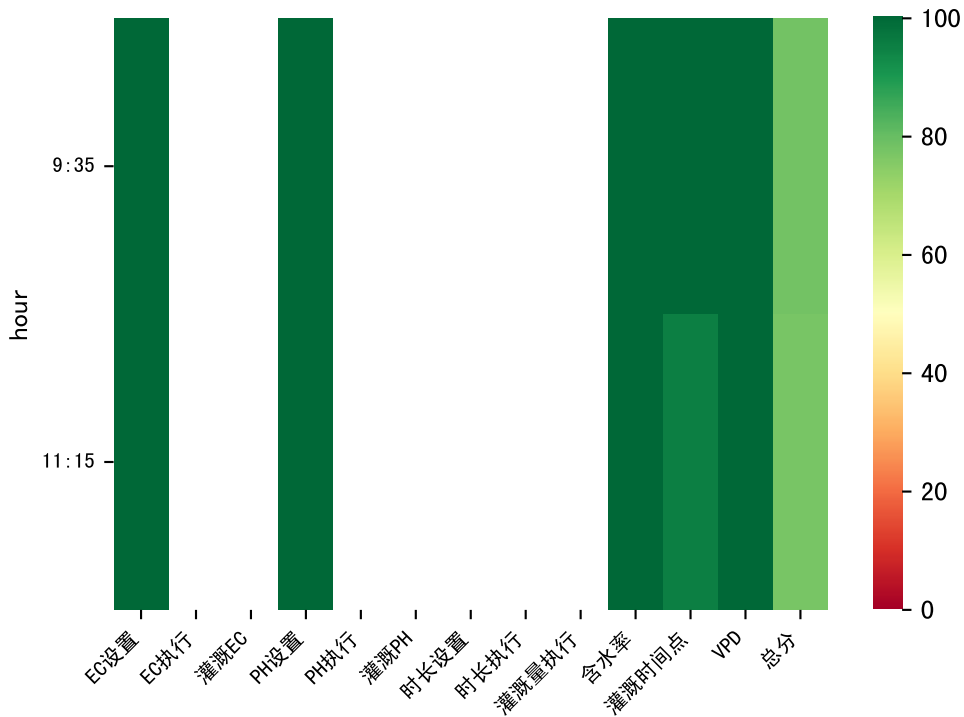
| 时间 | 灌溉时长(秒) | 灌溉量(毫升/株) | 天气 | 注释 |
| 09:35 | 120 | 100.0 | 雪 | 预期@09:35 (未用传感器) |
| 11:15 | 120 | 100.0 | 晴 | 预期@11:15 (未用传感器) |
| 总计 | 240.0 (2次) | 200.0 | | 建议进液EC: 2080.0, PH: 6.5 |

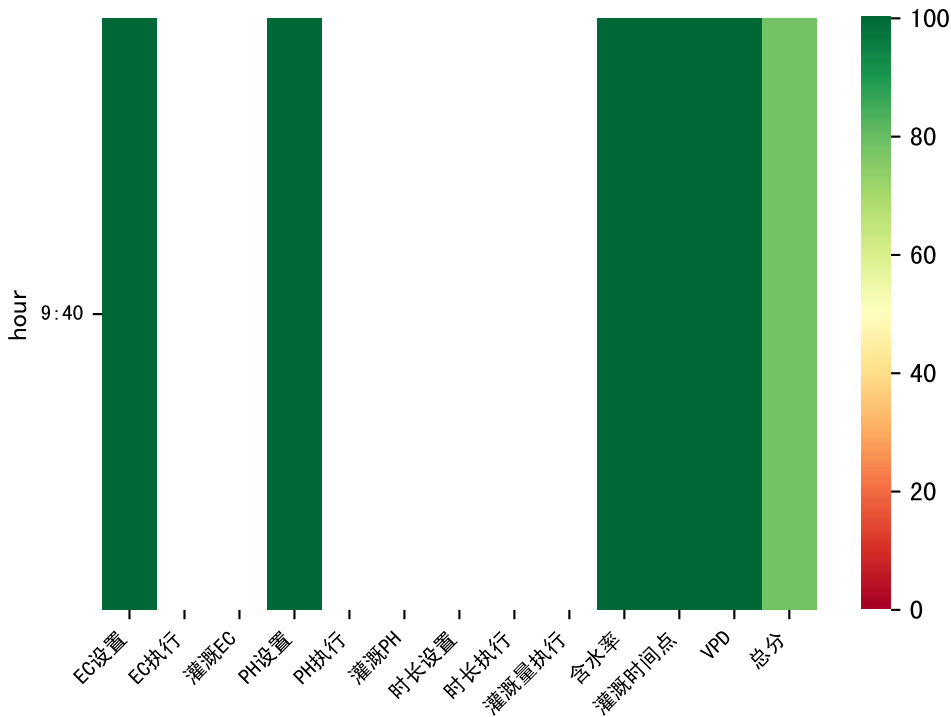
| 时间 | 灌溉时长(秒) | 灌溉量(毫升/株) | 天气 | 注释 |
| 09:40 | 70 | 100.0 | 多云 | 假设@09:40（未用传感器） |
| 总计 | 70.0（1次） | 100.0 | | 建议进液EC: 2080.0, PH: 6.5 |

滴头平均流速偏大（1.15），请检查  
上次灌溉流速比平时小（0.93 vs 1.15），可能有多阀同灌或管道堵塞或水压不足  
施肥机灌溉量与预期值不符（65.0：27.0），可能水表需要校准  
上次灌溉时长未按模型建议（70.0 vs 256.0）  
默认实际灌溉27.0 ml.  
上次灌溉EC（2430.0）与模型建议（2080.0）偏差较大，请检查。  
上次灌溉PH（5.5）与设定值（6.5）偏差较大，请检查。  
上次灌溉PH（5.5）与模型建议（6.5）偏差较大，请检查。

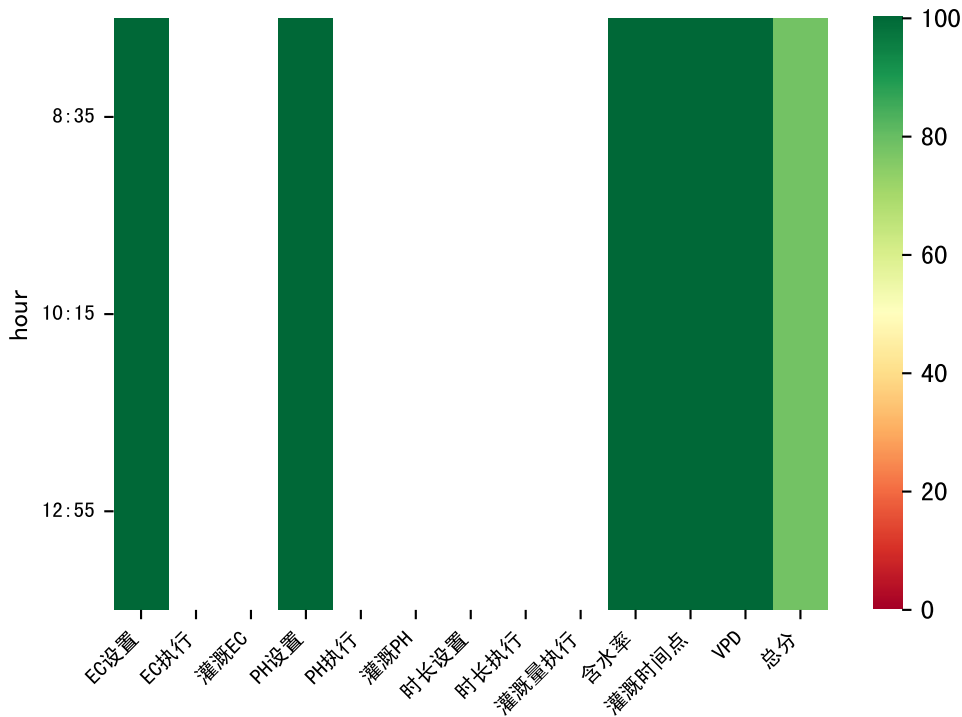
| 时间 | 灌溉时长(秒) | 灌溉量(毫升/株) | 天气 | 注释 |
| 08:35 | 70 | 100.0 | 多云 | 假设@08:35（未用传感器） |
| 10:15 | 70 | 100.0 | 多云 | 假设@10:15（未用传感器） |
| 12:55 | 70 | 100.0 | 多云 | 假设@12:55（未用传感器） |
| 总计 | 210.0（3次） | 300.0 | | 建议进液EC：2080.0， PH： 6.5 |

滴头平均流速偏大（1.38），请检查  
上次灌溉流速比平时小（0.92 vs 1.38），可能有多阀同灌或管道堵塞或水压不足  
施肥机灌溉量与预期值不符（64.0 ： 27.0），可能水表需要校准  
上次灌溉时长未按模型建议（70.0 vs 256.0）  
默认实际灌溉27.0 ml.

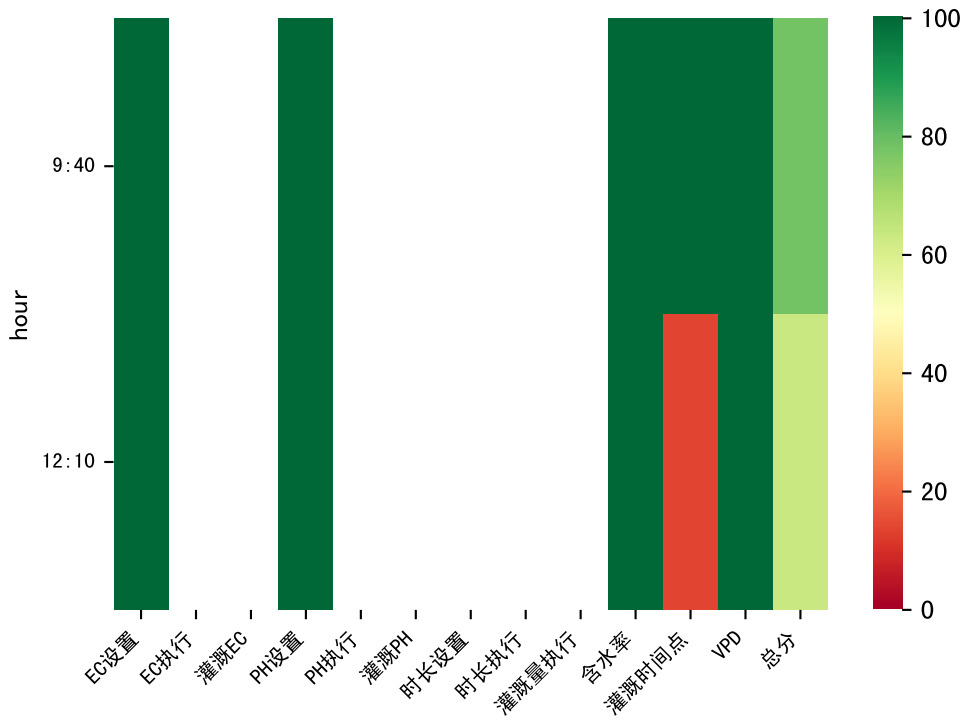
| 时间 | 灌溉时长(秒) | 灌溉量(毫升/株) | 天气 | 注释 |
| 09:40 | 161 | 100.0 | 阴 | 假设@09:40（未用传感器） |
| 12:10 | 161 | 100.0 | 晴 | 假设@12:10（未用传感器） |
| 总计 | 322.0（2次） | 200.0 | | 建议进液EC：2117.0， PH： 6.5 |

滴头平均流速偏大（1.38），请检查  
上次灌溉流速比平时小（0.9 vs 1.38），可能有多阀同灌或管道堵塞或水压不足  
施肥机灌溉量与预期值不符（109.0 ： 47.0），可能水表需要校准  
上次灌溉时长未按模型建议（120.0 vs 256.0）  
默认实际灌溉47.0 ml.  
回液EC（2108.0 vs 2185）偏低

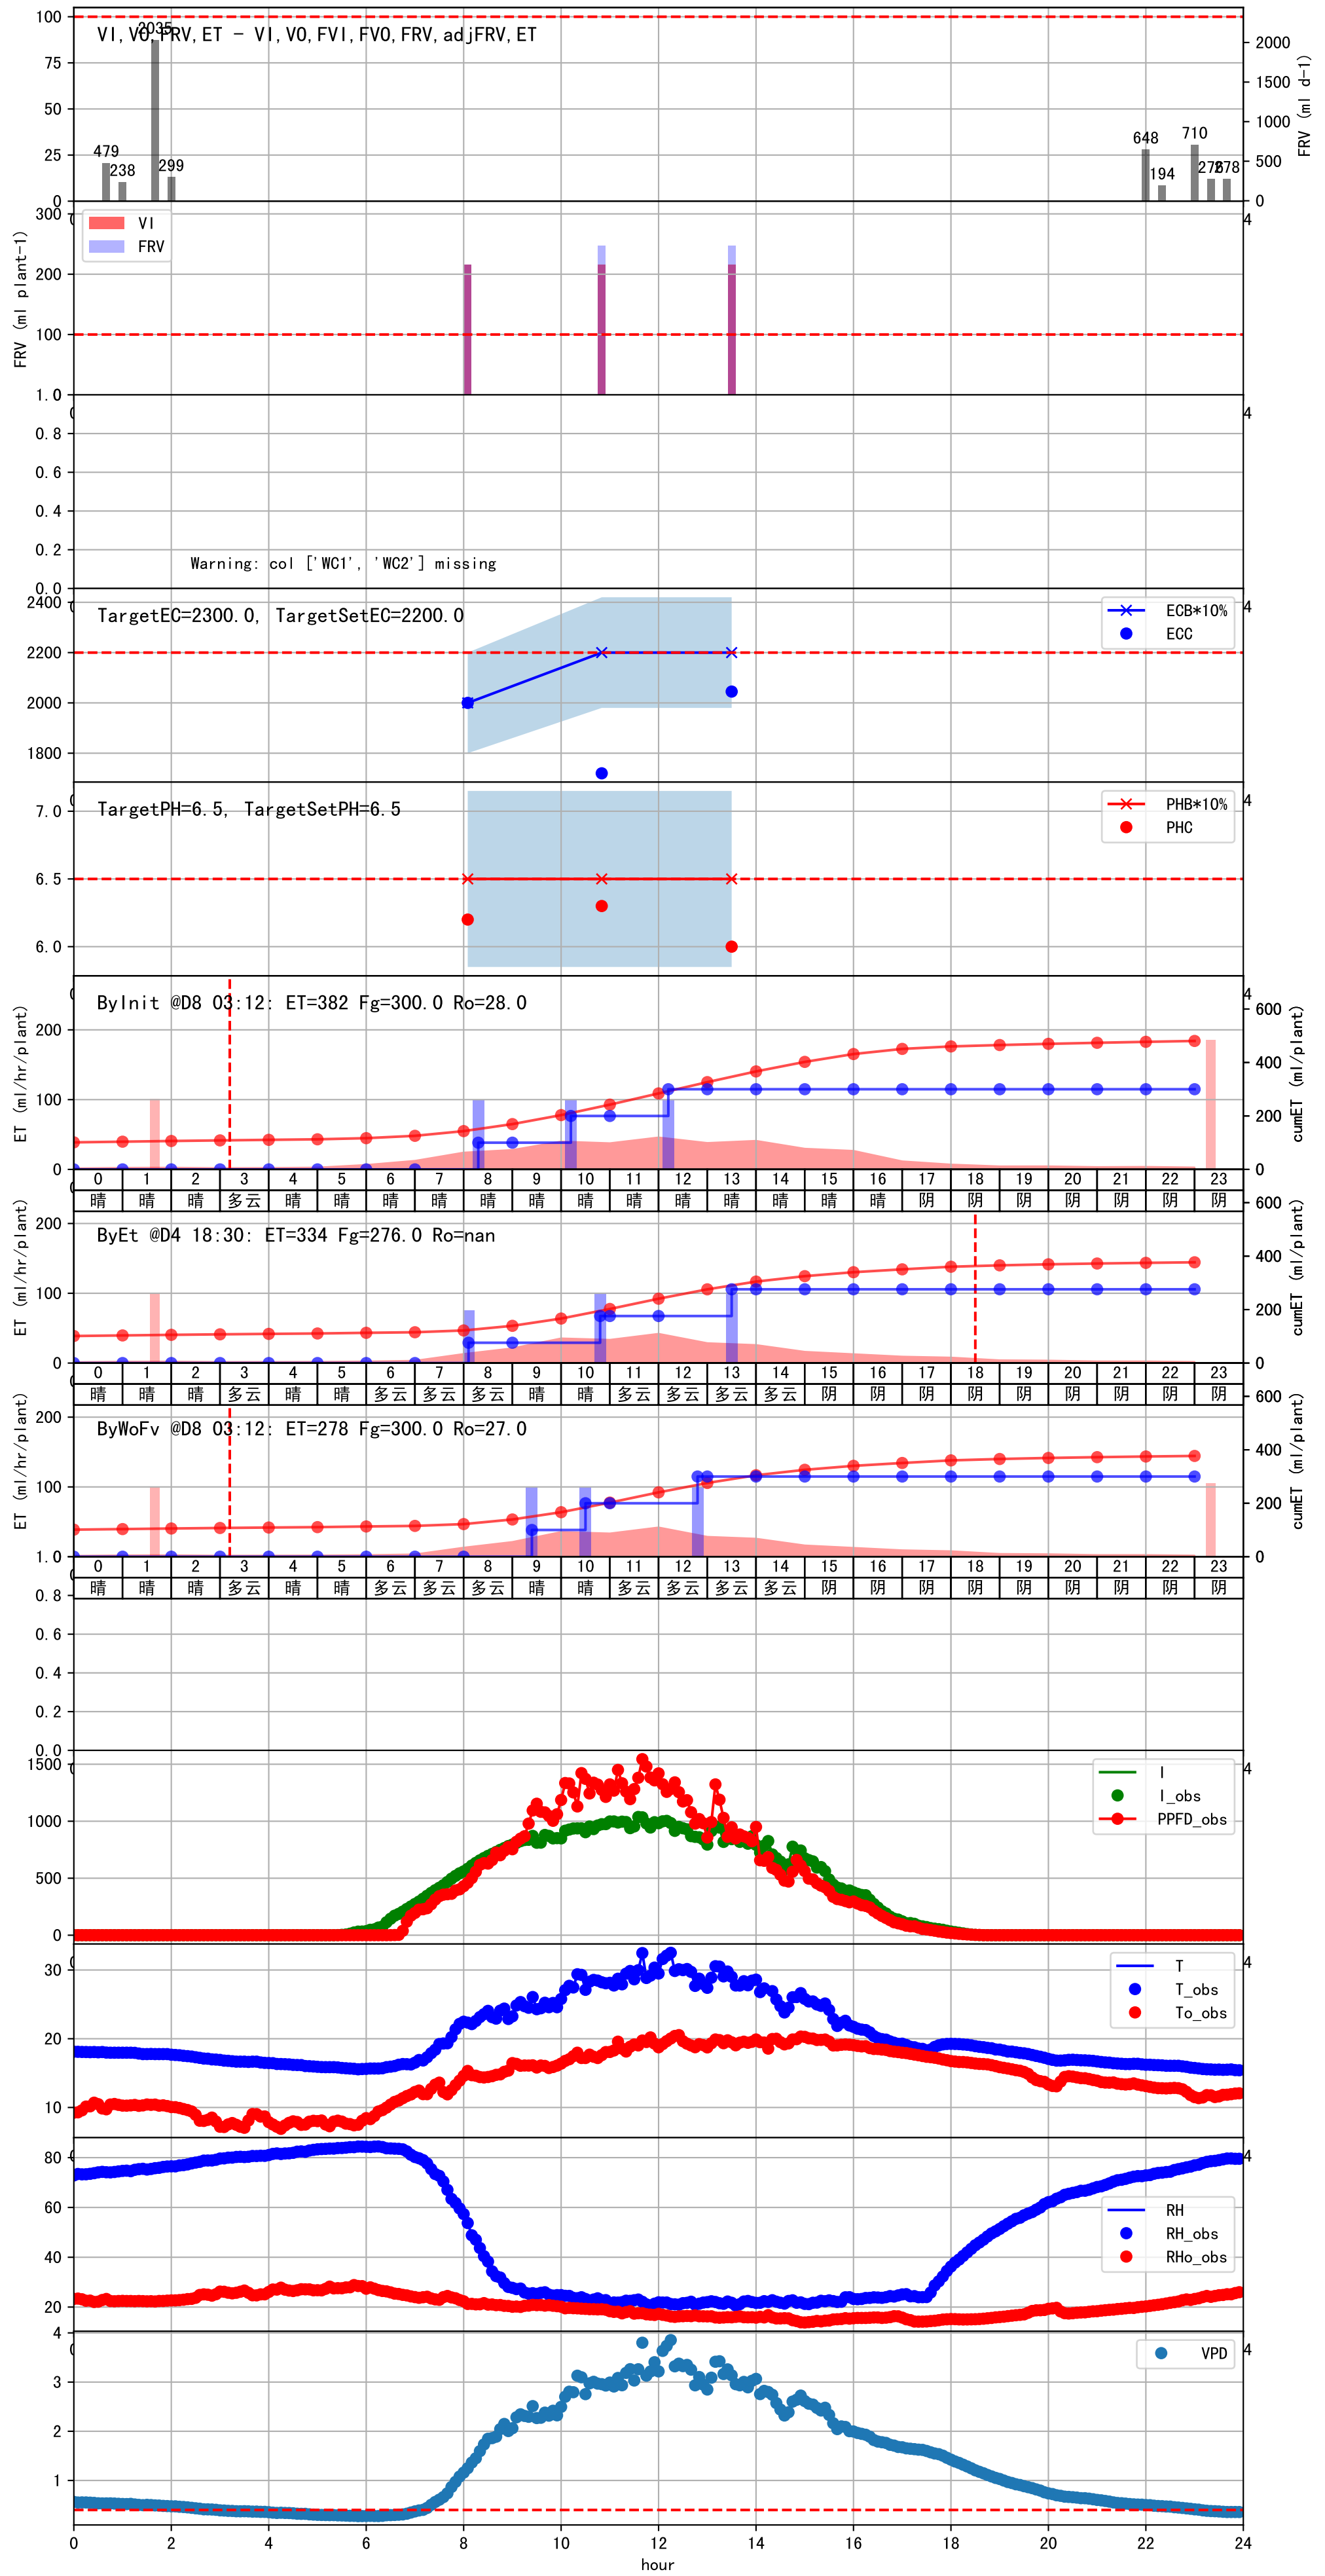
滴头平均流速偏大（1.38），请检查  
上次灌溉流速比平时小（0.89 vs 1.38），可能有多阀同灌或管道堵塞或水压不足  
施肥机灌溉量与预期值不符（247.0：100.0），可能水表需要校准  
默认实际灌溉100.0 ml.  
回液EC（1881.0 vs 2185）偏低
