NC11 P5

2025-04-13 (Day 9)

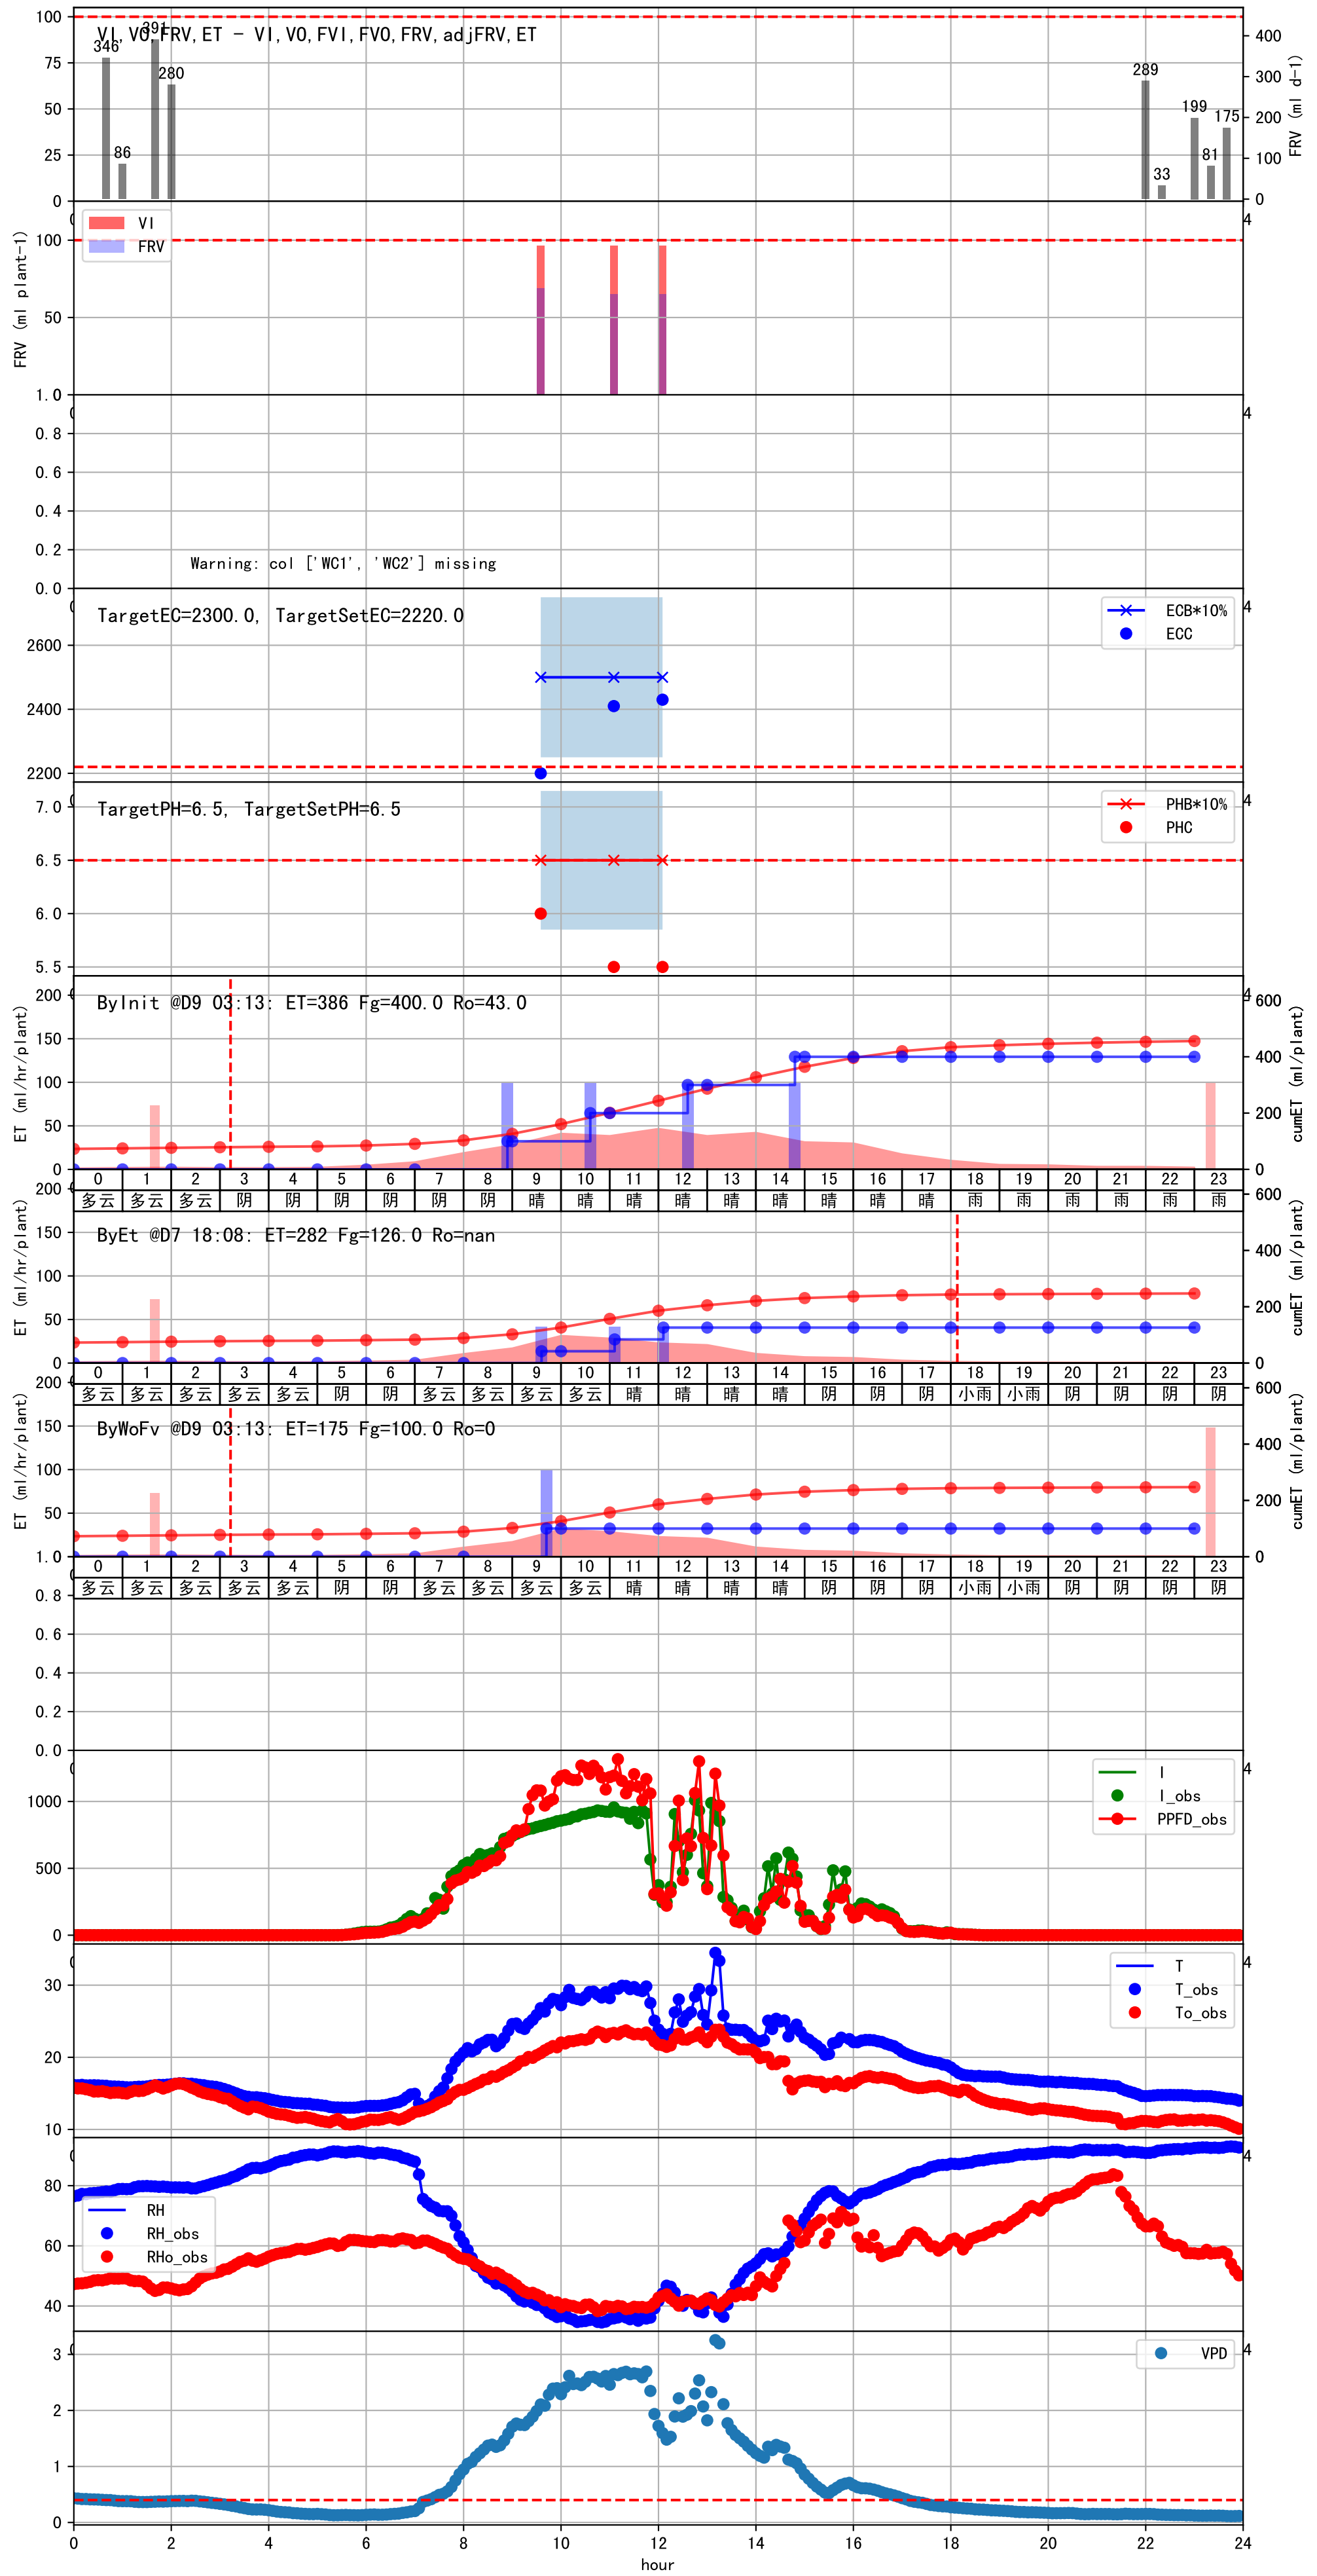
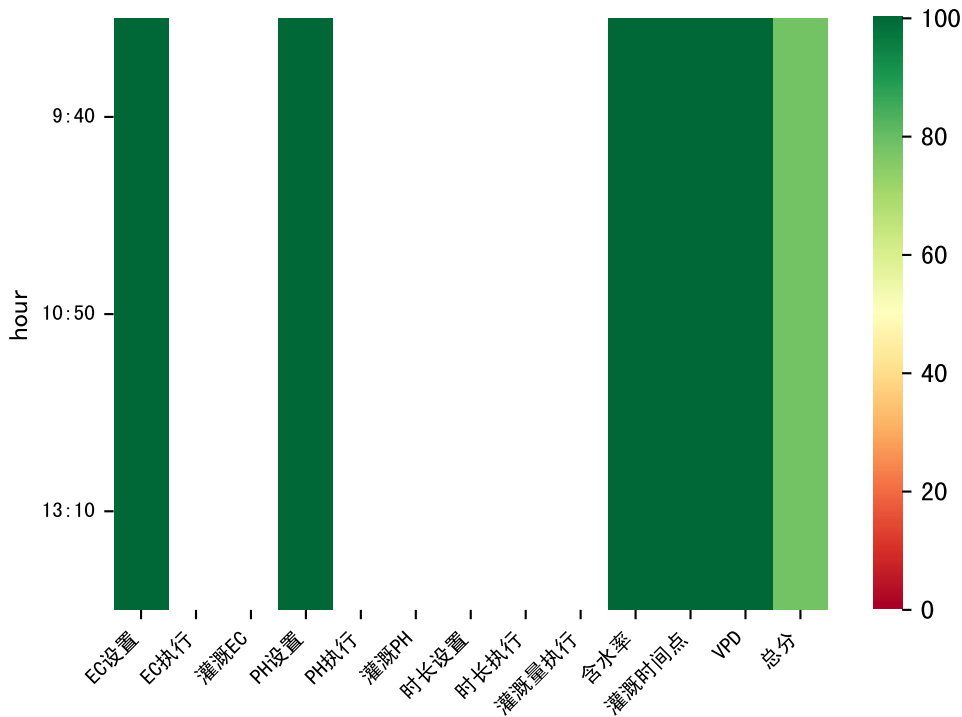
滴头平均流速偏大（1.15），请检查  
上次灌溉流速比平时小（0.93 vs 1.15），可能有多阀同灌或管道堵塞或水压不足  
施肥机灌溉量与预期值不符（65.0：27.0），可能水表需要校准  
上次灌溉时长未按模型建议（70.0 vs 256.0）  
默认实际灌溉27.0 ml.  
上次灌溉PH（5.5）与设定值（6.5）偏差较大，请检查。  
上次灌溉PH（5.5）与模型建议（6.5）偏差较大，请检查。

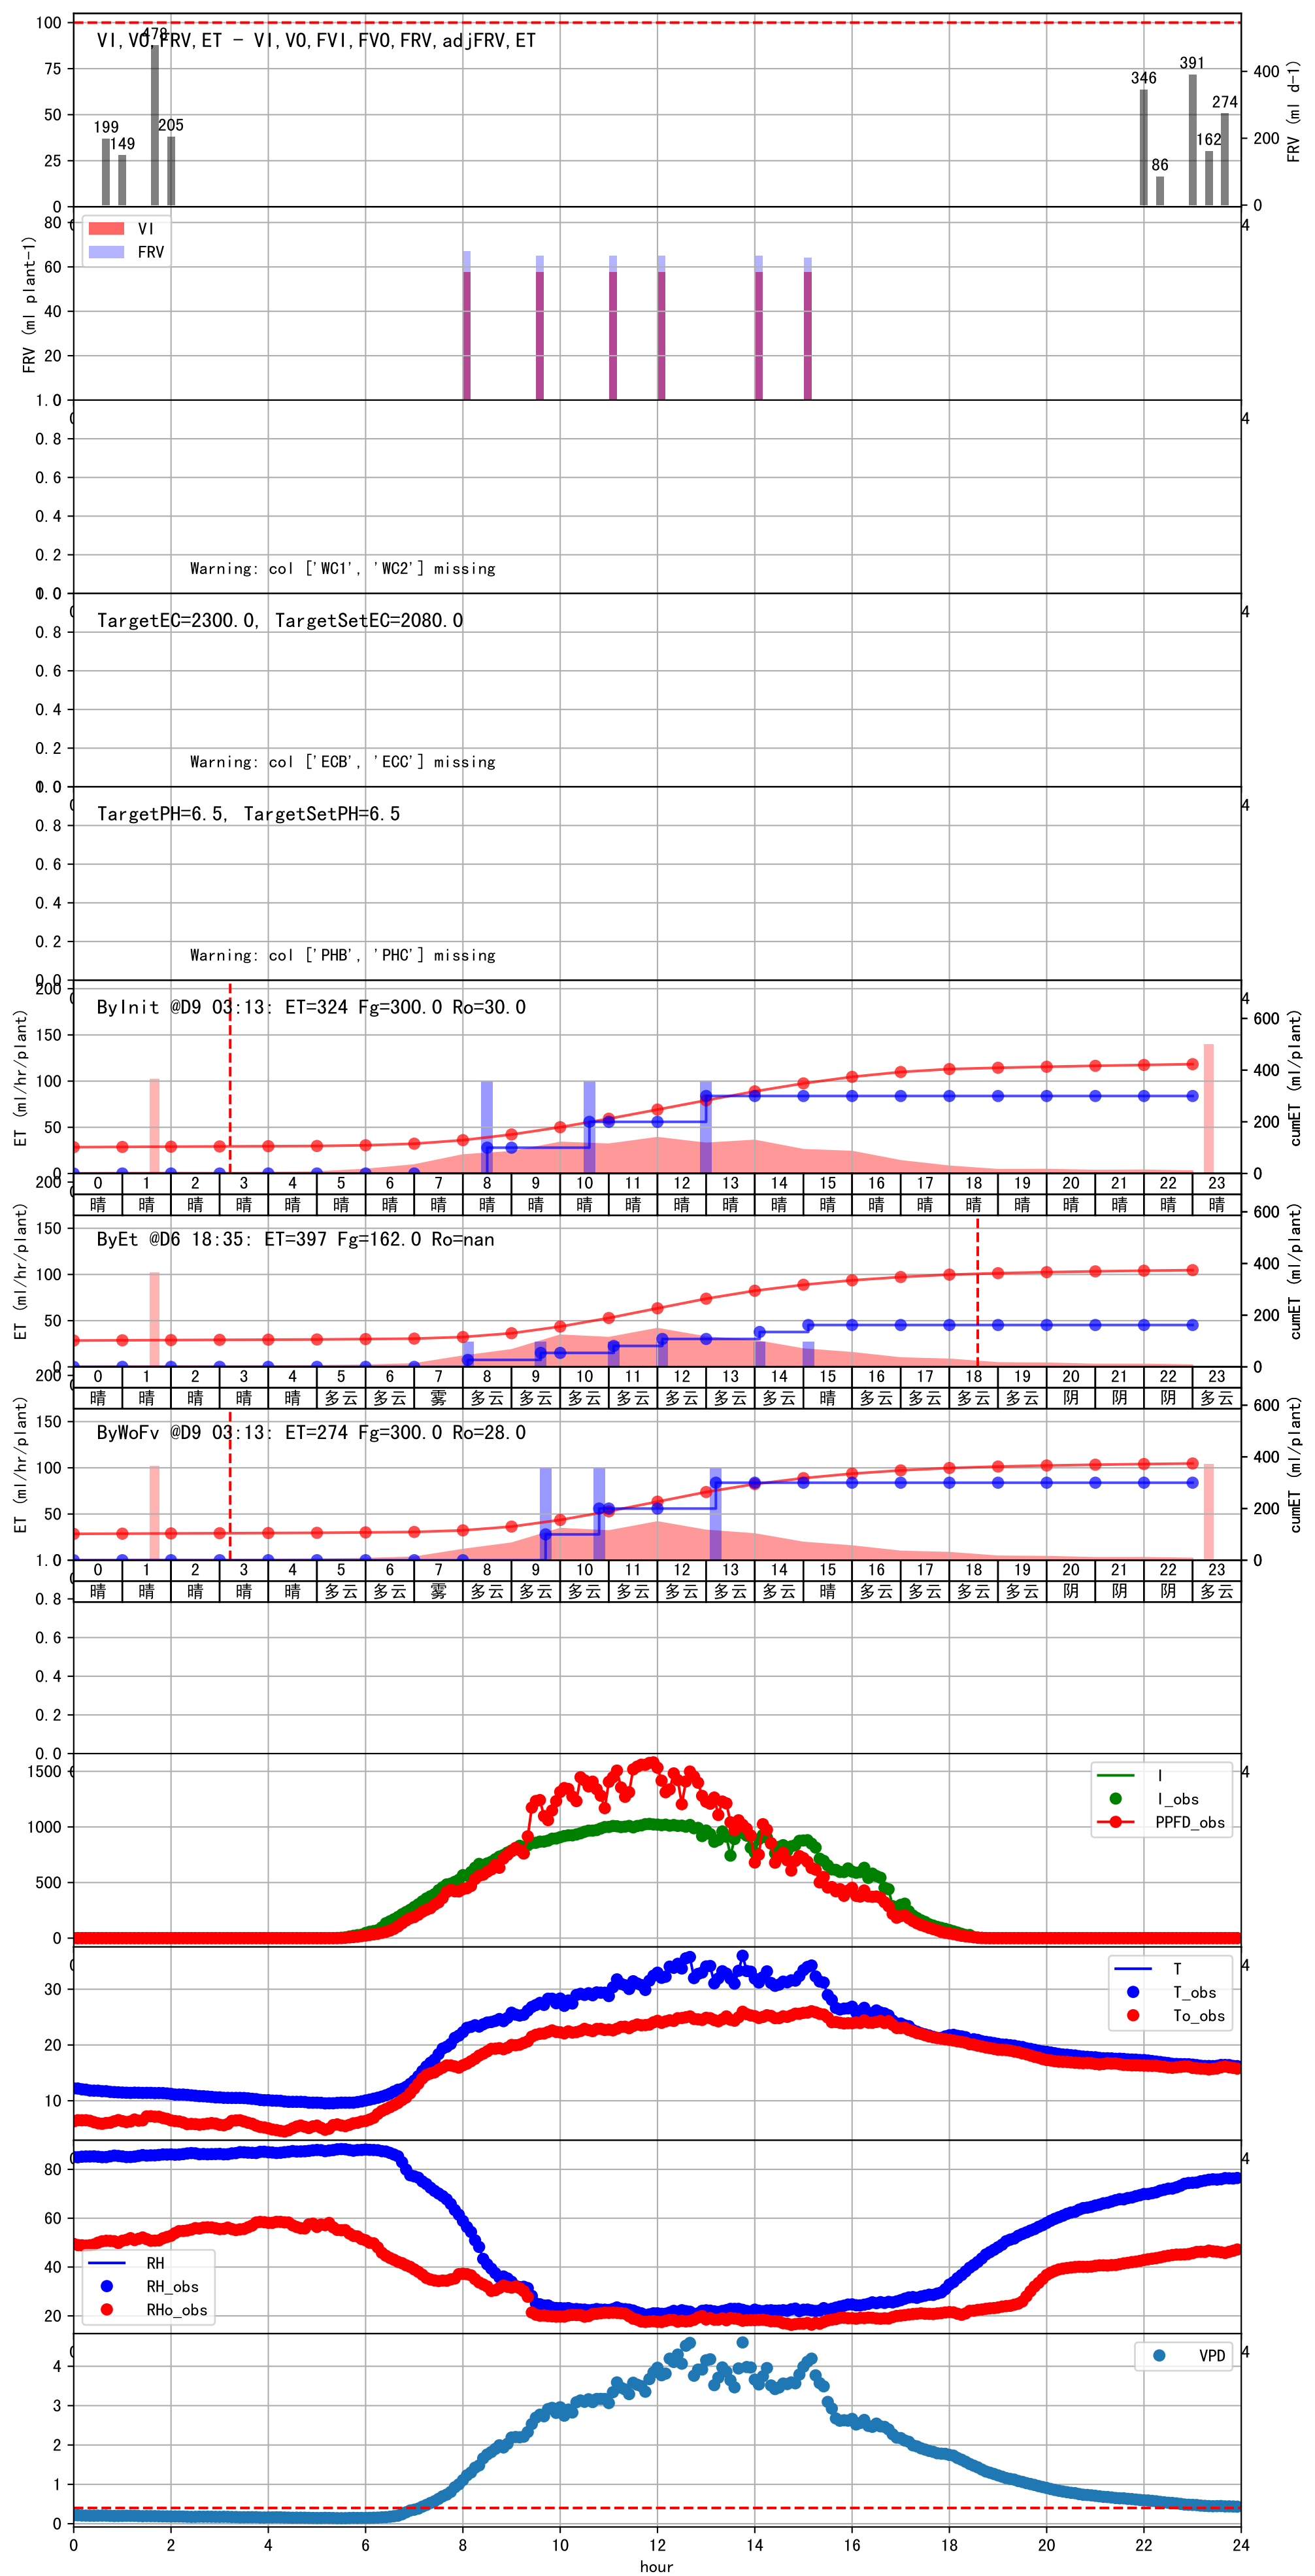
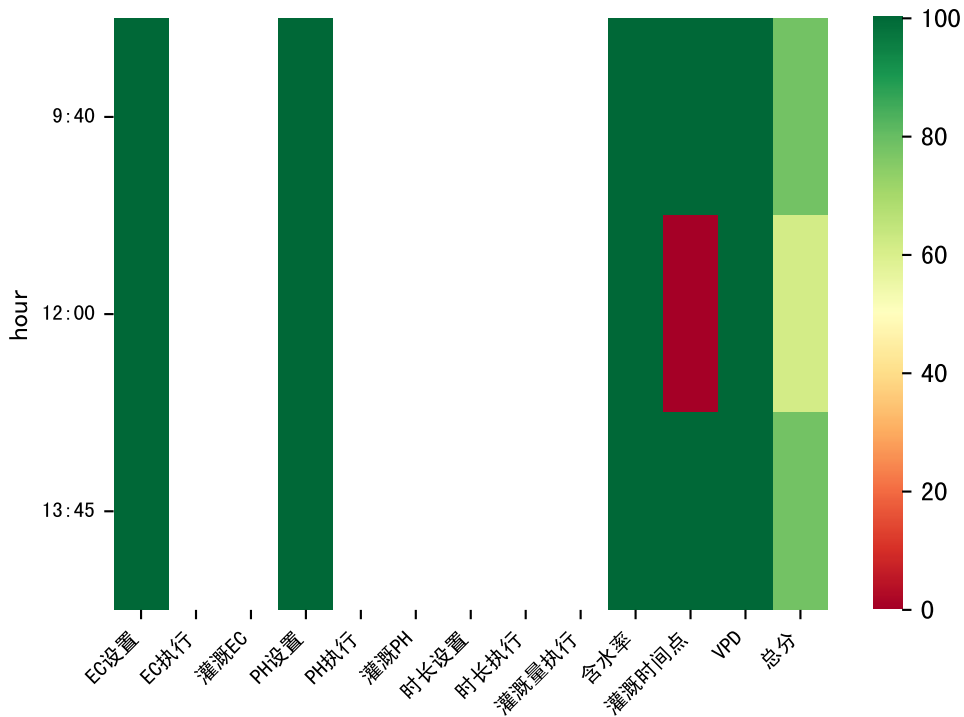
滴头平均流速偏大（1.38），请检查  
上次灌溉流速比平时小（0.92 vs 1.38），可能有多阀同灌或管道堵塞或水压不足  
施肥机灌溉量与预期值不符（64.0 ： 27.0），可能水表需要校准  
上次灌溉时长未按模型建议（70.0 vs 256.0）  
默认实际灌溉27.0 ml.

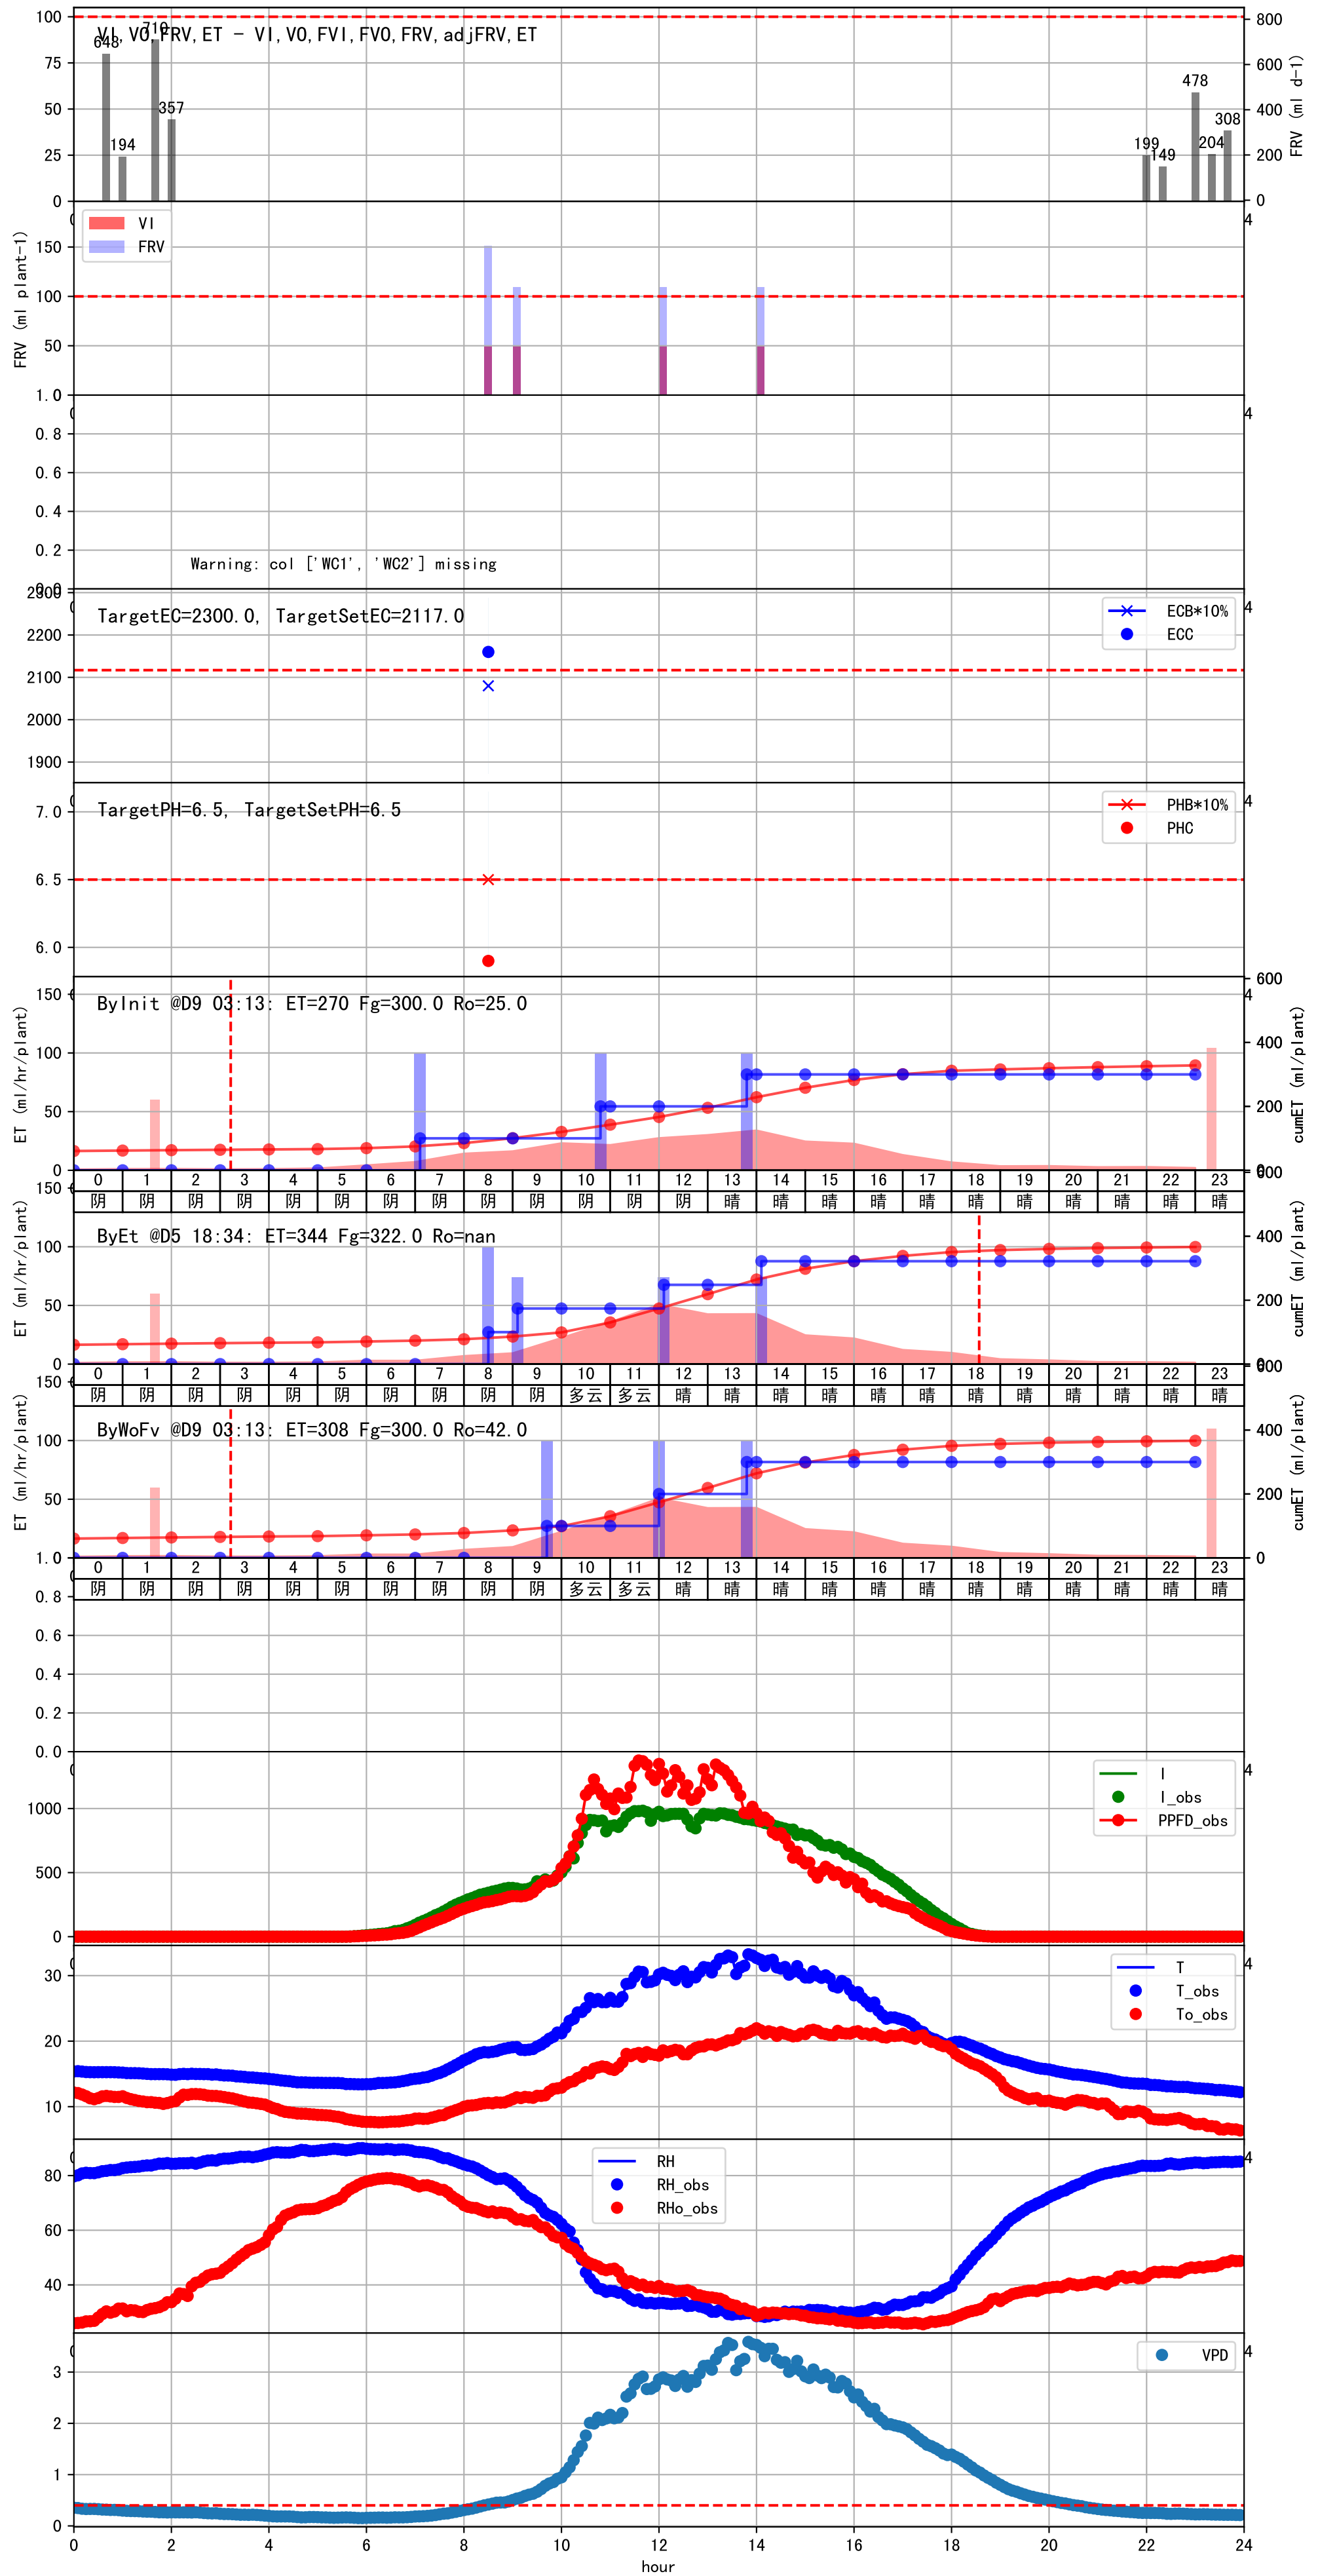
滴头平均流速偏大（1.38），请检查  
上次灌溉流速比平时小（0.9 vs 1.38），可能有多阀同灌或管道堵塞或水压不足  
施肥机灌溉量与预期值不符（109.0 ： 47.0），可能水表需要校准  
上次灌溉时长未按模型建议（120.0 vs 256.0）  
默认实际灌溉47.0 ml.  
回液EC（2108.0 vs 2185）偏低
