FgArea: [' C4']
NJ15 L1
2026-03-08 (Day 153)

Trend plot for L1AC4_C4

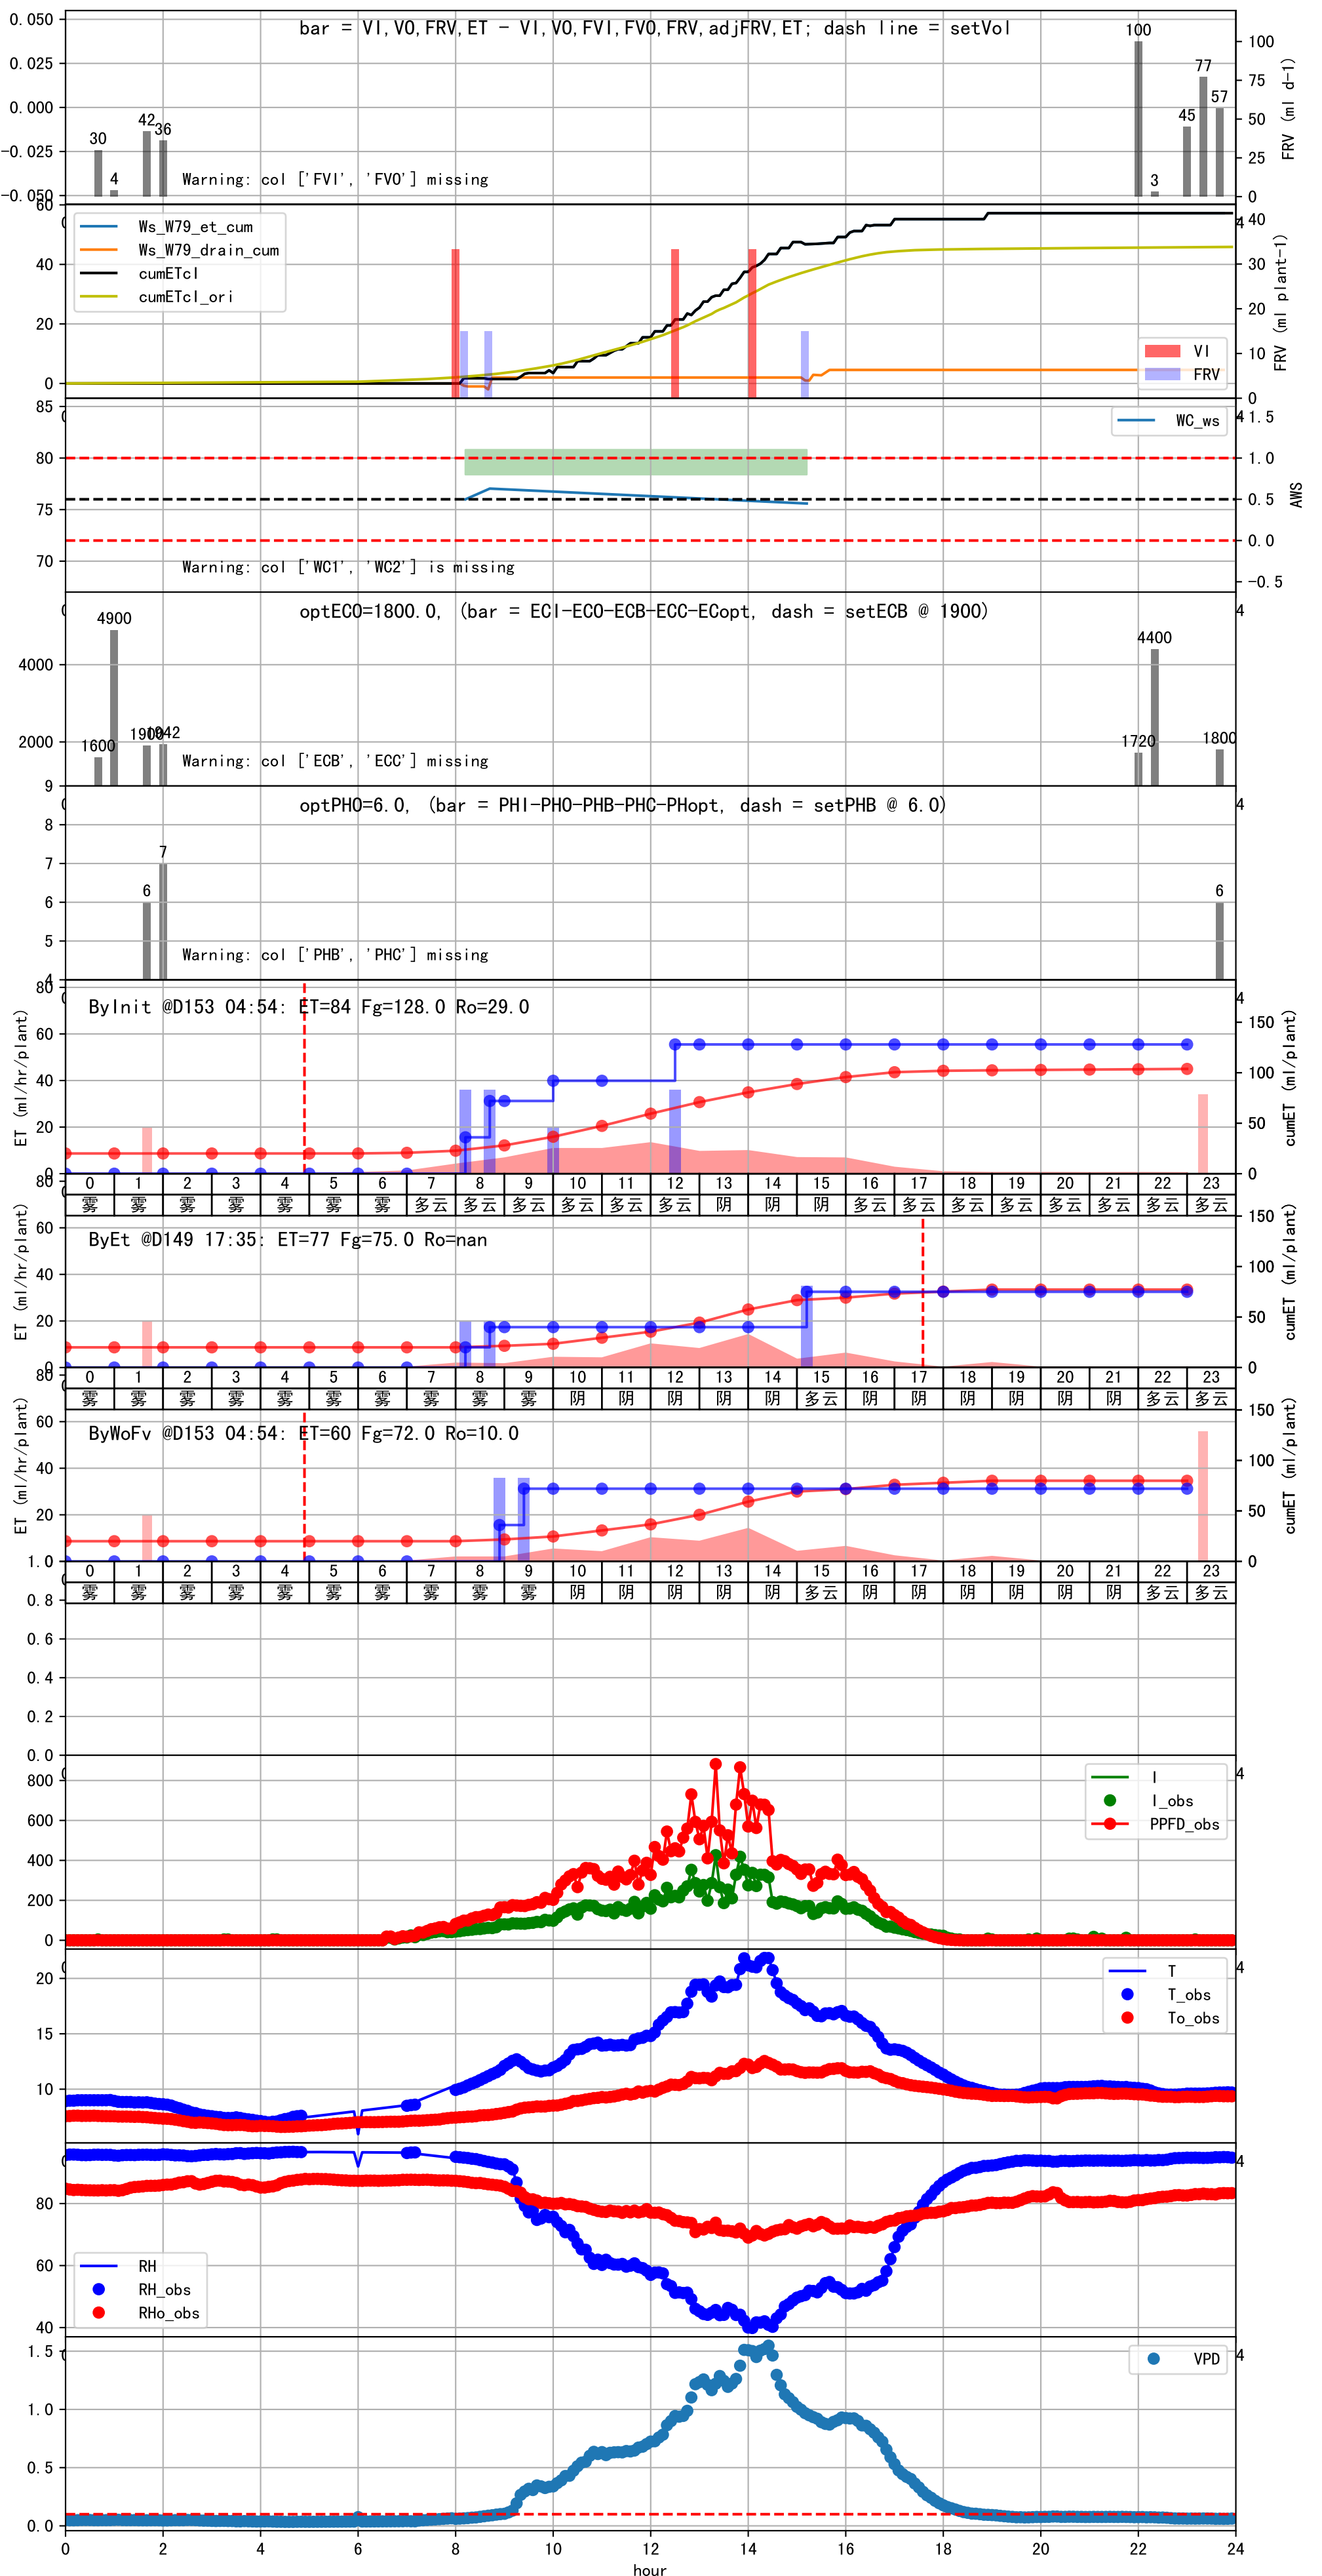
A阀开关时间(秒)	B阀开
: 5, '关' : 14, '占空比' : 50.0}, ['开' : 35, '关' : 44, '占空比' : 50.0]	[['开' : 15, '关' : 24, '占空比' : 50.0
: 5, '关' : 14, '占空比' : 50.0}, ['开' : 35, '关' : 44, '占空比' : 50.0]	[['开' : 15, '关' : 24, '占空比' : 50.0

上次灌溉流速比过去5天平均小 (0.2 vs 0.6), 可能管道压力异常或有管道堵塞
 施肥机灌溉量与预期值不符 (15.0 : 36.0), 可能水表需要校准
 默认实际灌溉36.0 ml.
 上次灌溉施肥机流速0.20485086856768273与平均值0.6偏差较大, 请检查。
