FgArea: [' C4']
NJ15 L1
2026-04-05 (Day 181)

Trend plot for L1AC4_C4

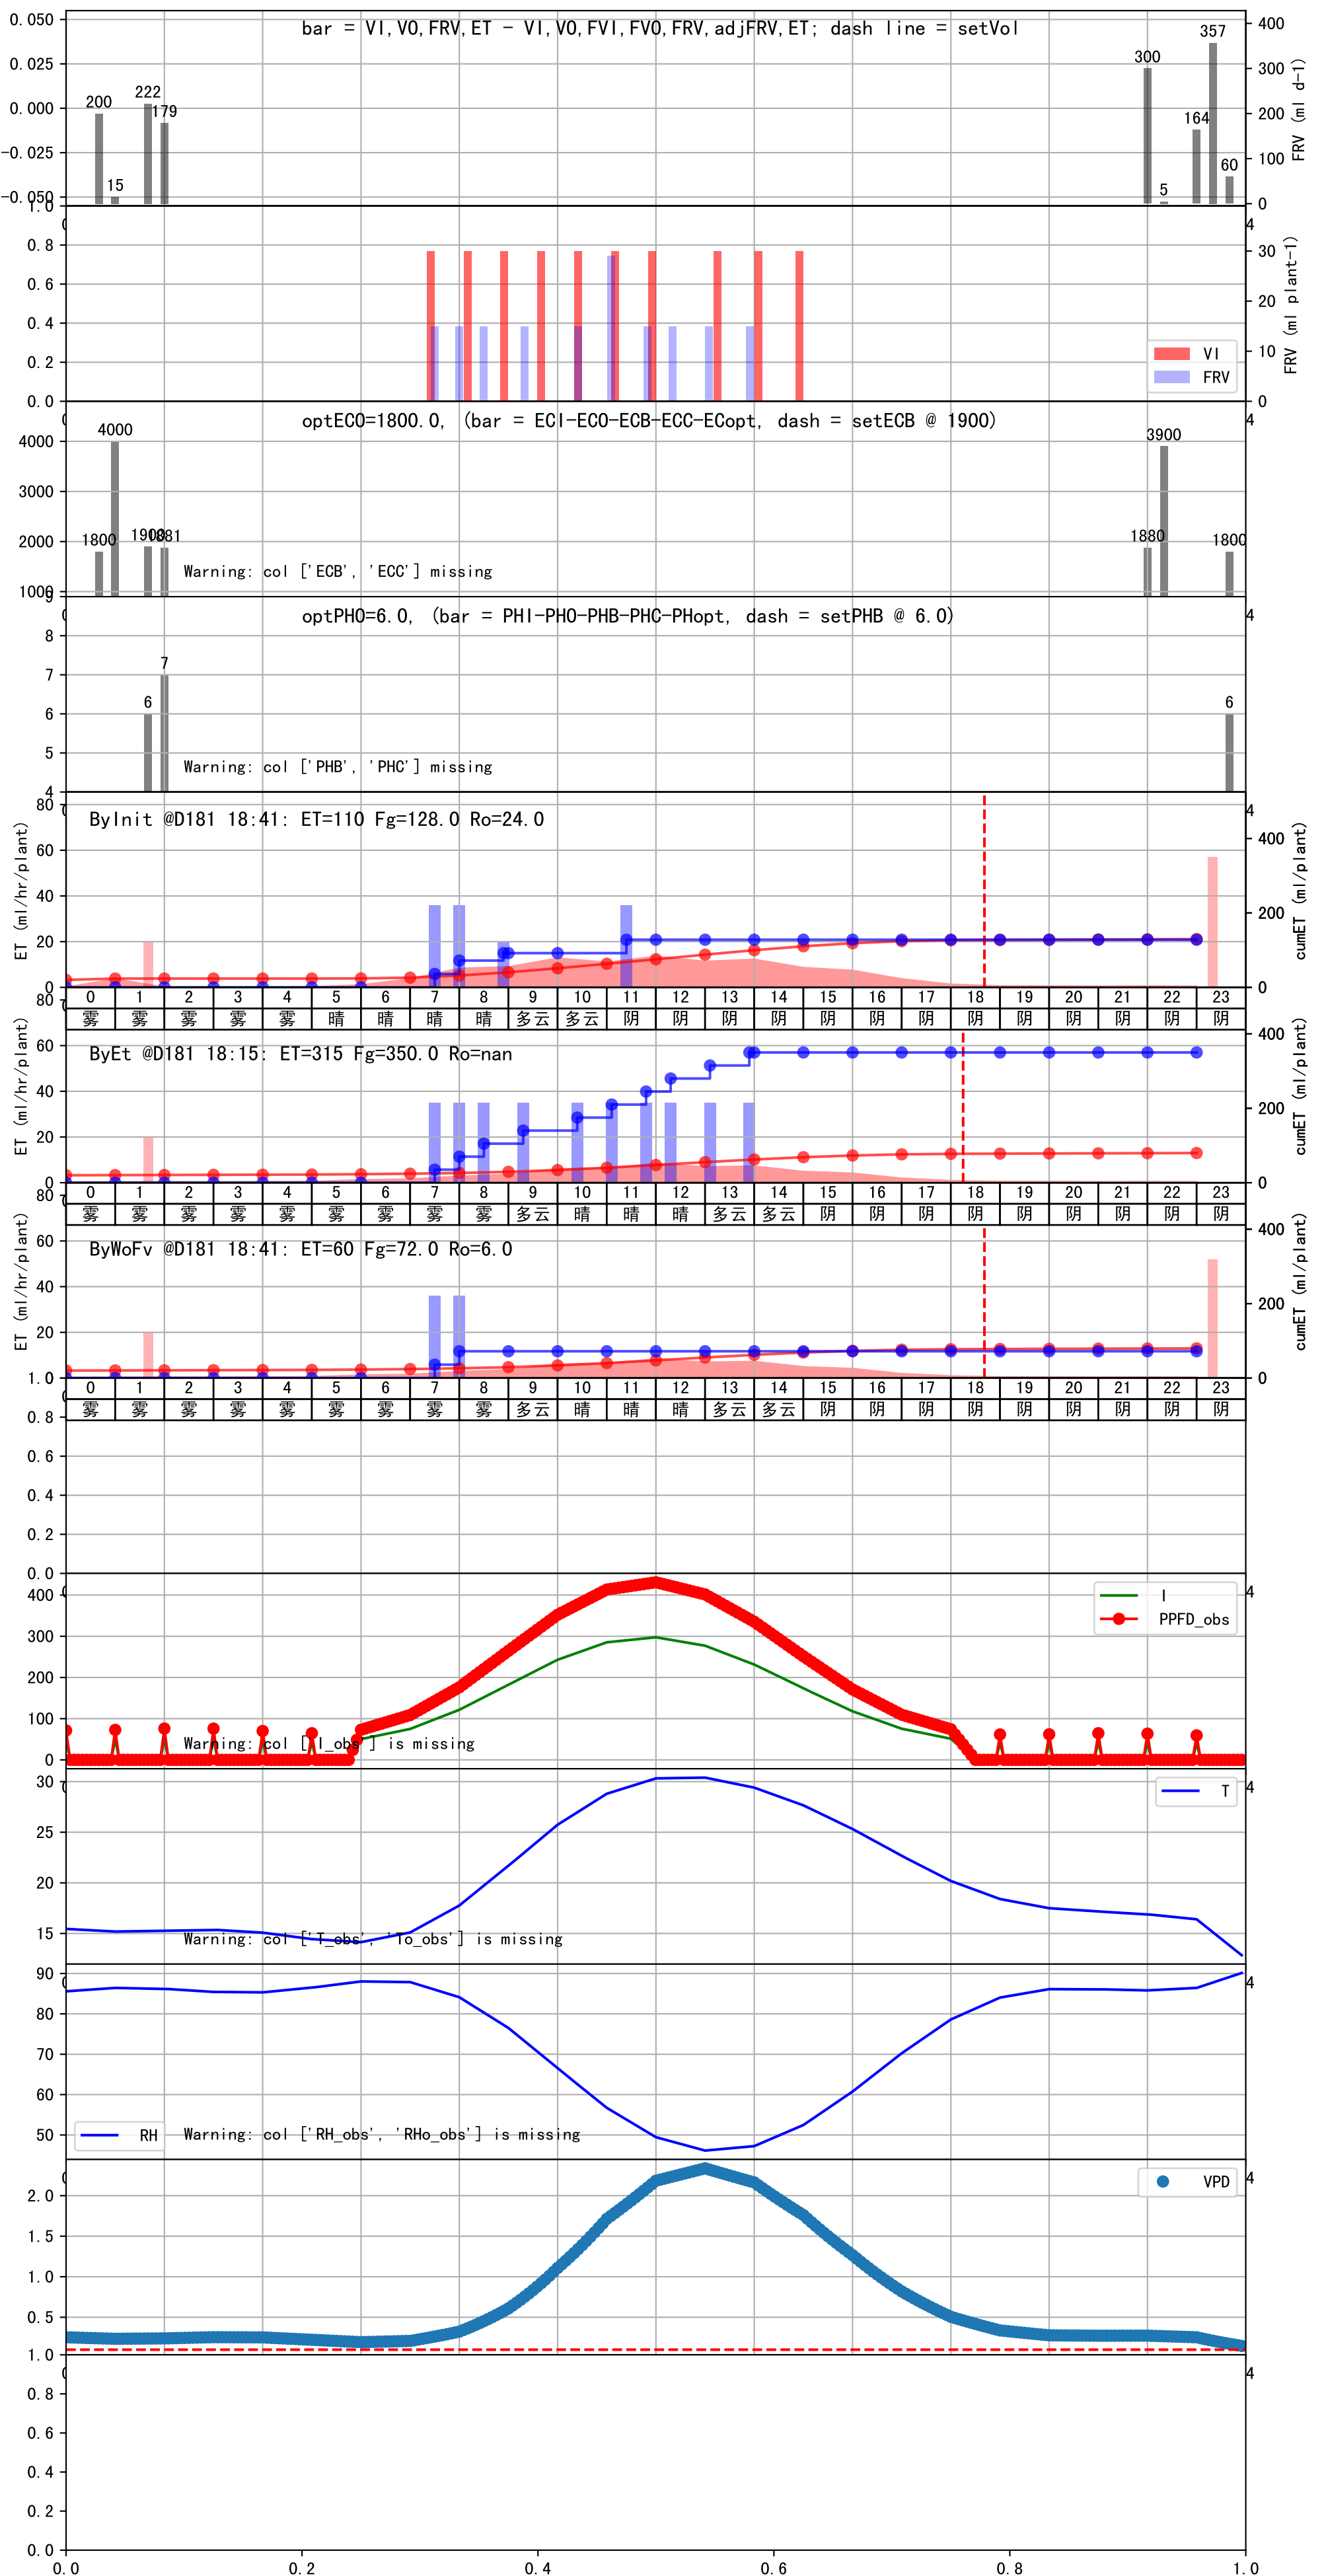
A阀开关时间(秒)	B阀开关时间(秒)
: 5, '关' : 17, '占空比' : 65.0], ['开' : 35, '关' : 47, '占空比' : 65.0]	[['开' : 18, '关' : 30, '占空比' : 65.0]
: 5, '关' : 17, '占空比' : 65.0], ['开' : 35, '关' : 47, '占空比' : 65.0]	[['开' : 18, '关' : 30, '占空比' : 65.0]

上次灌溉流速比过去5天平均小 (0.21 vs 0.61), 可能管道压力异常或有管道堵塞
 施肥机灌溉量与预期值不符 (15.0 : 36.0), 可能水表需要校准
 默认实际灌溉36.0 ml.
 上次灌溉施肥机流速0.207736092068636与平均值0.61偏差较大, 请检查。

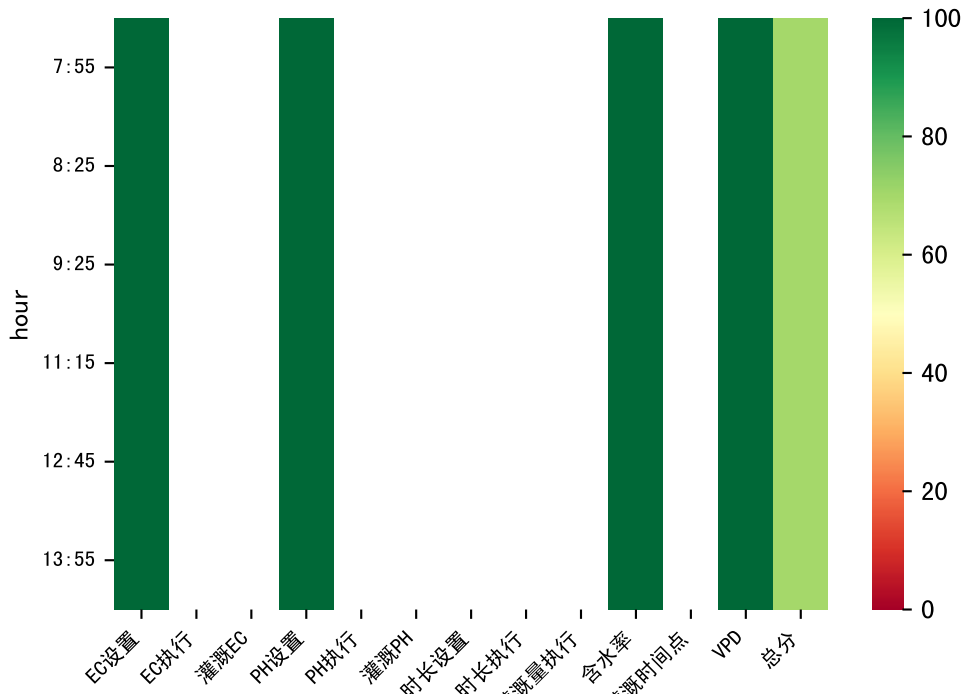
A 阀开关时间(秒)	B 阀
['开': 5, '关': 17, '占空比': 65.0], ['开': 35, '关': 47, '占空比': 65.0]	['开': 18, '关': 30, '占空比': 65.0]
['开': 5, '关': 17, '占空比': 65.0], ['开': 35, '关': 47, '占空比': 65.0]	['开': 18, '关': 30, '占空比': 65.0]
['开': 5, '关': 17, '占空比': 65.0], ['开': 35, '关': 47, '占空比': 65.0]	['开': 18, '关': 30, '占空比': 65.0]
['开': 5, '关': 17, '占空比': 65.0], ['开': 35, '关': 47, '占空比': 65.0]	['开': 18, '关': 30, '占空比': 65.0]
['开': 5, '关': 17, '占空比': 65.0], ['开': 35, '关': 47, '占空比': 65.0]	['开': 18, '关': 30, '占空比': 65.0]
['开': 5, '关': 17, '占空比': 65.0], ['开': 35, '关': 47, '占空比': 65.0]	['开': 18, '关': 30, '占空比': 65.0]

上次灌溉流速比过去5天平均小 (0.21 vs 0.61)，可能管道压力异常或有管道堵塞

施肥机灌溉量与预期值不符 (15.0 : 35.0)，可能水表需要校准

默认实际灌溉35.0 ml.

上次灌溉施肥机流速0.21070375052675938与平均值0.61偏差较大，请检查。

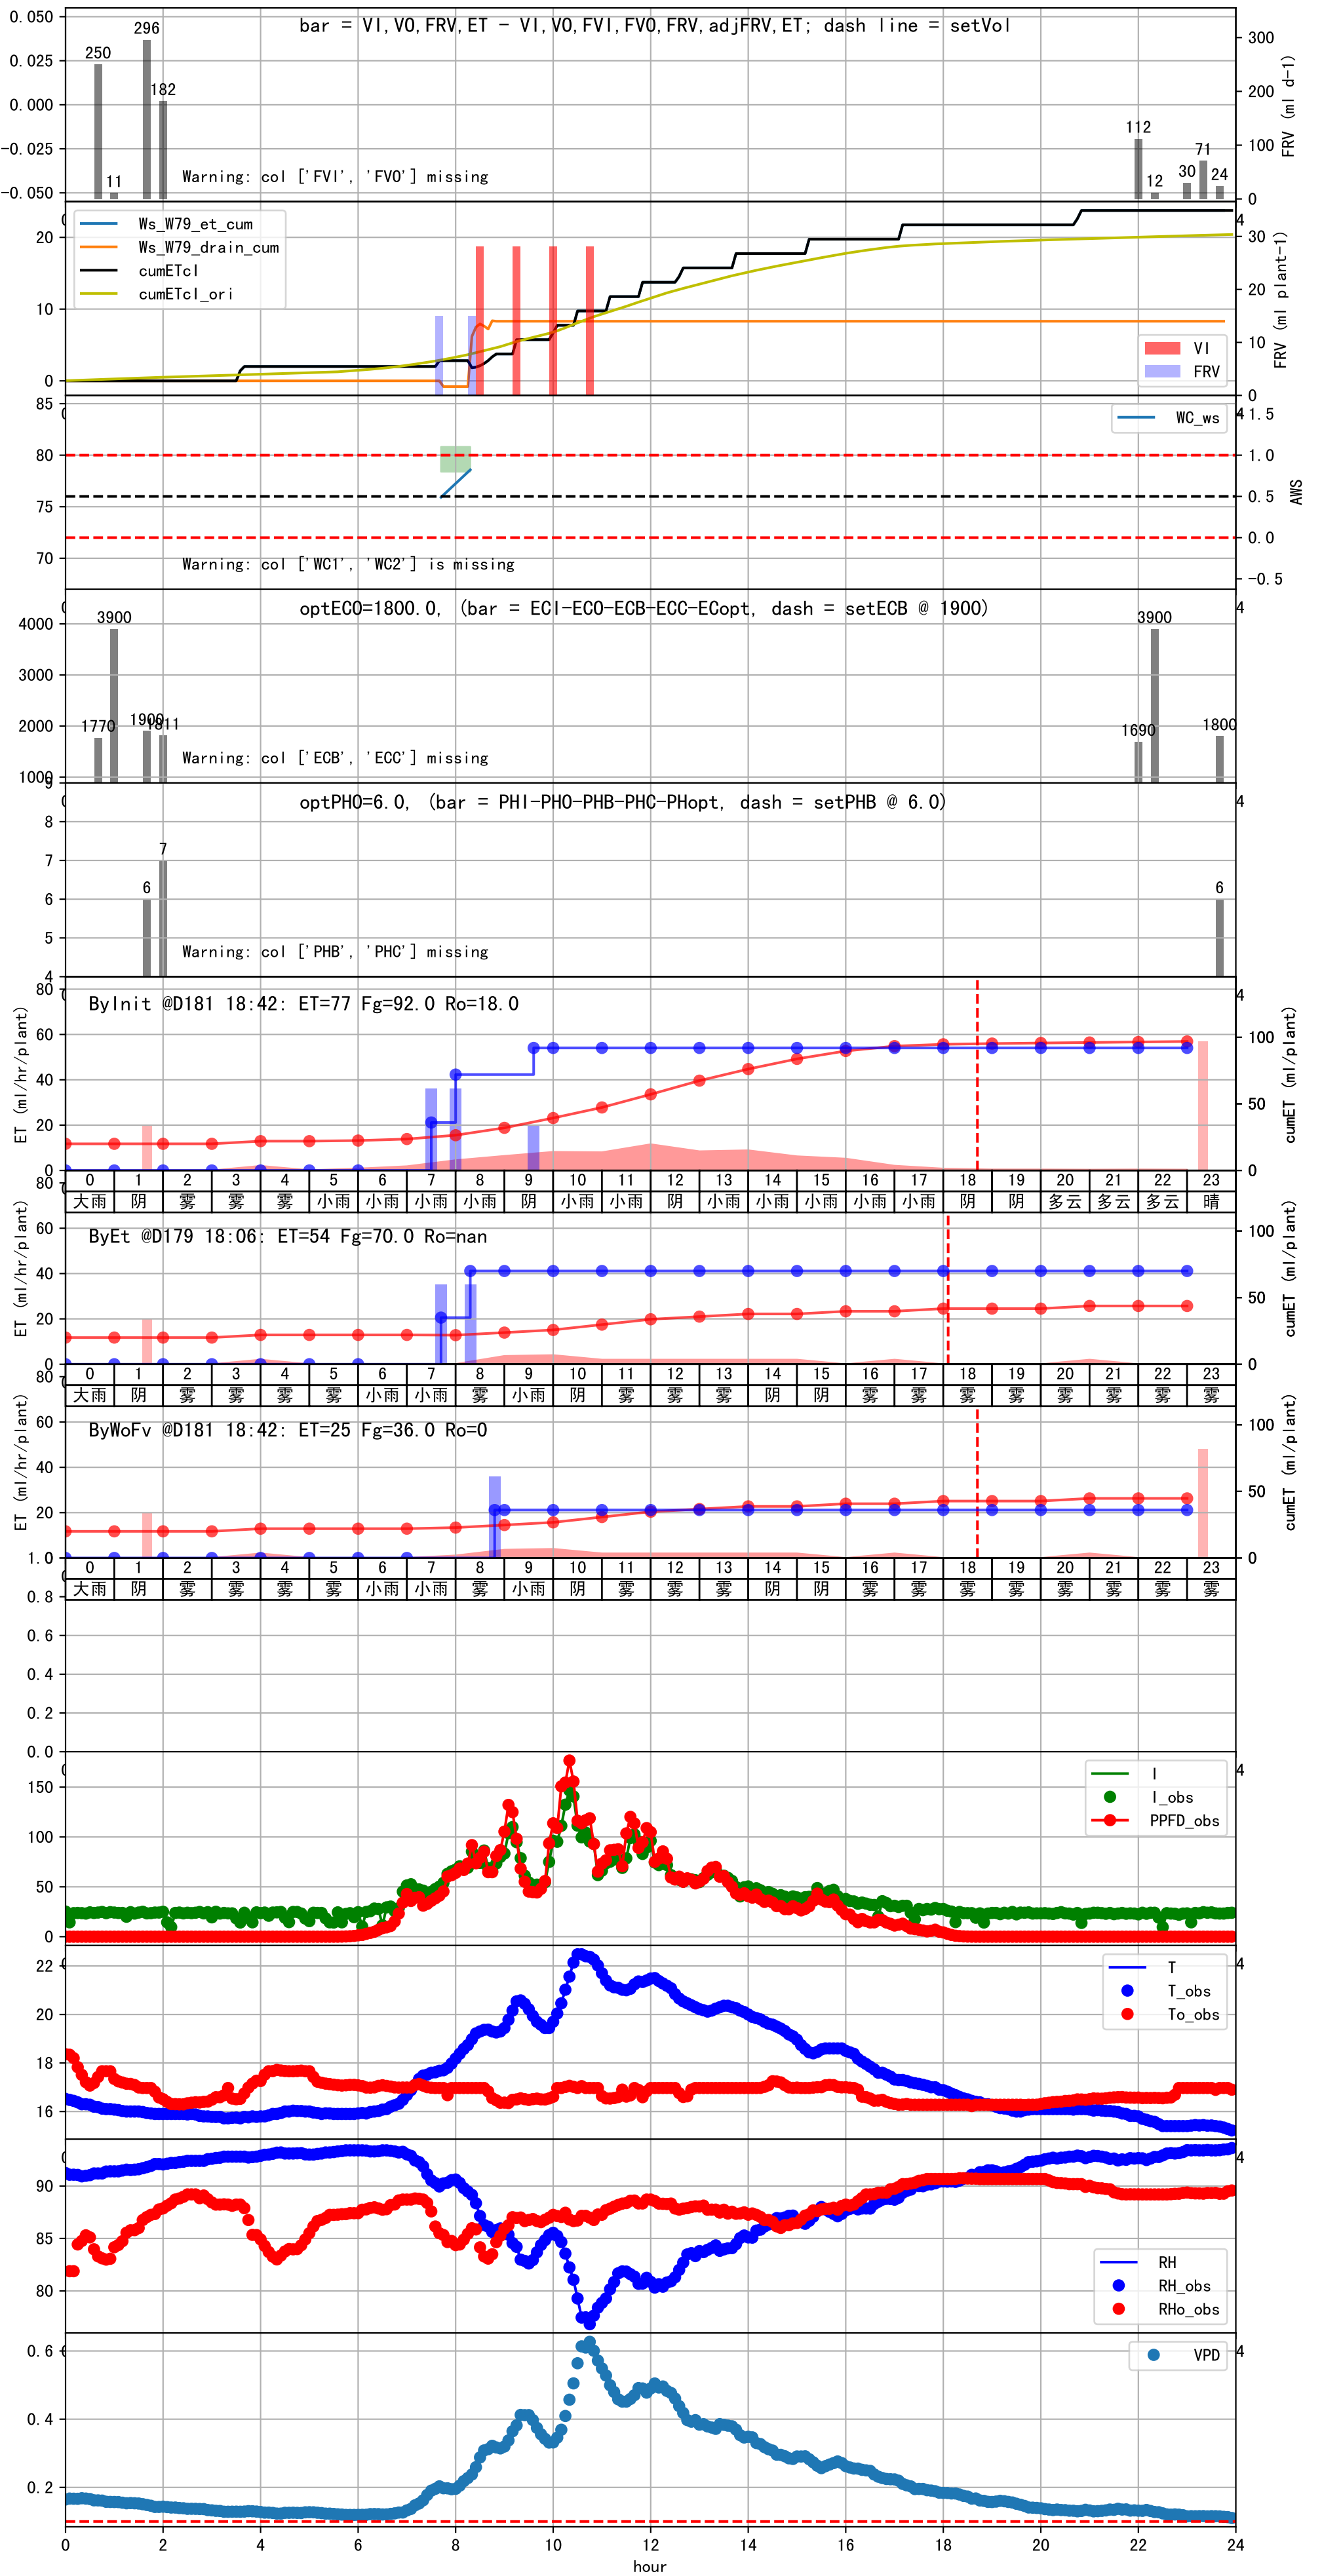
A阀开关时间(秒)	B阀开关
, '关' : 17, '占空比' : 65.0], ['开' : 35, '关' : 47, '占空比' : 65.0]	[['开' : 18, '关' : 30, '占空比' : 65.0],

上次灌溉流速比过去5天平均小 (0.2 vs 0.61), 可能管道压力异常或有管道堵塞
 施肥机灌溉量与预期值不符 (15.0 : 36.0), 可能水表需要校准
 默认实际灌溉36.0 ml.
 上次灌溉施肥机流速0.20485086856768273与平均值0.61偏差较大, 请检查。

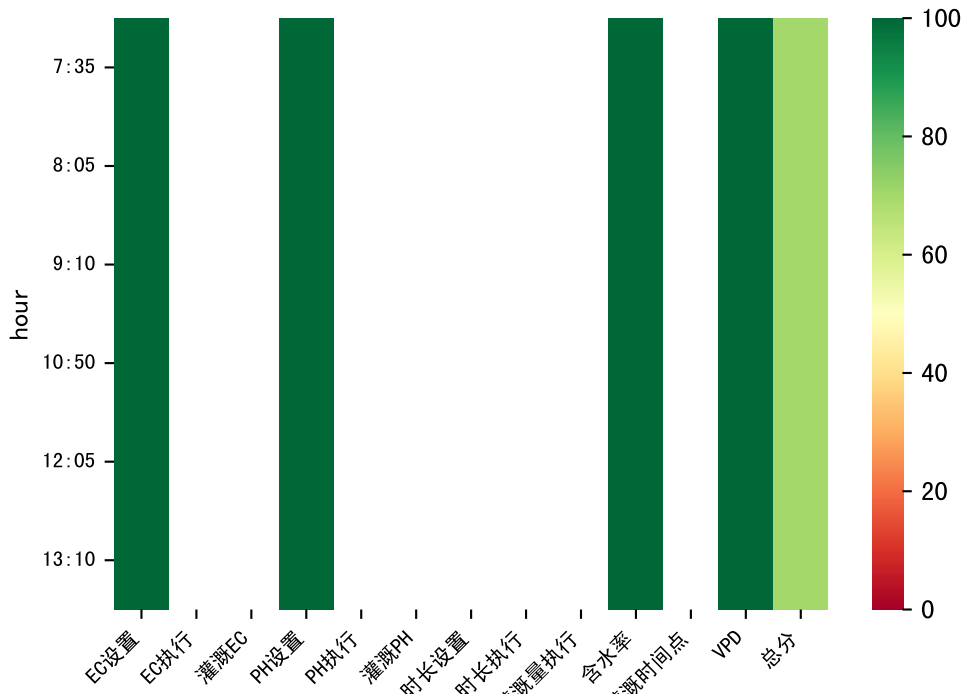
A 阀开关时间(秒)	B 阀
['开' : 5, '关' : 17, '占空比' : 65.0], ['开' : 35, '关' : 47, '占空比' : 65.0]	['开' : 18, '关' : 30, '占空比' : 65.0]
['开' : 5, '关' : 17, '占空比' : 65.0], ['开' : 35, '关' : 47, '占空比' : 65.0]	['开' : 18, '关' : 30, '占空比' : 65.0]
['开' : 5, '关' : 17, '占空比' : 65.0]	
['开' : 5, '关' : 17, '占空比' : 65.0], ['开' : 35, '关' : 47, '占空比' : 65.0]	['开' : 18, '关' : 30, '占空比' : 65.0]
['开' : 5, '关' : 17, '占空比' : 65.0], ['开' : 35, '关' : 47, '占空比' : 65.0]	['开' : 18, '关' : 30, '占空比' : 65.0]
['开' : 5, '关' : 17, '占空比' : 65.0], ['开' : 35, '关' : 47, '占空比' : 65.0]	['开' : 18, '关' : 30, '占空比' : 65.0]

上次灌溉流速比过去5天平均小 (0.21 vs 0.61)，可能管道压力异常或有管道堵塞

施肥机灌溉量与预期值不符 (15.0 : 35.0)，可能水表需要校准

默认实际灌溉35.0 ml.

上次灌溉施肥机流速0.21070375052675938与平均值0.61偏差较大，请检查。
