FgArea: [' C5']
NJ15 L1
2026-03-13 (Day 158)

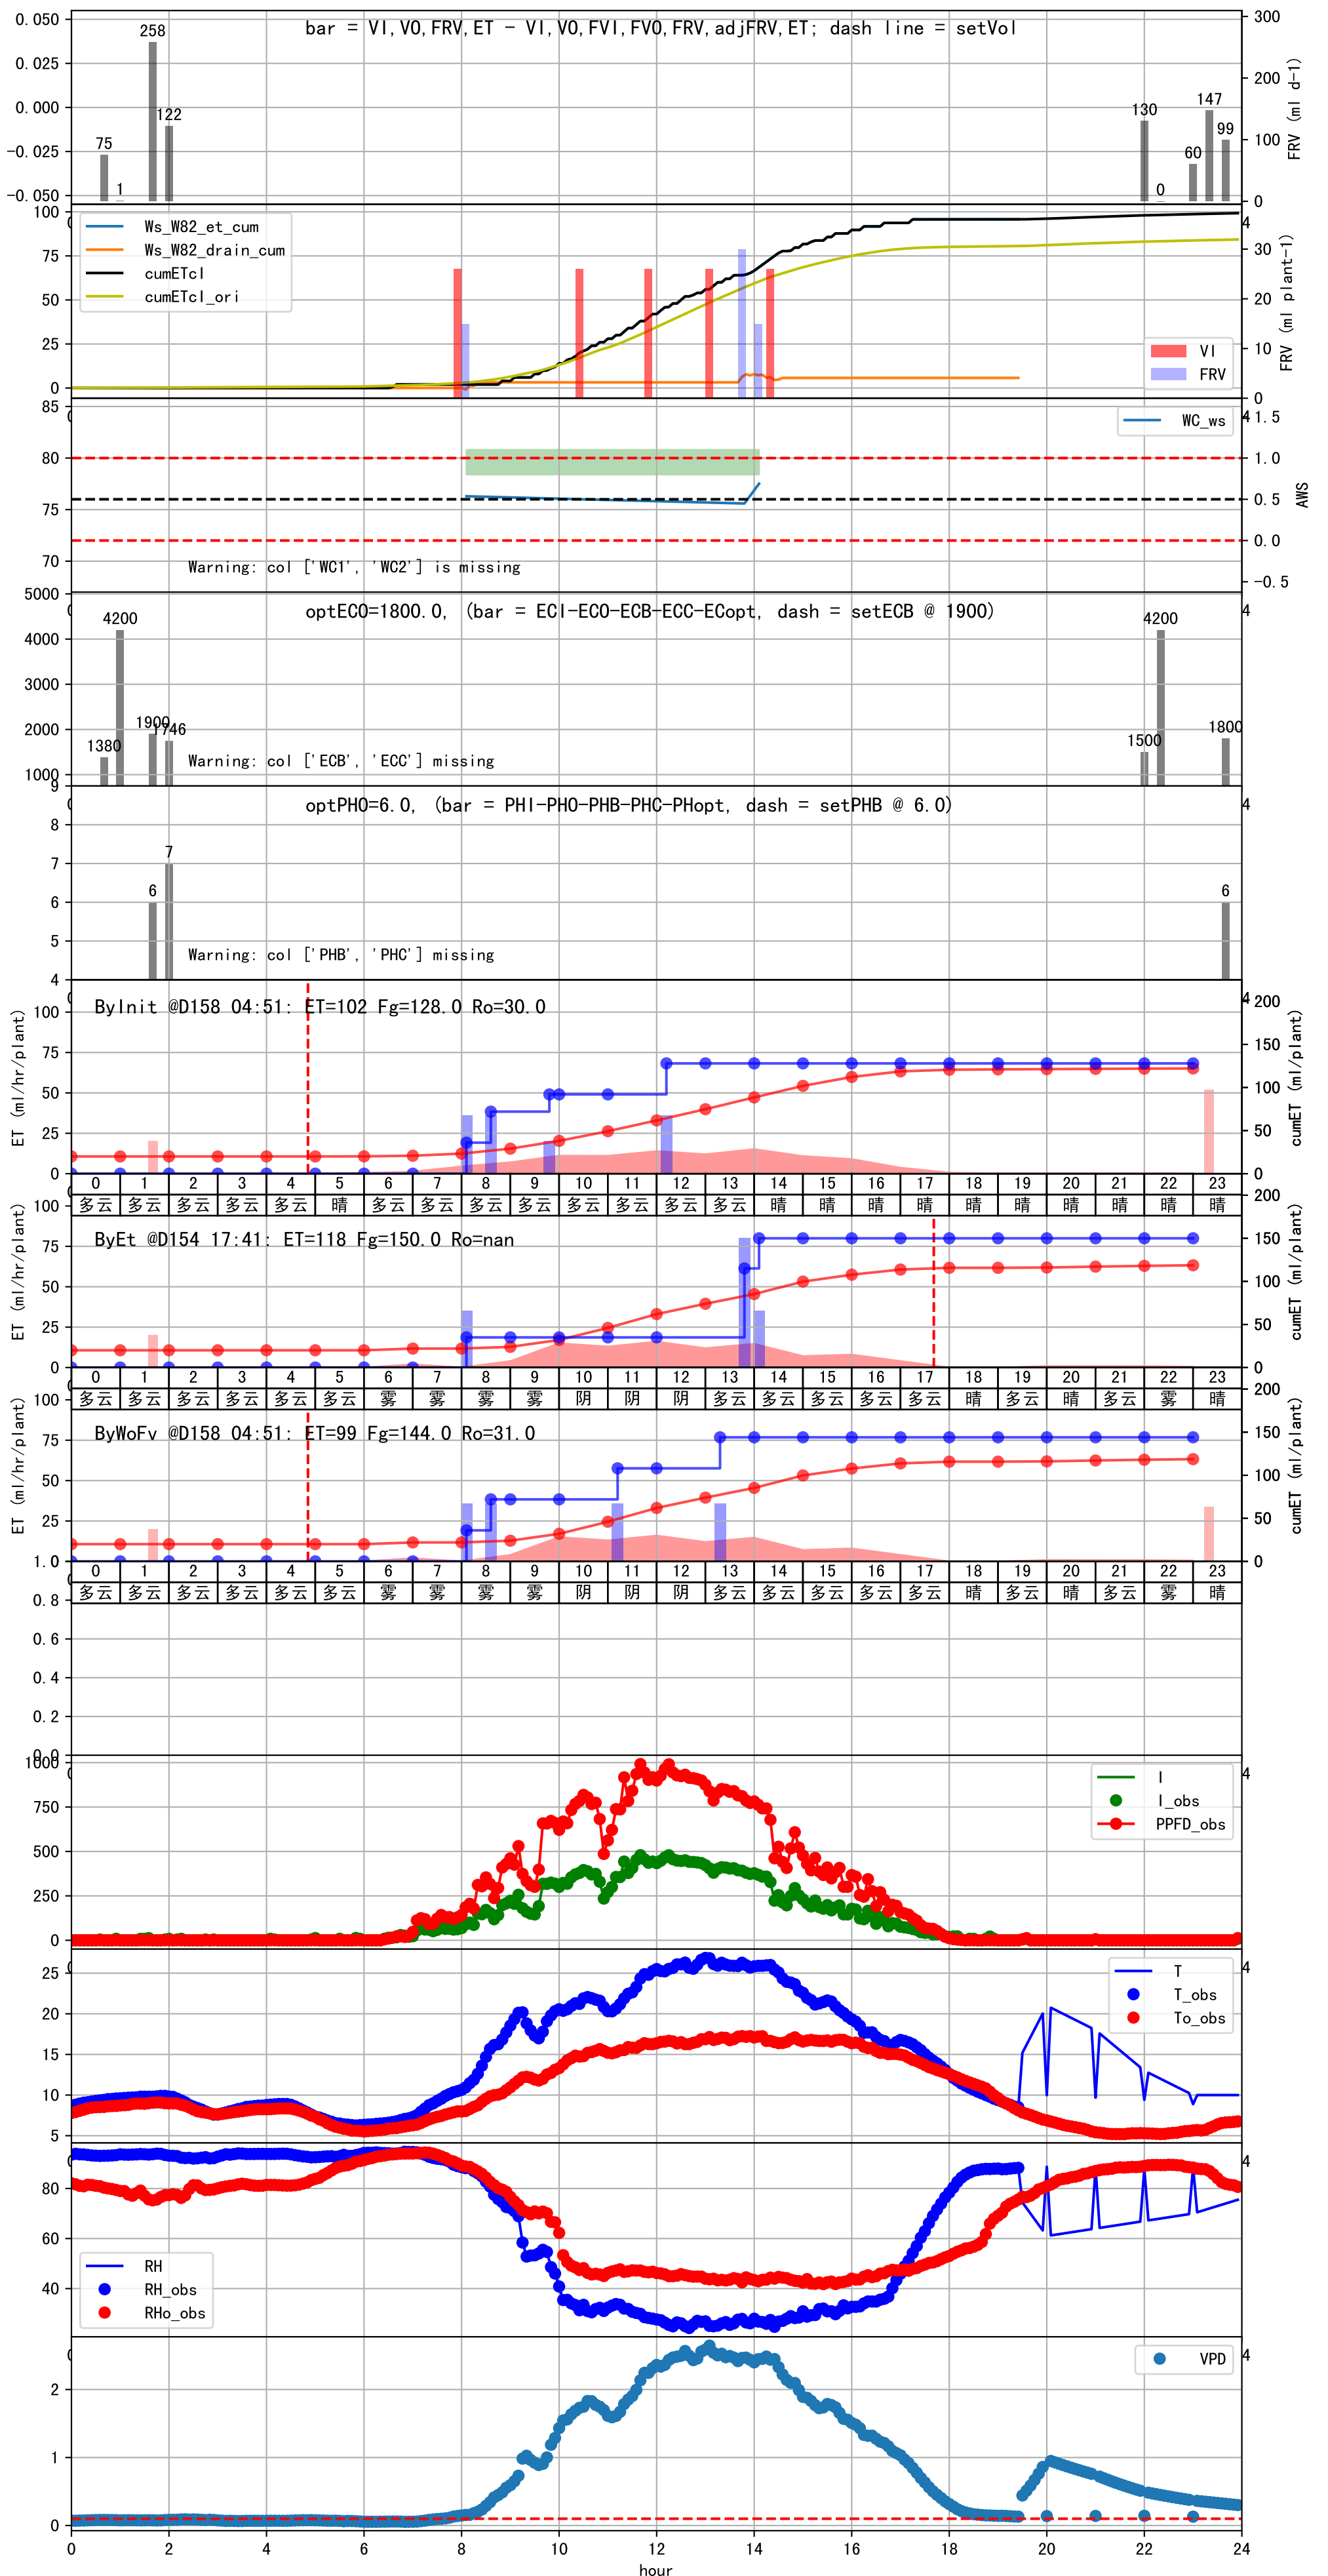
A阀开关时间(秒)	B阀开
: 5, '关' : 14, '占空比' : 50.0}, {'开' : 35, '关' : 44, '占空比' : 50.0}]	[{'开' : 15, '关' : 24, '占空比' : 50.0
: 5, '关' : 14, '占空比' : 50.0}, {'开' : 35, '关' : 44, '占空比' : 50.0}]	[{'开' : 15, '关' : 24, '占空比' : 50.0
: 5, '关' : 14, '占空比' : 50.0}, {'开' : 35, '关' : 44, '占空比' : 50.0}]	[{'开' : 15, '关' : 24, '占空比' : 50.0
: 5, '关' : 14, '占空比' : 50.0}, {'开' : 35, '关' : 44, '占空比' : 50.0}]	[{'开' : 15, '关' : 24, '占空比' : 50.0

上次灌溉流速比过去5天平均小 (0.21 vs 0.7), 可能管道压力异常或有管道堵塞
 施肥机灌溉量与预期值不符 (15.0 : 36.0), 可能水表需要校准

上次灌溉施肥机流速0.207736092068636与平均值0.7偏差较大, 请检查。
