FgArea: [' C5' ]  
NJ15 L1  
2026-04-05 (Day 181)

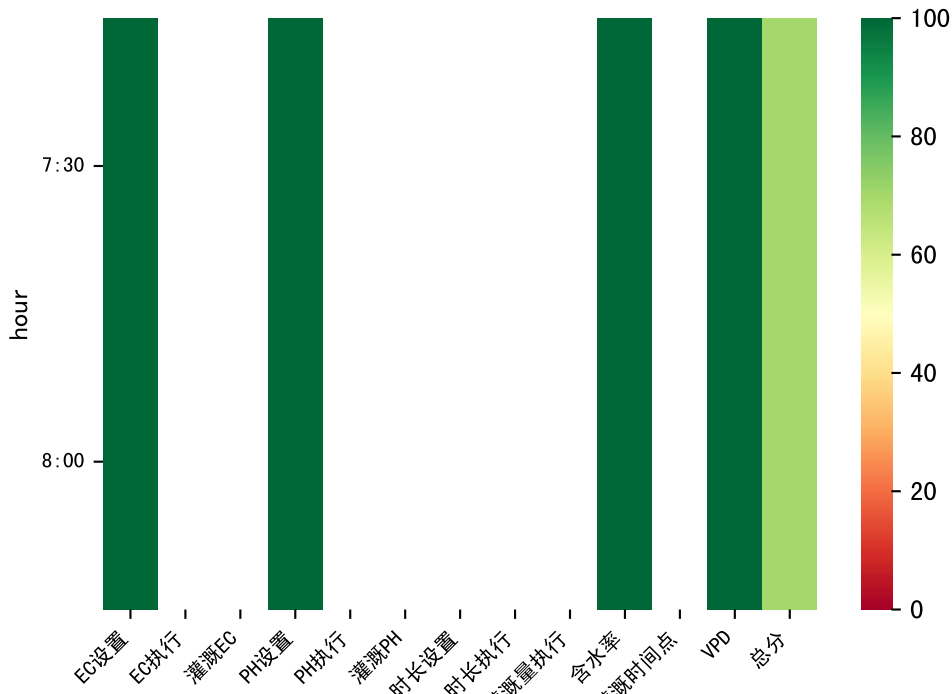
A阀开关时间(秒)	B阀开关时间(秒)
: 5, '关' : 17, '占空比' : 65.0], ['开' : 35, '关' : 47, '占空比' : 65.0]	[['开' : 18, '关' : 30, '占空比' : 65.0]
: 5, '关' : 17, '占空比' : 65.0], ['开' : 35, '关' : 47, '占空比' : 65.0]	[['开' : 18, '关' : 30, '占空比' : 65.0]

上次灌溉流速比过去5天平均小 (0.42 vs 0.61), 可能管道压力异常或有管道堵塞  
 施肥机灌溉量与预期值不符 (29.0 : 36.0), 可能水表需要校准  
 默认实际灌溉36.0 ml.

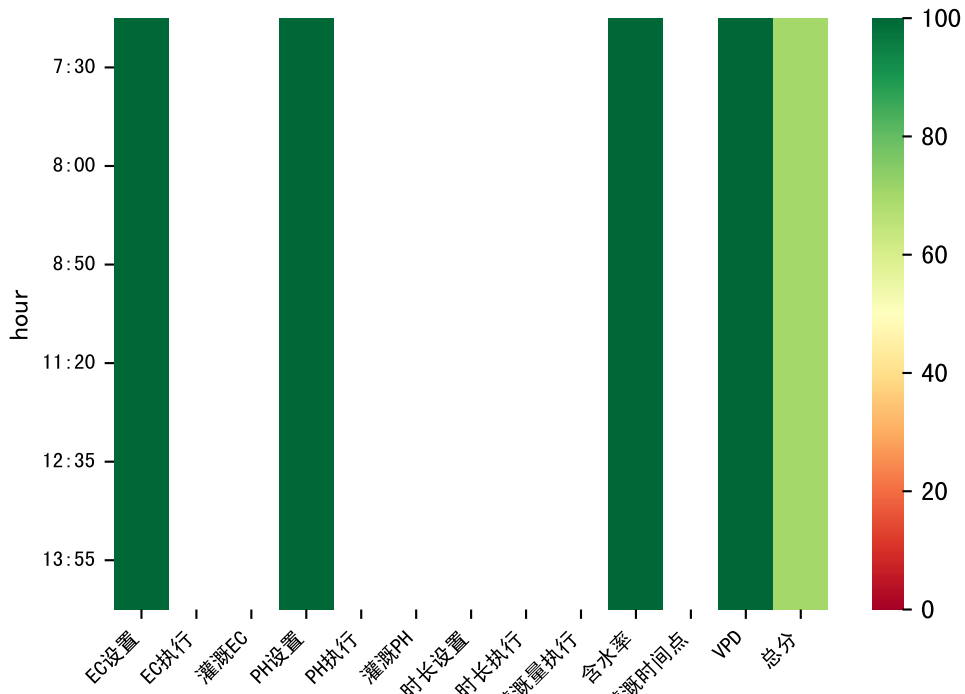
A阀开关时间(秒)	B阀
['开': 5, '关': 17, '占空比': 65.0], ['开': 35, '关': 47, '占空比': 65.0]	['开': 18, '关': 30, '占空比': 65.0]
['开': 5, '关': 17, '占空比': 65.0], ['开': 35, '关': 47, '占空比': 65.0]	['开': 18, '关': 30, '占空比': 65.0]
['开': 5, '关': 17, '占空比': 65.0], ['开': 35, '关': 47, '占空比': 65.0]	['开': 18, '关': 30, '占空比': 65.0]
['开': 5, '关': 17, '占空比': 65.0], ['开': 35, '关': 47, '占空比': 65.0]	['开': 18, '关': 30, '占空比': 65.0]
['开': 5, '关': 17, '占空比': 65.0], ['开': 35, '关': 47, '占空比': 65.0]	['开': 18, '关': 30, '占空比': 65.0]
['开': 5, '关': 17, '占空比': 65.0], ['开': 35, '关': 47, '占空比': 65.0]	['开': 18, '关': 30, '占空比': 65.0]

上次灌溉流速比过去5天平均小 (0.21 vs 0.61)，可能管道压力异常或有管道堵塞  
 施肥机灌溉量与预期值不符 (15.0 : 36.0)，可能水表需要校准  
 默认实际灌溉36.0 ml.  
 上次灌溉施肥机流速0.207736092068636与平均值0.61偏差较大，请检查。

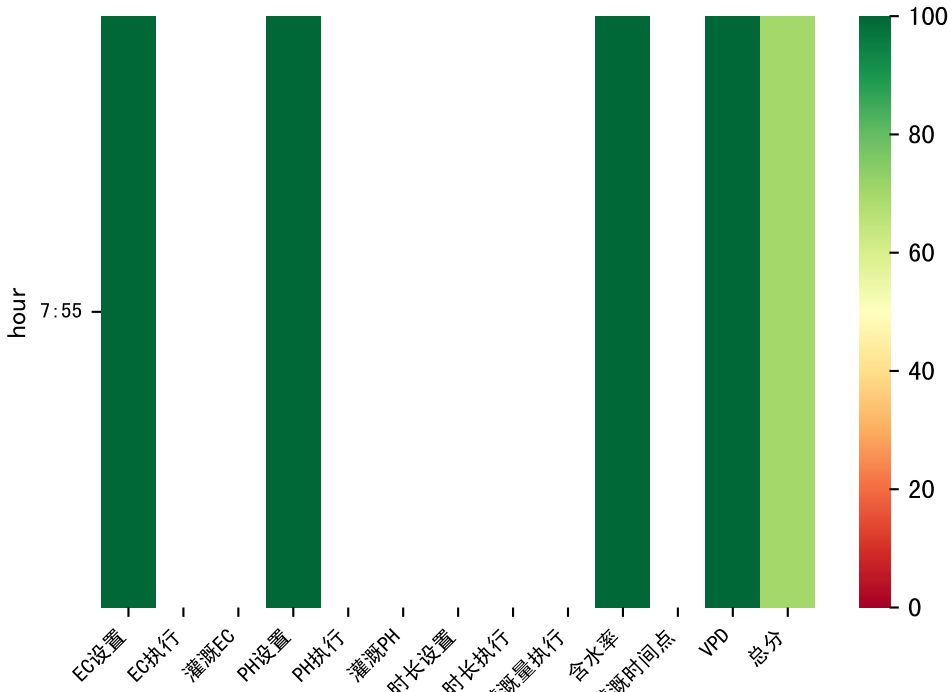
A阀开关时间(秒)	B阀开关
, '关' : 17, '占空比' : 65.0], ['开' : 35, '关' : 47, '占空比' : 65.0]	[{'开' : 18, '关' : 30, '占空比' : 65.0],

上次灌溉流速比过去5天平均小 (0.21 vs 0.61), 可能管道压力异常或有管道堵塞  
 施肥机灌溉量与预期值不符 (15.0 : 36.0), 可能水表需要校准  
 默认实际灌溉36.0 ml.  
 上次灌溉施肥机流速0.207736092068636与平均值0.61偏差较大, 请检查。

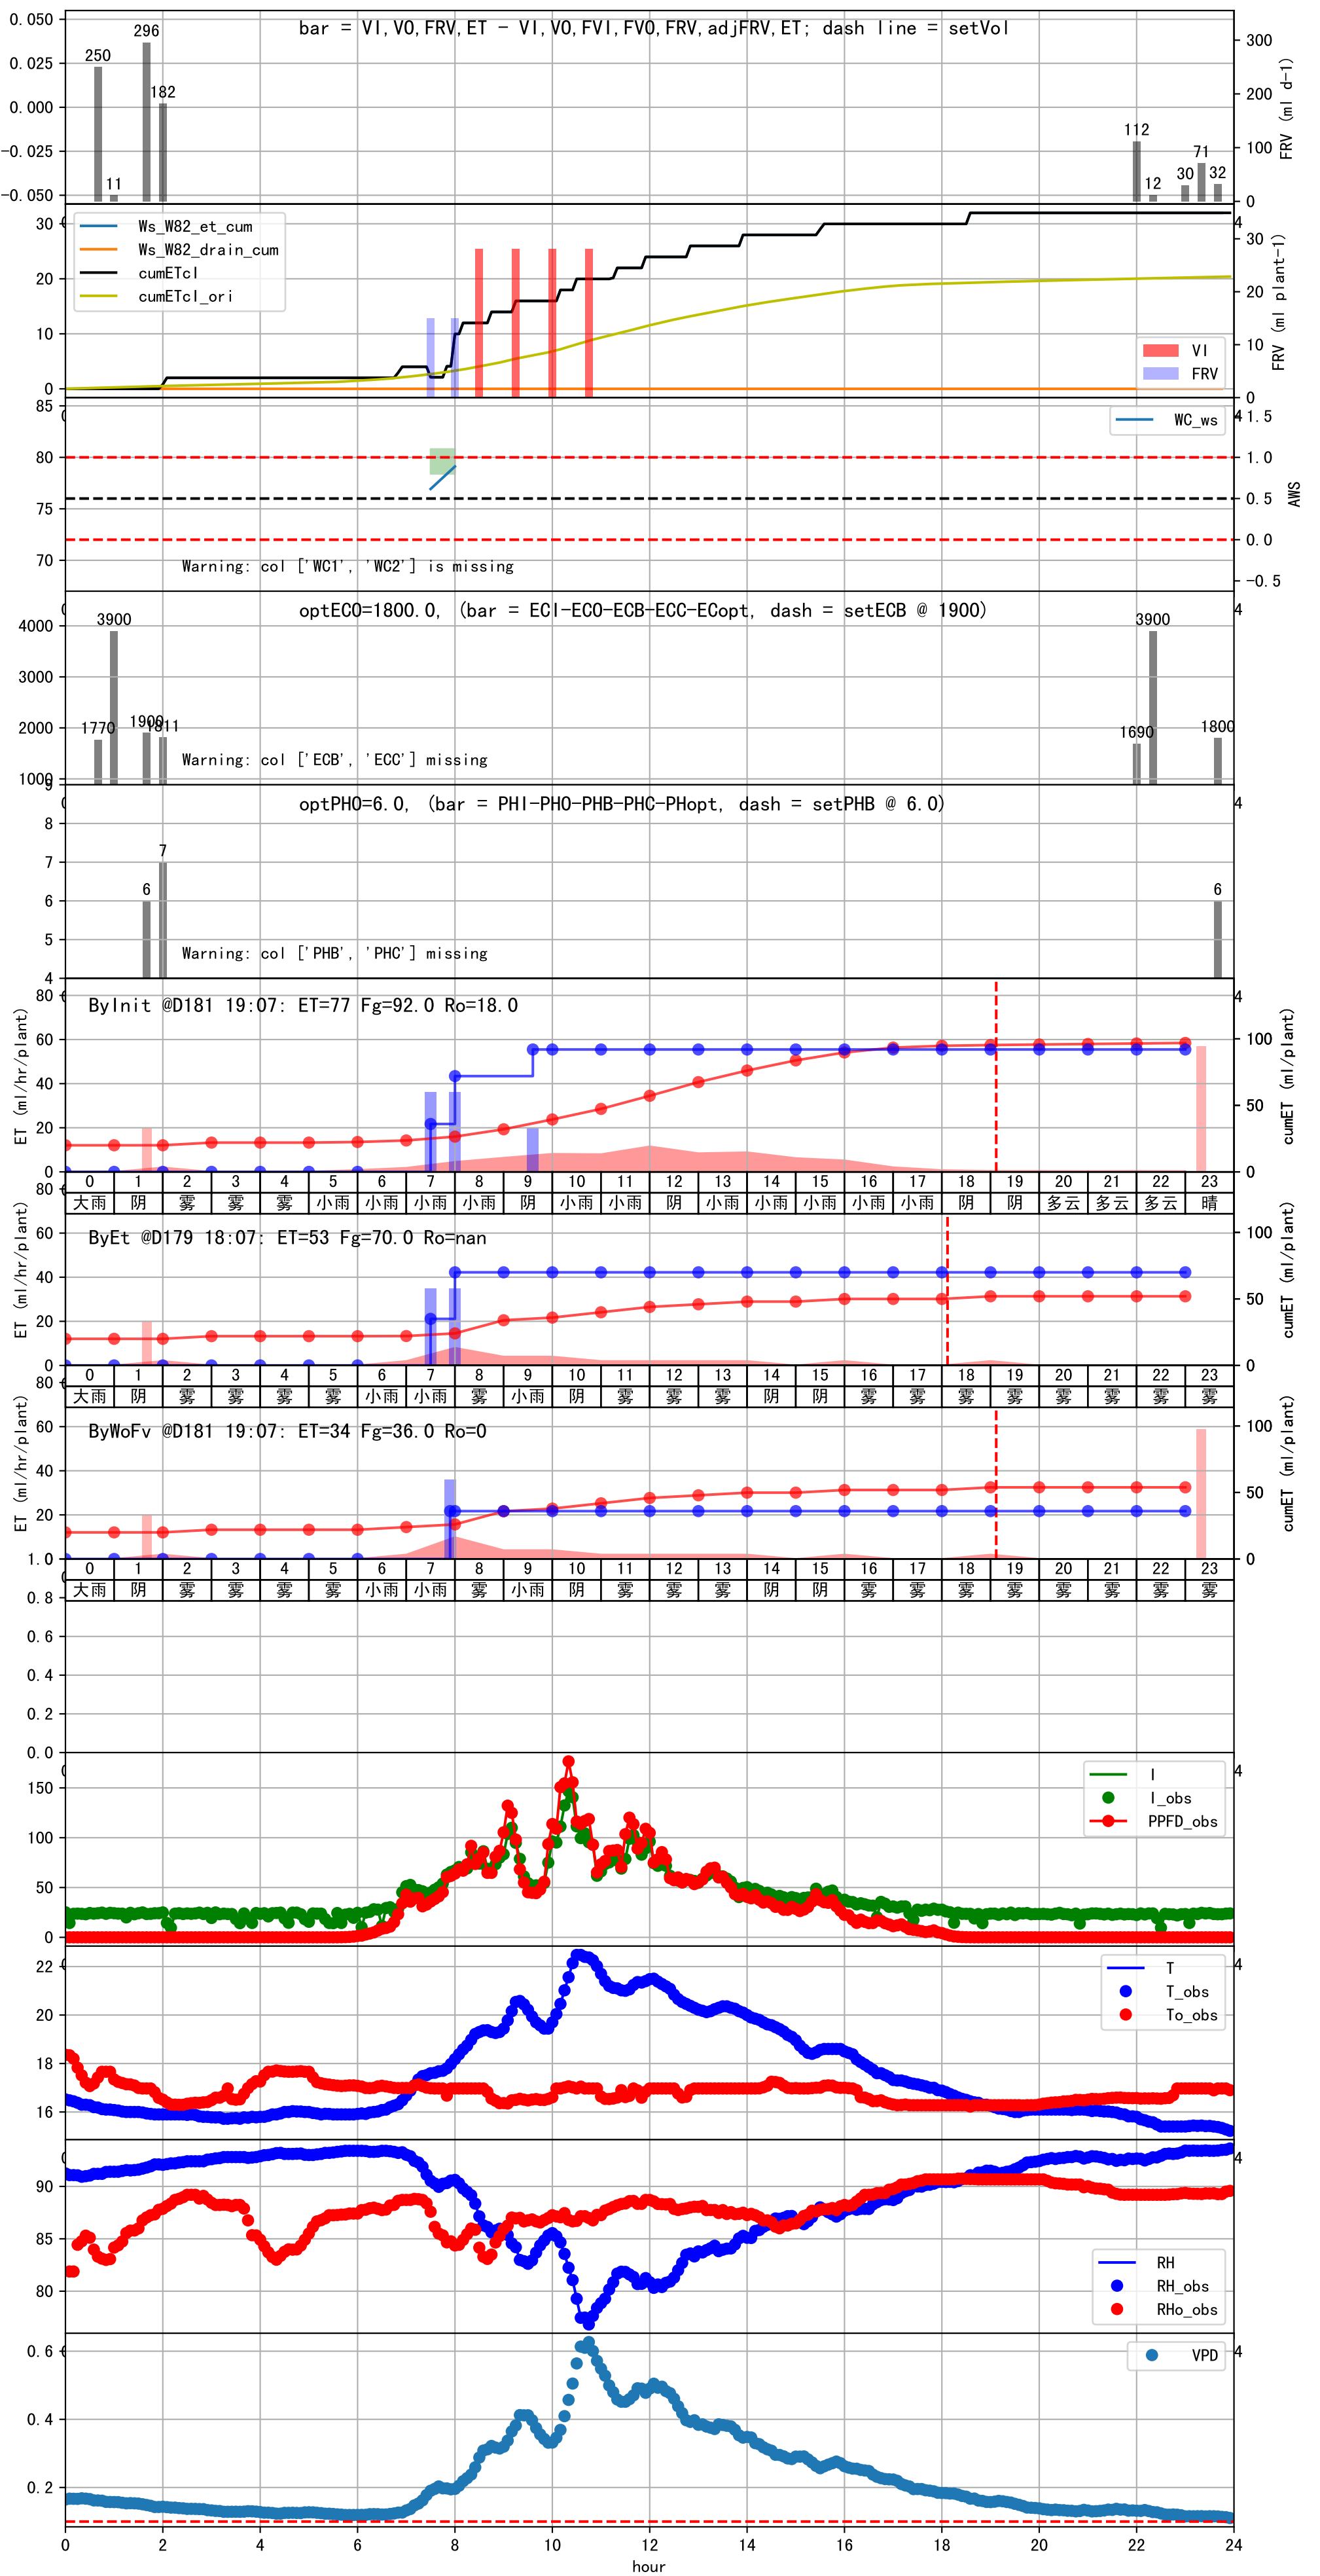
A阀开关时间(秒)	B阀
' : 5, '关' : 17, '占空比' : 65.0], ['开' : 35, '关' : 47, '占空比' : 65.0]	['开' : 18, '关' : 30, '占空比' : 65.
' : 5, '关' : 17, '占空比' : 65.0], ['开' : 35, '关' : 47, '占空比' : 65.0]	['开' : 18, '关' : 30, '占空比' : 65.
['开' : 5, '关' : 17, '占空比' : 65.0]	
' : 5, '关' : 17, '占空比' : 65.0], ['开' : 35, '关' : 47, '占空比' : 65.0]	['开' : 18, '关' : 30, '占空比' : 65.
' : 5, '关' : 17, '占空比' : 65.0], ['开' : 35, '关' : 47, '占空比' : 65.0]	['开' : 18, '关' : 30, '占空比' : 65.
' : 5, '关' : 17, '占空比' : 65.0], ['开' : 35, '关' : 47, '占空比' : 65.0]	['开' : 18, '关' : 30, '占空比' : 65.
' : 5, '关' : 17, '占空比' : 65.0], ['开' : 35, '关' : 47, '占空比' : 65.0]	['开' : 18, '关' : 30, '占空比' : 65.

上次灌溉流速比过去5天平均小 (0.21 vs 0.61), 可能管道压力异常或有管道堵塞

施肥机灌溉量与预期值不符 (15.0 : 36.0), 可能水表需要校准

默认实际灌溉36.0 ml.

上次灌溉施肥机流速0.207736092068636与平均值0.61偏差较大, 请检查。

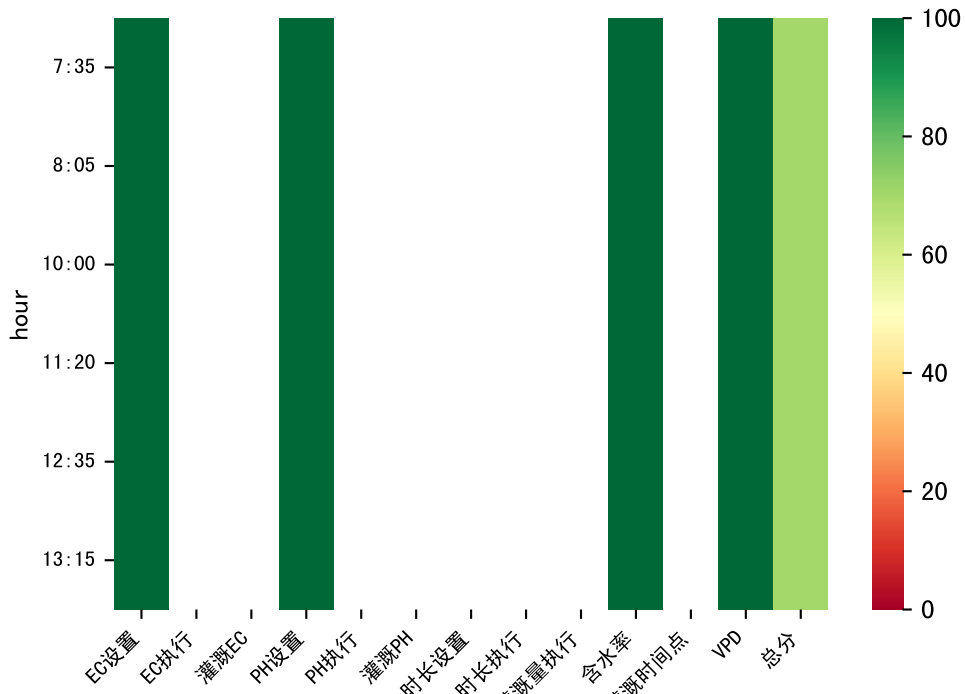
A 阀开关时间(秒)	B 阀
' : 5, '关' : 17, '占空比' : 65.0], ['开' : 35, '关' : 47, '占空比' : 65.0]	['开' : 18, '关' : 30, '占空比' : 65.
' : 5, '关' : 17, '占空比' : 65.0], ['开' : 35, '关' : 47, '占空比' : 65.0]	['开' : 18, '关' : 30, '占空比' : 65.
['开' : 5, '关' : 17, '占空比' : 65.0]	
' : 5, '关' : 17, '占空比' : 65.0], ['开' : 35, '关' : 47, '占空比' : 65.0]	['开' : 18, '关' : 30, '占空比' : 65.
' : 5, '关' : 17, '占空比' : 65.0], ['开' : 35, '关' : 47, '占空比' : 65.0]	['开' : 18, '关' : 30, '占空比' : 65.
['开' : 5, '关' : 17, '占空比' : 65.0]

上次灌溉流速比过去5天平均小 (0.2 vs 0.61), 可能管道压力异常或有管道堵塞  
 施肥机灌溉量与预期值不符 (15.0 : 36.0), 可能水表需要校准

默认实际灌溉36.0 ml.

上次灌溉施肥机流速0.20485086856768273与平均值0.61偏差较大, 请检查。
