FgArea: [' 0']
SS40 XX6
2026-02-18 (Day 164)

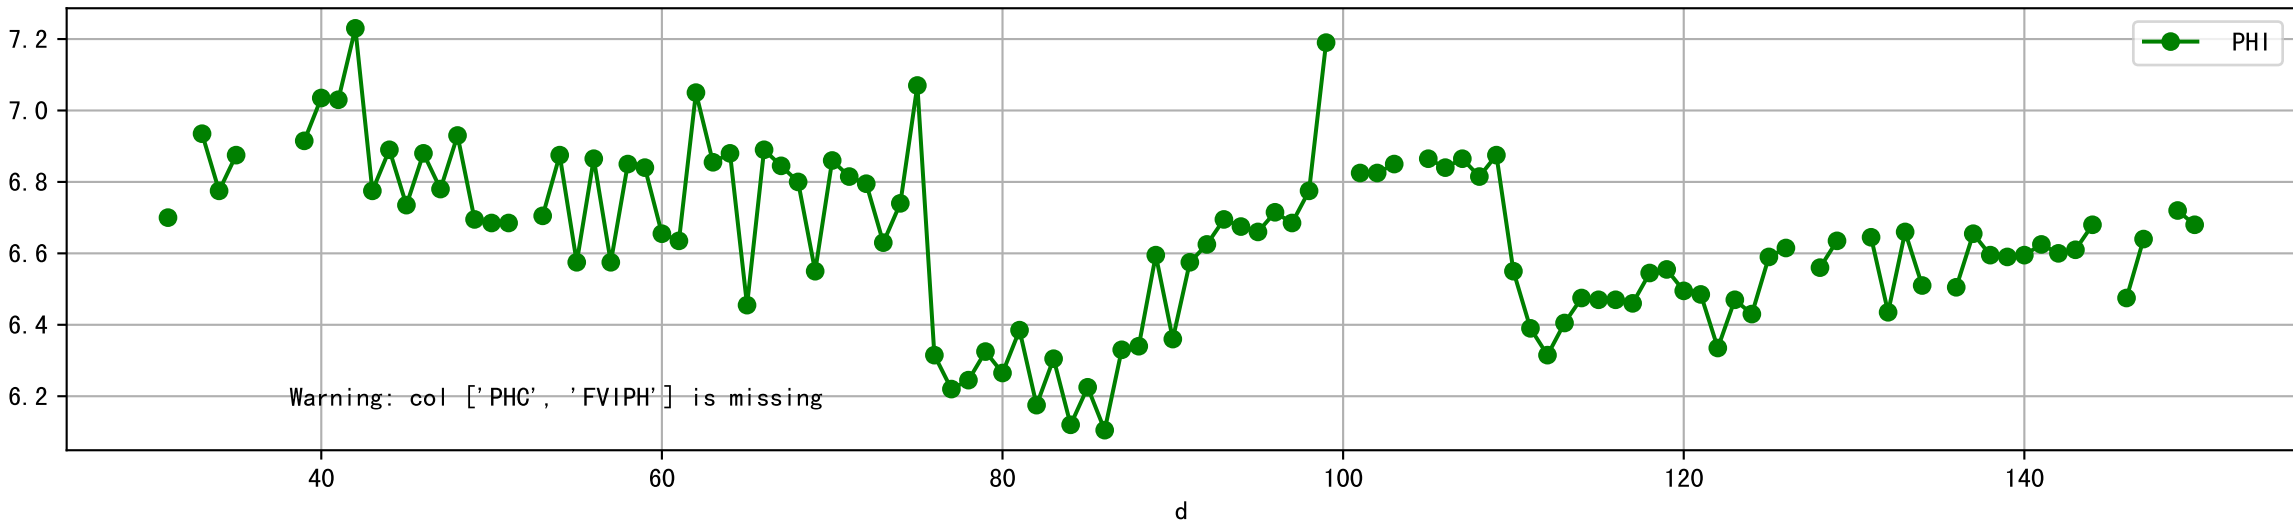
Plot [['PHC:b-o', 'FVIPH:r-o', 'PHI:g-o']]

Warning: col ['PHC', 'FVIPH'] is missing
